This is a repository copy of *Induced thermo-mechanical damage in the drilling of thermoplastic-toughened CFRP composites*.

Merino Perez, J.L., Hodzic, A., Merson, E. et al. (1 more author) (2015) Induced thermo-mechanical damage in the drilling of thermoplastic-toughened CFRP composites. In: Proceedings of;. 20th International Conference on Composite Materials, 19-24 Jul 2015, Copenhagen, Denmark. .

INDUCED THERMO-MECHANICAL DAMAGE IN THE DRILLING OF THERMOPLASTIC-TOUGHENED CFRP COMPOSITES

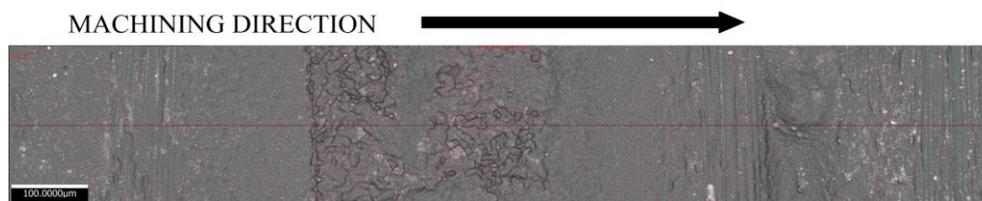
Figure 1. Corrected scanned area of a drilled hole surface. The image allows distinguishing layers having different fibre orientations.

The surface analysis considered three different locations on each scanned specimen profile: hole entry, middle and hole exit. The size of the scan box was $1,250 \times 200 \mu\text{m}$, resulting in an actual size of approximately $1,250 \times 220 \mu\text{m}$ after surface area calibration. Figure 1 illustrates an example of a corrected scanned area.

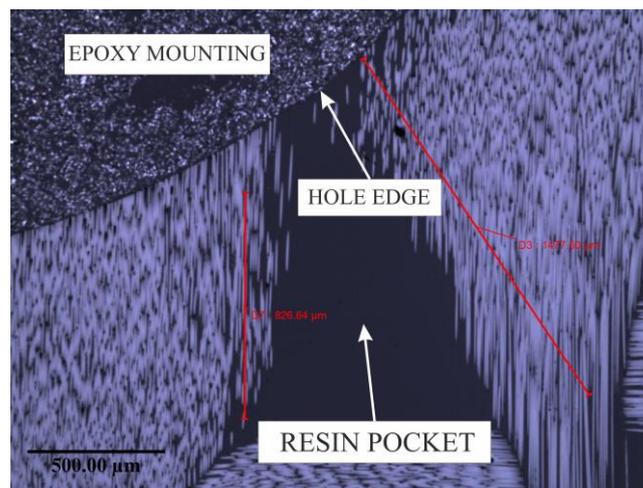
Figure 2. Micrograph showing an example of resin pocket around the hole edge. D3 (1,477.50 μ m) and D7 (826.64 μ m) indicate the magnitude of the pocket. This image obtained using Nikon *Eclipse LV150* optical microscope.

The grinding stage utilised P400, P800 and P1200 grit size silicon carbide discs, whereas the polishing utilised 6 μ m, 3 μ m, 1 μ m and 0.25 μ m diamond suspensions. Since the heat generated in the drilling of composites was localised in a small area around the borehole (HAZ) [22], this study measured the bulk resin properties in resin pockets from the hole edge up to 1 mm away, as represented in Figure 2.

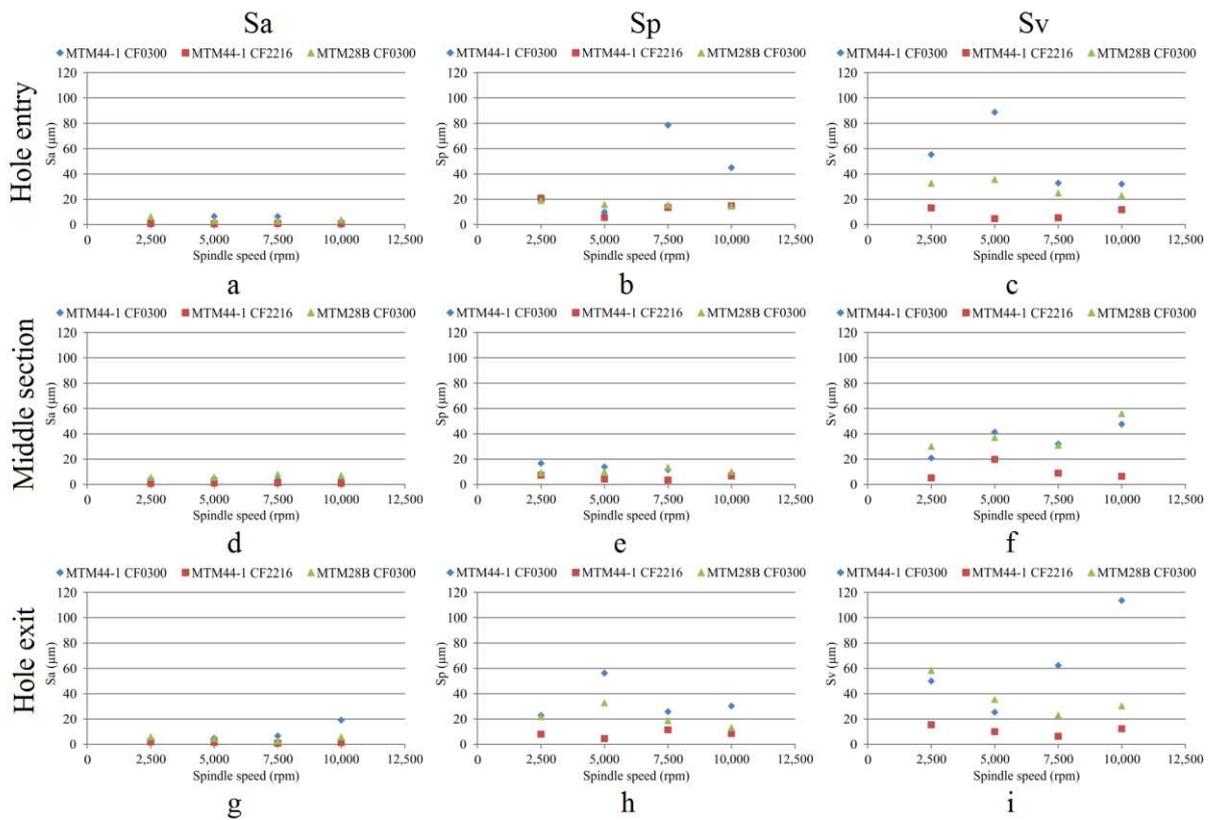
Figure 3 illustrates the values of surface average height (S_a), maximum peak height (S_p) and maximum valley depth (S_v) for the drilled CFRP composites profiles at selected cutting speeds. Results show low surface average height values (10-20 μ m) through the inspected hole (Figures 3a, d and g) for all the considered CFRP systems and cutting speeds. However, values of maximum peak height and valley depth indicate dissimilar trends. For MTM44-1 CF2216 composite, S_p and S_v values are consistently low and comparable to those of surface average height (S_a).

On the other hand, composites having HS reinforcement (CF0300) exhibited S_p and S_v values higher and more deviated from their respective values of S_a , especially in the system containing high T_g resin (MTM44-1), at the hole entry and hole exit (Figures 3(b, c), 3(h) and 3(i)).

Figure 3. Surface analysis values of the scanned drilled profiles. Top, middle and bottom rows show hole entry, middle section and hole exit values respectively, while left, middle and right columns show surface average height (Sa), maximum peak height (Sp) and maximum valley depth (Sv) measurements respectively.

A possible explanation for these trends is related to the stability of the machining at different drilling stages. At the hole entry, the tool is not fully engaged in the material yet, whereas at the hole exit the tool is no longer backed by the workpiece and the developed temperatures are maximum [22]. Hence, these regions would yield a less stable drilling operation, and less uniform drilled surfaces compared to the middle section. In order to understand the values of Sa, Sp and Sv in this investigation, it is necessary to analyse the 3D surface topography and SEM scans obtained, as depicted in Figure 4.

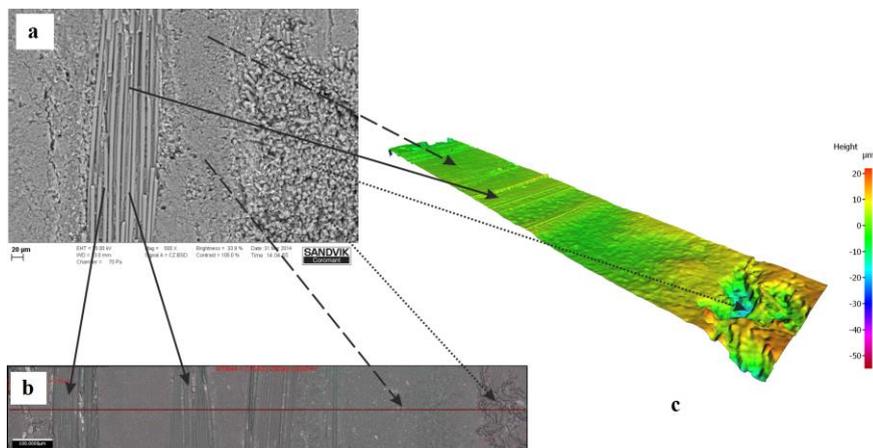
Figure 4. Visual description of the surface topography features in a) SEM, b) 2D corrected surface, and c) 3D surface scans. Continuous, dashed and dotted lines point to areas having approximately 90° , 0° and $\pm 45^\circ$ fibres respectively.

Figure 4(c) shows that maximum heights correspond to areas having 90° and ±45° fibre orientations. These regions show significant out-of-plane fibres and fibre pull-out, hence Sp values would correspond to these types of defects (splintering and irregularly cut fibres). On the other hand, regions showing negative height values correspond to ±45° fibre regions. According to the scans, these regions would develop unclean fibre cutting compared to 0° and 90° regions, thus removing significant volumes of fibre with resin attached, and creating this type of crater defects.

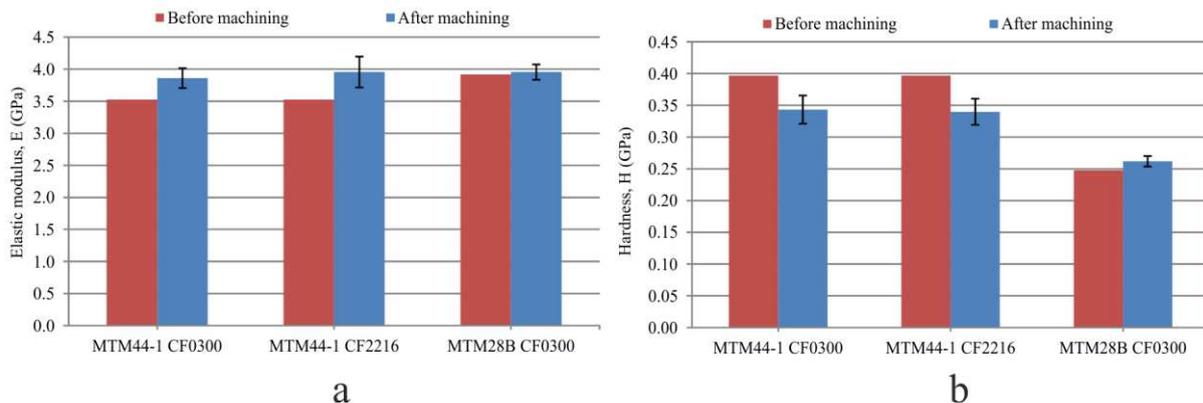
Figure 5. Average values of elastic modulus and hardness of the resin phase around the hole after drilling three CFRP systems at different cutting speeds (blue) and bulk values before drilling (red).

Values of the elastic modulus increased for all the studied systems (Figure 5a), with the difference being greater for the system with highly cross-linked resin (MTM44-1) compared to the system with lower cross-linking density (MTM28B) [21-23]. However, the hardness values (Figure 5b) show a dissimilar behaviour. Composites with MTM44-1 resin exhibited a decrease in hardness, whereas the system with MTM28B showed a slight increase in hardness values. These results indicate a characteristic thermal ageing at different stages of the machining process.

Temperatures developed in the drilling process for the studied systems were higher than their respective T_g in all the cases. Systems having MTM44-1 resin developed temperatures in the workpiece between 205°C and 250°C, depending on the type of reinforcement and the cutting speed, whereas MTM28B CF0300 system developed temperatures around 135°C [21, 22]. These

Localised post cross-linking of the resin during the drilling in the regions close to the hole edge would help to explain the increased elastic modulus in MTM44-1 resins.

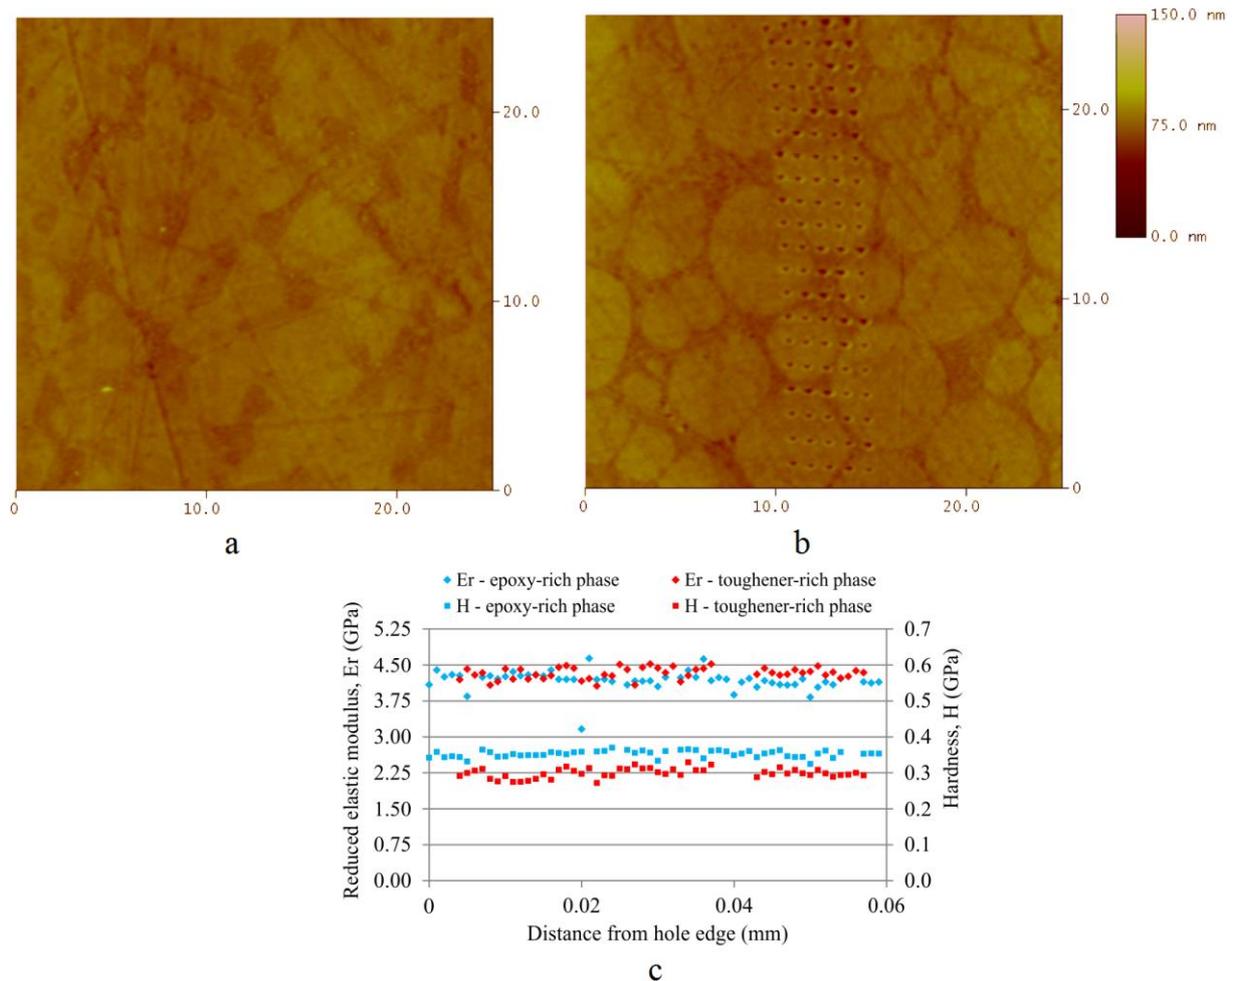
Figure 6. AFM images showing the phase distribution and morphology of a) MTM28B, b) MTM44-1 resins and (c) the hardness and reduced elastic modulus corresponding to the phases in MTM44-1 resin.

The AFM micrographs depicted in Figure 6 revealed highly toughened, two-phase morphologies of the studied resins, however they presented distinct structures. MTM28B resin showed a more uniform phase distribution having a lobe-like toughener-rich phase inside a dominant epoxy-rich phase (Figure 6a). On the other hand, MTM44-1 presented total phase separation where the epoxy-rich phase acquired a globular structure surrounded by a reticulated toughener-rich phase (Figure 6b). Both phases also exhibited differences on their mechanical properties, being more clear for the hardness than for the reduced elastic modulus values (Figure 6c). The epoxy-rich phase yielded consistently

values of hardness above those of the toughener-rich phase; however the difference is not as evident for the reduced elastic modulus, which presented similar values in both phases. In addition to this, the epoxy-rich phase yielded more consistent values of both properties, while the values corresponding to the toughener-rich phase exhibited more fluctuation.

Another reason that would explain this behaviour and also the elevated values of elastic modulus of MTM28B resin compared to MTM44-1 systems, both before and after drilling, is related to the viscoelastic nature of the epoxies, their respective molecular structures and some limitations of the nanoindentation technique to study polymers. Figure 6 illustrates the morphologies of MTM44-1 and MTM28B resins.

This can be explained because of the yield or relaxation process (related to the partially viscous behaviour of polymers), which is more pronounced in polymers and phases presenting lower degree of cross-linking [3, 4], and the way the reduced elastic modulus is calculated from the nanoindentations [25]. In the nanoindentation of polymers, after the loading stage (or the load hold stage if set), the polymer relaxation process produces the yield flow, therefore varying the maximum indentation depth (h) and load (P). This forms a meniscus (or nose) at the beginning of the unloading stage, more or less pronounced depending on the material and the indentation set-up, which impedes a proper fitting of the tangent at the beginning of the unloading curve. This tangent is used to calculate the stiffness (S) of the material ($S=dP/dh$), which is then used to obtain the reduced elastic modulus. Hence, the non-proper fitting of the tangent to the unload curve caused by the material flow can lead to anomalous measurements of the reduced elastic modulus.
