6th International Workshop on Performance, Protection & Strengthening of Structures under Extreme Loading, PROTECT2017, 11-12 December 2017, Guangzhou (Canton), China

Fire Protection of Concrete Tunnel Linings with Waste Tyre Fibres

Abstract

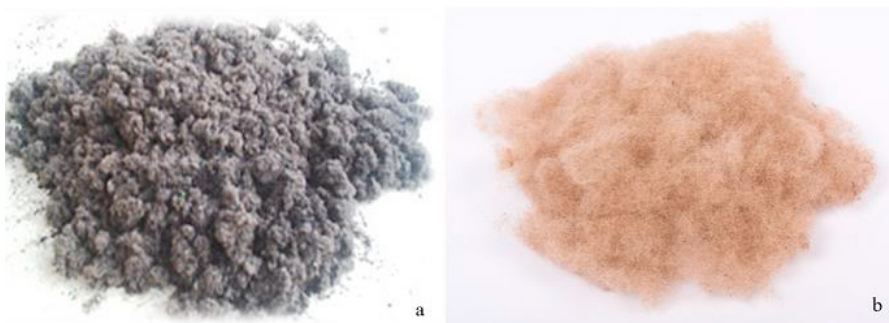
Fig. 1. (a) Waste fibre before the cleaning process; (b) cleaned fibre for use in concrete (RTPF)

Type polymer fibres are extracted from mechanical shredding of end-of-life tyres, Fig. 1a. The waste fibres supplied by the tyre recyclers are heavily contaminated with over 30% (by weight) of rubber fine dusts or larger partials, which can affect concrete properties significantly. Therefore, intensive cleaning is required before these waste fibres can be used in concrete. The cleaned fibre, called Recycle Tyre Polymer Fibre, is shown Fig. 1b. Techniques for removing rubber contamination and separating tangled filaments for the large-scale production of RTPF for use in concrete did not exist. A prototype device for removing rubber dusts and particles from the tyre polymer fibres has been developed in this research. The device is based on an airflow method, which was proved efficient in processing contaminated tyre polymer into RTPF.

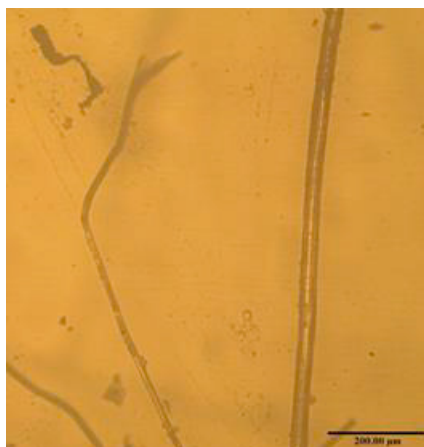
Fig. 2. RTPF enlarged 100 times using an optical microscope

It is also essential to assess the geometrical characteristics (i.e. fibres diameter and length), especially for quality control and product certification purposes. The fibres diameter and length analysis were conducted based on the ISO 137 [10] and ISO 6989 [11], respectively. The fibre samples were randomly collected from the cleaned RTPF. The fibre length and diameter were measured from images taken using microscopes, Fig. 2. The fibre diameter and length were then measured using a computer-aided design software. Note: the images need to be scaled in the software so that the dimension tool of the software can correctly ($\pm 0.01 \mu\text{m}$) measure the dimension of the ‘ruler’ on the image, which was generated by the microscope (see bottom right of Fig 2).

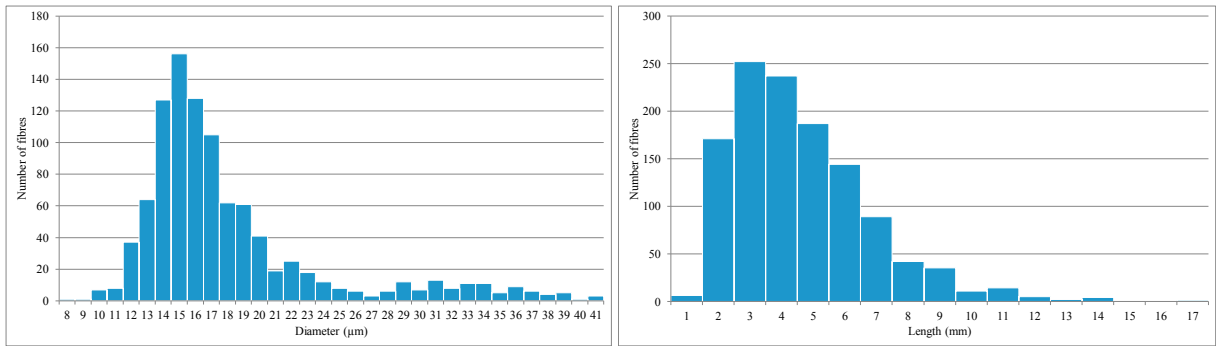
Fig. 3 shows the length and diameter distribution, measured from 1200 samples for length analysis and 991 samples for diameter measurements. The RTPF length ranges from 0.8 mm to 16 mm and the diameter ranges from $7.5 \mu\text{m}$ to $41 \mu\text{m}$. The results showed that more than 90% of fibres are shorter than 7 mm and the diameter of more than 89% of fibres are shorter than $25 \mu\text{m}$.

Fig. 3. RTPF length and diameter distributions.

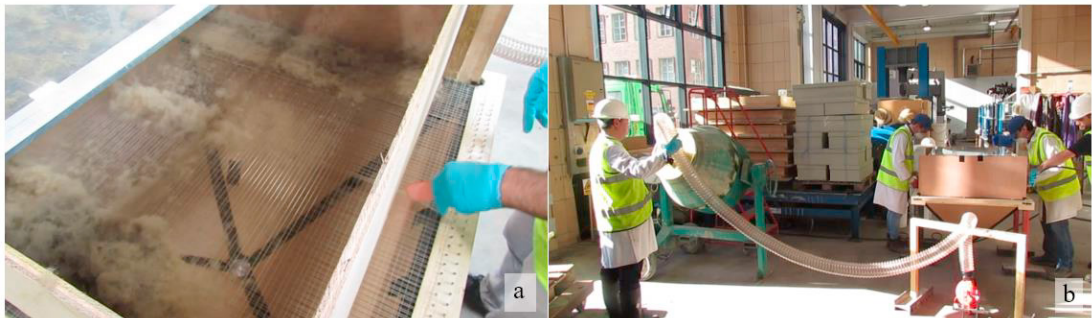
RTPF are too tangled to be added directly in concrete; fibre balling will significantly reduce the quality of the concrete. A prototype machine for the integration and dispersal of RTPF into fresh concrete was developed in this study, Fig. 4. This prototype uses the vibration of plastic strings to separate the fibres. The basic principle behind this technique is to use the shear forces produced by vibrating the strings to untangle the fibres. Nylon strings were mounted on a 0.5 x 1 m wood frame. They were arranged in two layers, forming a mesh. Steel strings were also tried, however, the performance of such strings were not satisfactory compared to nylon strings. Steel strings were more difficult to mount them on the frame and required more energy to vibrate them. Fig. 4 shows this technique and it can be noted that during the process the fibres are falling down completely untangled.

Fig. 4. Fibres integration stages (a) strings being manually excited; (b) fibres being integrated into the concrete mix.

The integration process starts by placing some fibres on top of the mesh, a timber box is also used to keep the fibres in place during the process and prevent fibres from flying away. The strings are manually excited and the vibration of the string untangle the fibres, Fig. 4a. A hopper is placed below the frame to collect the fibres. The untangled fibres are integrated into the concrete mix using a blower, which blows the fibres directly to the mixer through anti-static pipes, Fig. 4b.

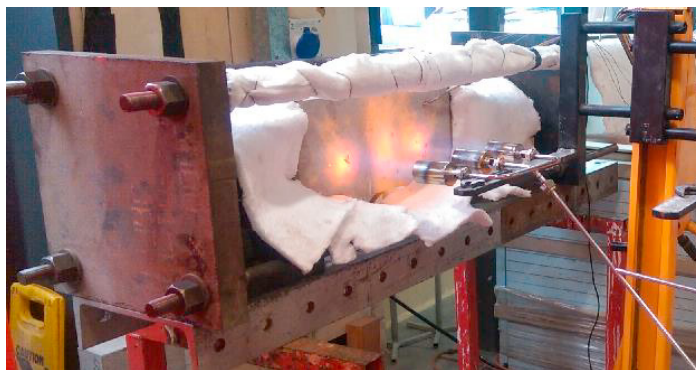
direction of principal heat flow; they had the same thickness as a typical full-scale tunnel lining. A typical C70 high-performance, high-strength and self-compacting concrete mix was used. In this study, the slabs were heated using a three-headed blowtorch, Fig. 5. Trials were conducted to determine the optimal distance between the blowtorch heads and the heated surface of a specimen, needed to reproduce an initial heating rate as close as possible to that of a large pool hydrocarbon fire [15]. Before and during heating, the slabs were also subjected to a uniaxial compression force.

Fig. 5. Test setup showing the three-headed blowtorch.

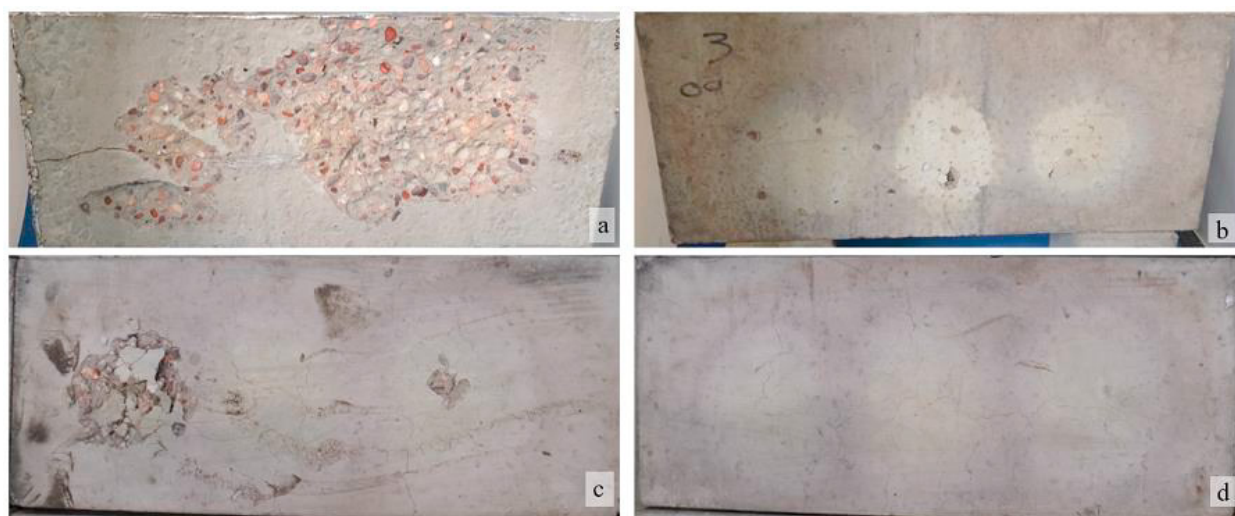
Four of the six (PC1 and PC2) plain concrete slabs and two of the three PFC1 slabs with low RTPF dose (1 kg/m^3) spalled. Note that the reference plain concrete slabs experienced severe spalling, Fig. 6a. One of the three specimens with RTSF and 2 kg/m^3 RTPF spalled, however in this case the spalled concrete was held by the steel fibres and kept attached to the specimen surface, as shown in Fig 6c. None of the other specimens, i.e. PFC2 (2 kg/m^3 RTPF), PFC7 (7 kg/m^3 RTPF) and SF5PFC (40 kg/m^3 RTSF and 5 kg/m^3 RTPF) experienced explosive spalling; one example post-test photo is shown in Fig. 6d.

Fig. 6. Example post-test photos: (a) PC1-1; (b) PF2-3 (c) SF40PF2-1; (d) SF40PF5-1.

Subject to the test conditions described above, RTPF is able to prevent fire-induced explosive spalling when the fibre dosage is higher than 2 kg/m^3 (the recommended dosage of PPF for fire spalling control, given in EC2 [16]). This clearly demonstrates the potential of RTPF in preventing explosive spalling and replacing totally or partially the manufactured fibres. The results also show that RTSF might contribute to the reduction of fire spalling risk.
