Celotto, S., Ghadbeigi, H. orcid.org/0000-0001-6507-2353, Pinna, C. orcid.org/0000-0002-9079-1381 et al. (2 more authors) (2018) Deformation-induced microstructural banding in TRIP steels. *Metallurgical and Materials Transactions A*, 49 (7). pp. 2893-2906. ISSN 1073-5623

Deformation-Induced Microstructural Banding in TRIP Steels

S. CELOTTO, H. GHADBEIGI, C. PINNA, B.A. SHOLLOCK, and P. EFTHYMIADIS

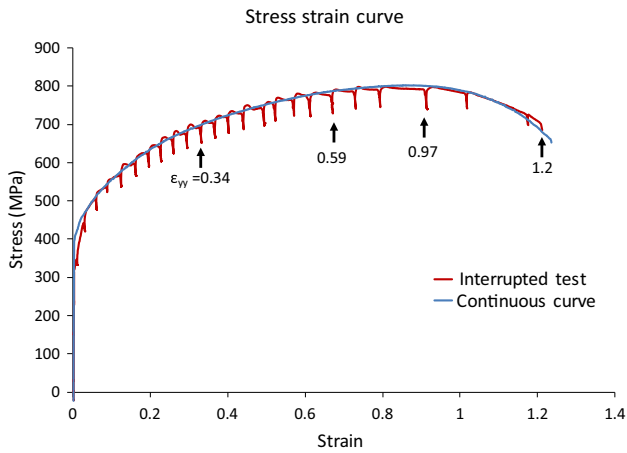
Fig. 3—Stress–strain curves for TRIP800 steel with and without interruptions. The specific interruptions where micrographs and DIC strain maps are presented in this study are highlighted.

Figure 3 shows the stress–strain curve derived from the load–displacement measurements recorded during *in situ* tensile testing. It shows the macroscopic mechanical behavior of the specimen, with the drops in the curve being due to the elastic stress relaxation when the interruptions were made to take micrographs. The stress–strain response is typical for a TRIP800 with continuous yielding beginning at approximately 500 MPa and work hardening through to the macroscopic stress magnitude of about 800 MPa. Thereafter, necking starts, but due to the relatively slow strain rate and relatively small gauge length, there is a relatively extensive post-uniform elongation region present. While the strength values correspond to a TRIP800, the strains at which necking began and the total elongation do not. The behavior up to maximum load should not be interpreted as uniform strain as in a conventional tensile test. This is because of the non-standard sample geometry that was designed to localize the deformation, such that necking and fracture would occur at a specific position to enable a series of observations at high magnifications. The observations in the text refer to the major strains (ϵ_{yy}) calculated from the crosshead extension (corrected for instrument compliance) and a gauge length of 2 mm.

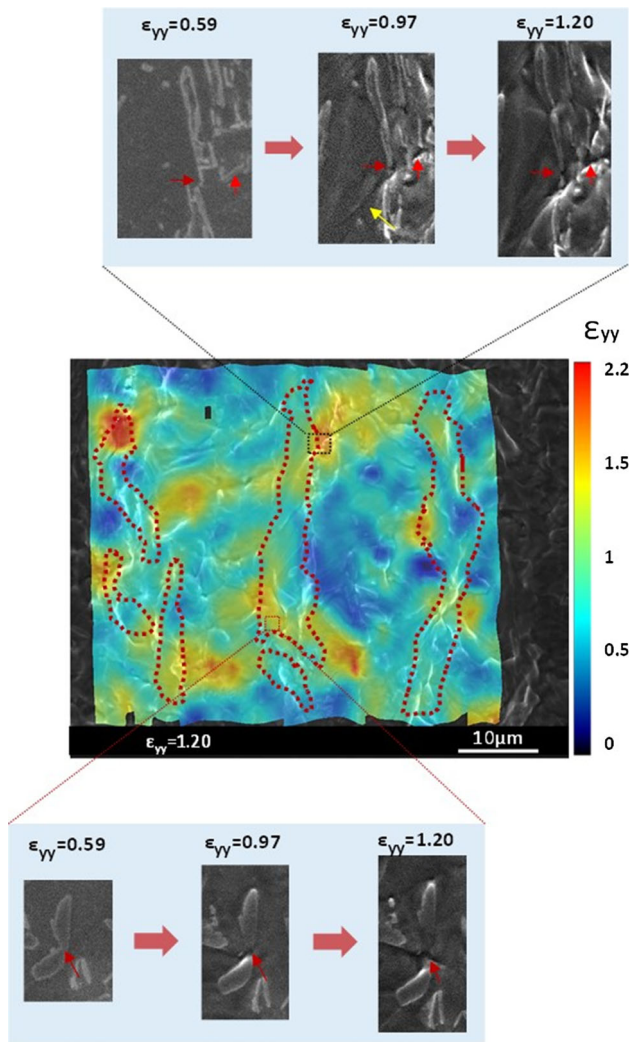
Fig. 5—The corresponding major strain map (ϵ_{yy}) for an applied strain of $\epsilon_{yy} = 1.2$. The insets show enlargements of regions where micro-void nucleation has occurred at the arrowed locations, which correspond to highly strained regions with hard phase microstructural constituents.

Figure 5 shows the major strain map corresponding to the micrograph of Figure 4(h) at an applied strain of $\epsilon_{yy} = 1.2$ just before final fracture. Based on a simple measurement of the elongation of ferrite region in region 2 between Figures 4(a) and (h), the tensile strain value is about 150 pct and therefore, local strain values up to 220 pct seen in Figure 5 are not surprising. Similarly, for the transverse compressive strain, the wider part of region 2 gives -38 pct while the strain map using DIC shows about -40 pct at that particular location (light blue color on the scale of Figure 4(i)).

The same regions highlighted in red in Figure 4(h) are outlined in Figure 5. A comparison between Figures 4(i) and 5 shows that the evolution of mechanisms involved in the formation of microstructural bands during tensile loading is better revealed by evaluating the minor strain component. The major strain distribution map does not show any indications of banded material flow.

The highest major strains were measured within or adjacent to the microstructural bands highlighted in Figure 5. Such high strains cannot be accommodated by the hard second-phases. The two magnified insets show micro-void nucleation at the neighborhood of the hard phases, accompanied by slip band formation in the neighboring ferrite matrix (indicated by yellow arrow). Local softening occurs upon the formation of microvoids at the red-arrowed locations within the two enlarged areas in the insets. It should be noted that

Comparing Figures 4 and 5 for the minor and major strain maps, it can be concluded that the latter does not reveal the banded material flow. The major strain distribution is similar to the strain maps shown in other studies on DP steels,^[14–17] where the high major strains are oriented at an angle (close to 45 deg) with respect to the loading direction due to localized slip and shear bands.

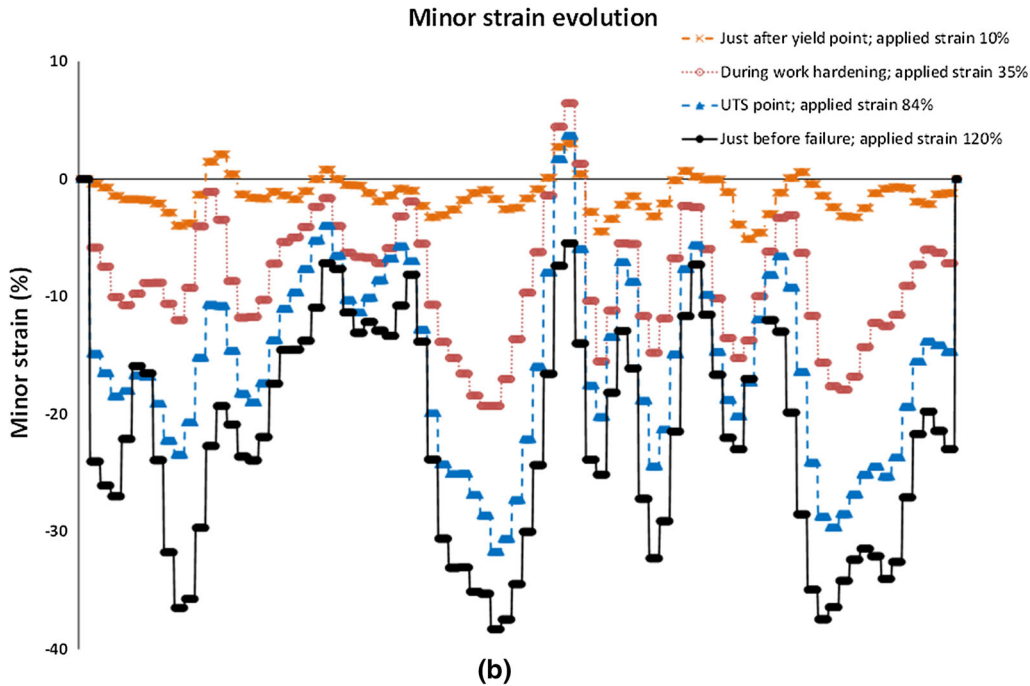
Fig. 9—The evolution of the minor strain during the tensile test taken along the dotted line shown in micrograph (a), and (b) the minor strains at (i) just after yielding, (ii) during work hardening, (iii) at UTS point and (iv) just before failure.

This is better illustrated in Figure 9, where the evolution of the minor strains along a line on the DIC strain map in Figure 9(a) was obtained at four different stages of the test. The evolution of the minor strains is shown at four stages during the test in Figure 9(b); just after yielding (0.1), during work hardening (0.35), at UTS point (0.84) and just before failure (1.25). Even at the first stages of plastic deformation, the material has started forming microstructural bands. Most of the microstructural rearrangements occur during plastic

deformation up to the UTS point. Consequently, it is during work hardening that the material forms these bands by redistributing the phases in the matrix. This can be seen by the considerable increase of the compressive strains between the yield point and UTS point. It is suggested here that an optimization of the distribution of the hard phases in the matrix could potentially increase the deformation capability of the alloy. The tendency to form microstructural bands of hard second-phases could, in turn, be reduced, even from the first stages of plastic deformation.
