D Altri, AM, Milani, G, de Miranda, S et al. (2019) On the Stability Analysis of a Geometrically Complex Leaning Historic Structure. In: Structural Analysis of Historical Constructions. RILEM Bookseries, 18. Springer, pp. 975-982. ISBN: 978-3-319-99440-6.

# On the stability analysis of a geometrically complex leaning historic structure

**Abstract.** In this paper, a simple approach for the stability analysis of the southwest leaning ruined tower of the Caerphilly castle (Wales, UK) is discussed. To account for the actual complex geometry of the tower, a mesh generation procedure recently proposed by the authors is used to automatically transform the 3D point cloud surveyed from the tower into a 3D solid finite element model. A simple approach based on nonlinear static analyses is pursued to evaluate the stability condition of the tower. Geometric nonlinearity and nonlinear plastic-damaging behavior of masonry are supposed. Results show that the proposed approach could serve as a simplified method to evaluate the stability of leaning historic structures considering their actual geometry.

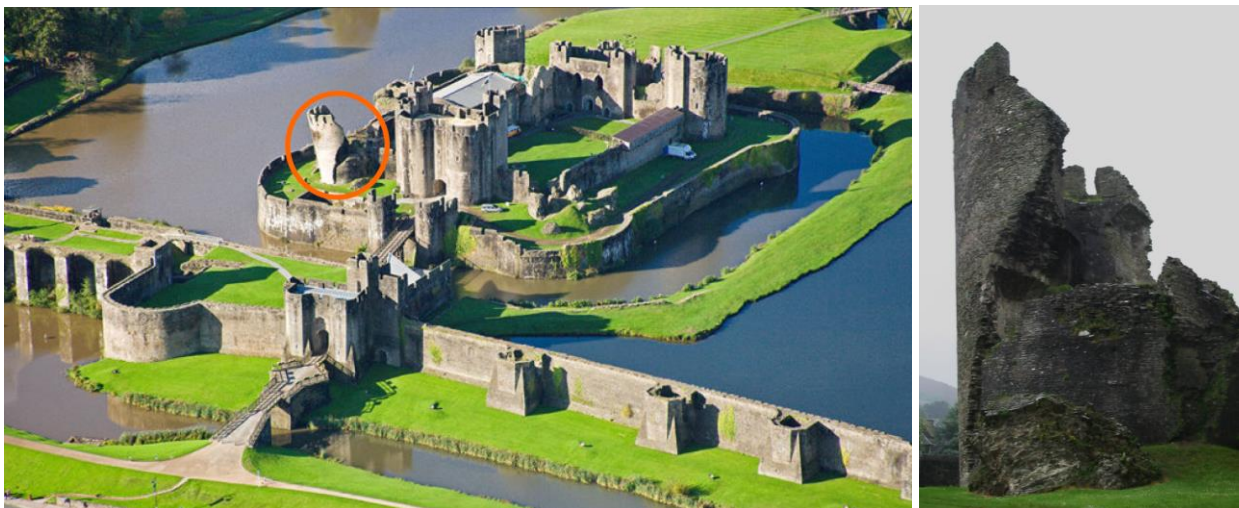
**Figure 1.** Southwest leaning tower of Caerphilly castle. The red circle indicates the location of the southwest leaning tower.

Caerphilly castle is one of the largest medieval concentric castle in Wales, UK. The dramatic inclination of its ruined southwest tower has been noted since 1539 (Figure 1). The tower is made by rubble stone masonry and it is almost 17 meters tall and circular in plan. The diameter of the tower is approximately 9 m.

A laser scanning survey of the southwest tower has been carried out in 2014 [7]. Several scans were taken around the base of the tower, with, however, difficulties in acquiring all the surfaces of the structures due to the presence of scaffolded areas and of tourists. From the survey, the inclination of the tower has been found to be about 10 degrees.

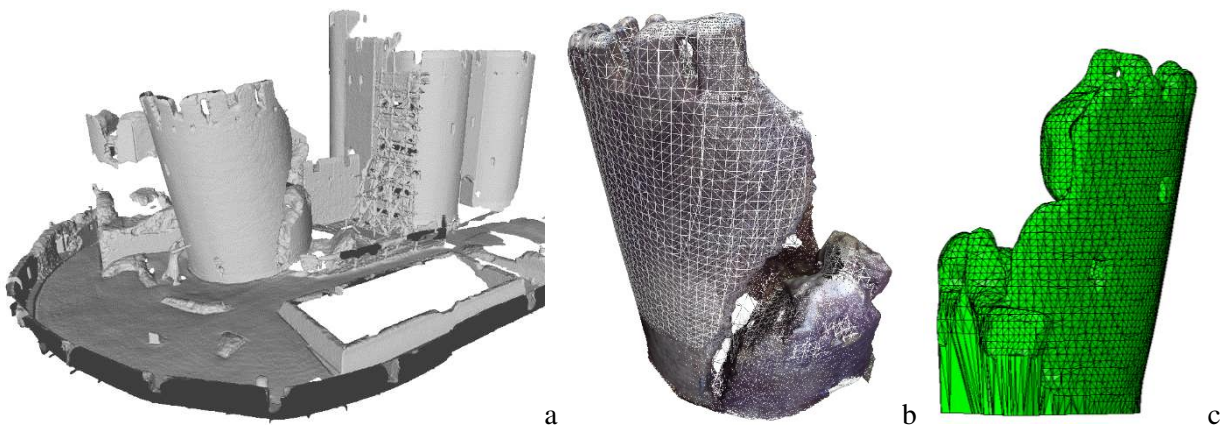
**Figure 2.** Automated generation of the finite element model from terrestrial laser scanning: a) rough point cloud, b) watertight mesh and c) 3D solid finite element model.

Detailed 3D finite element model of the southwest leaning tower of Caerphilly castle has been generated starting from a laser scanner survey, see Figure 2. Preliminary standardized operations, such as cloud cleaning and sub-sampling have been carried out on the rough point cloud (Figure 2a) in order to lower the dimension of the problem and to reduce the whole point cloud to only the tower space.

Then, the generation of the surface has been undertaken using a further simplification of the topology of the cloud points along with the idea proposed in [3] [5] [8]. Although, this algorithm produces an approximation of the surface, it was found to be adequate for structural analysis purposes since it produces watertight surface. The obtained watertight mesh, consisting of triangles, is shown in Figure 2b.

It has to be pointed out that the initial point cloud presented some missing portions, due to practical complications in the surveying operations [7] thus, a projection of the bottom surface nodes has been undertaken, see Figure 2c, in order to easily apply boundary conditions as described in the following sections.

Successively, the triangles of the watertight mesh have been transformed into a boundary mesh of triangular finite elements and, finally, they have been used to generate a solid tetrahedral finite elements free mesh. This operation, which fill the volume delimited by the watertight mesh with tetrahedrons, has been performed by means of a standard subroutine implemented in the software Abaqus. The resulting solid finite element model is shown in Figure 2c. Since the bottom face of finite element model was irregular in shape, nodes at the base of the tower were projected to a horizontal plane. It should be highlighted that every operation carried out for the generation of the solid finite element model was automatic, apart from the initial clean-up of the rough point cloud.

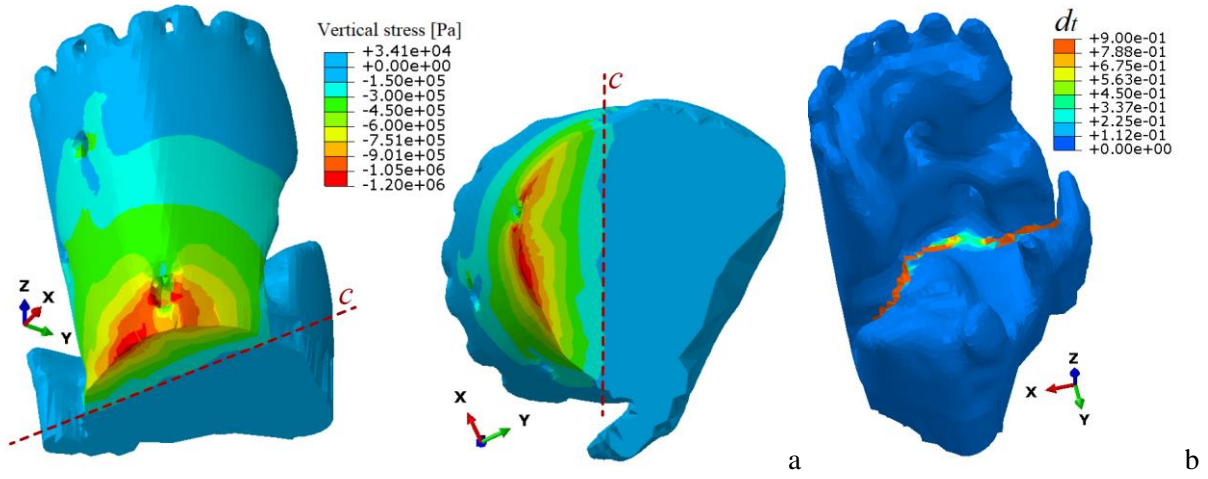
Figure 3. Nonlinear static analysis under dead load conditions: a) vertical stress and b) damage contour plots.

Dead load is initially applied to the structure by means of an incremental procedure, considering clamped boundary conditions at the base (Figure 3). Particularly, geometric nonlinearity is considered to account for large-displacement effects, which in this case are expected to play a fundamental role.

The resulting vertical stress contour plots and the tensile damage contour plot of the structure are depicted in Figure 3a-b, respectively, for the last incremental step, corresponding to the full application of the dead load.

By inspecting Figure 3a, it clearly appears a significant concentration of vertical stresses at the base of the structure along the edge where the tower is leaning. In particular, the vertical stresses appear to increase approximately in a linear way as we move perpendicularly from the axis  $c$ , shown in Figure 3a through a dotted red line, to the edge of the base of the tower. In addition, from Figure 3b appears that the tower experiences significant cracking (red elements in Figure 3b) with the application of dead load only, suggesting that possible failure could occur due to overturning of the taller part.

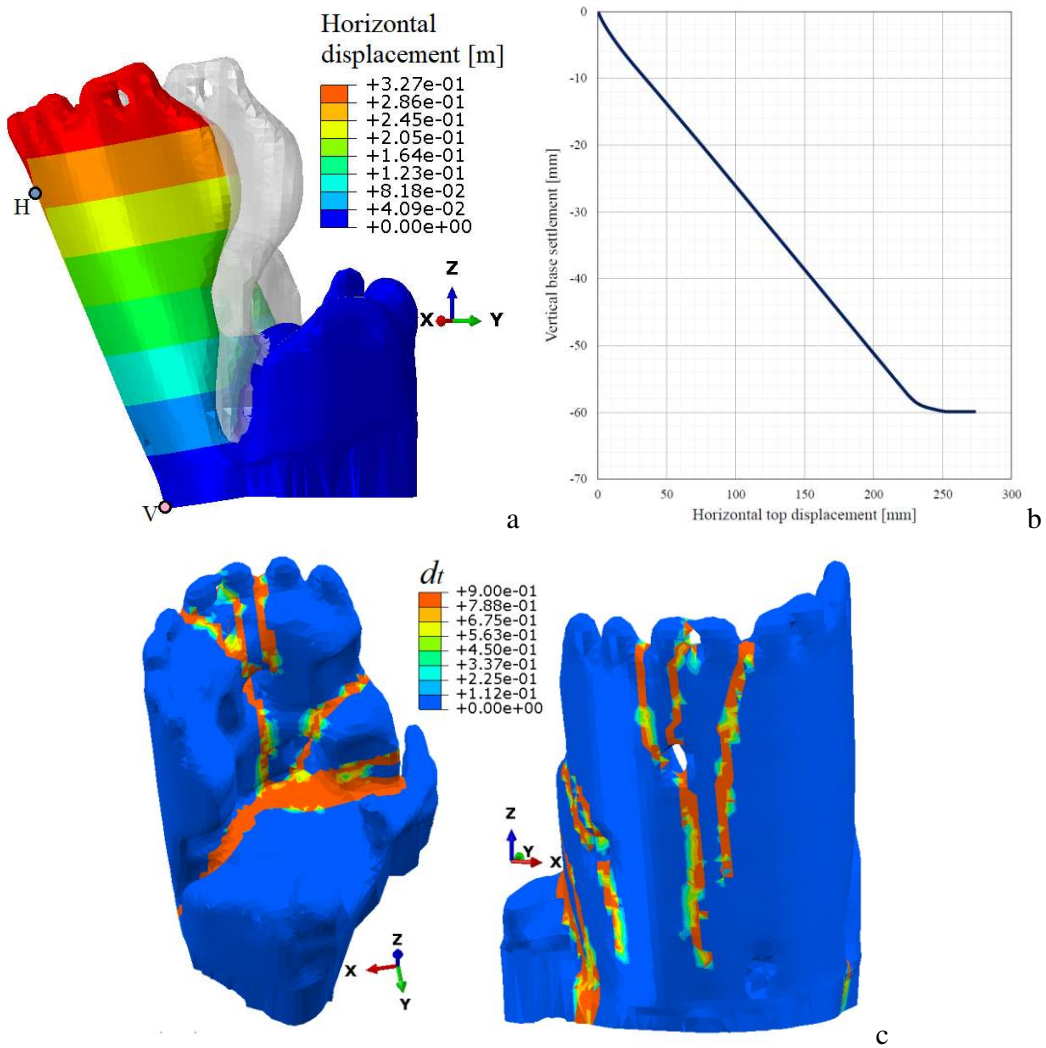
Figure 4. Nonlinear static differential settlement of the base: a) horizontal top displacement – vertical base displacement curve, b) magnified deformed shape and c) damage contour plots at collapse.

Figure 4 collects the results of the nonlinear static differential settlement analysis. In particular, Figure 4a shows the magnified deformed shape of the structure at collapse. Furthermore, Figure 4b depicts the horizontal top displacement – vertical base settlement curve, where the displacements are computed at points H and V in Figure 4a, respectively. Finally, Figure 4c shows the tensile damage contour plots at collapse.

As can be noted in Figure 4b, when the vertical base settlement reaches a value close to 60mm, the horizontal top displacement starts to increase while the base settlement remains constant. This condition can be considered as the collapse of the structure. Furthermore, it is worth noting that the inclination of the base which leads to collapse of the tower is about  $1.4^\circ$ , a value very close to the critical inclination evaluated by means of 3D homogenized limit analysis (about  $1.5^\circ$ ) in [6] for the same case study. Finally, the collapse mechanism (Figure 4c) is governed by the overturning of the taller part of the tower, which shows further vertical fissures at collapse.
