Christoforou, P., Fletcher, D.I. and Lewis, R. orcid.org/0000-0002-4300-0540 (2019)
Benchmarking of premium rail material wear. *Wear*, 436-437. 202990. ISSN 0043-1648

BENCHMARKING OF PREMIUM RAIL MATERIAL WEAR

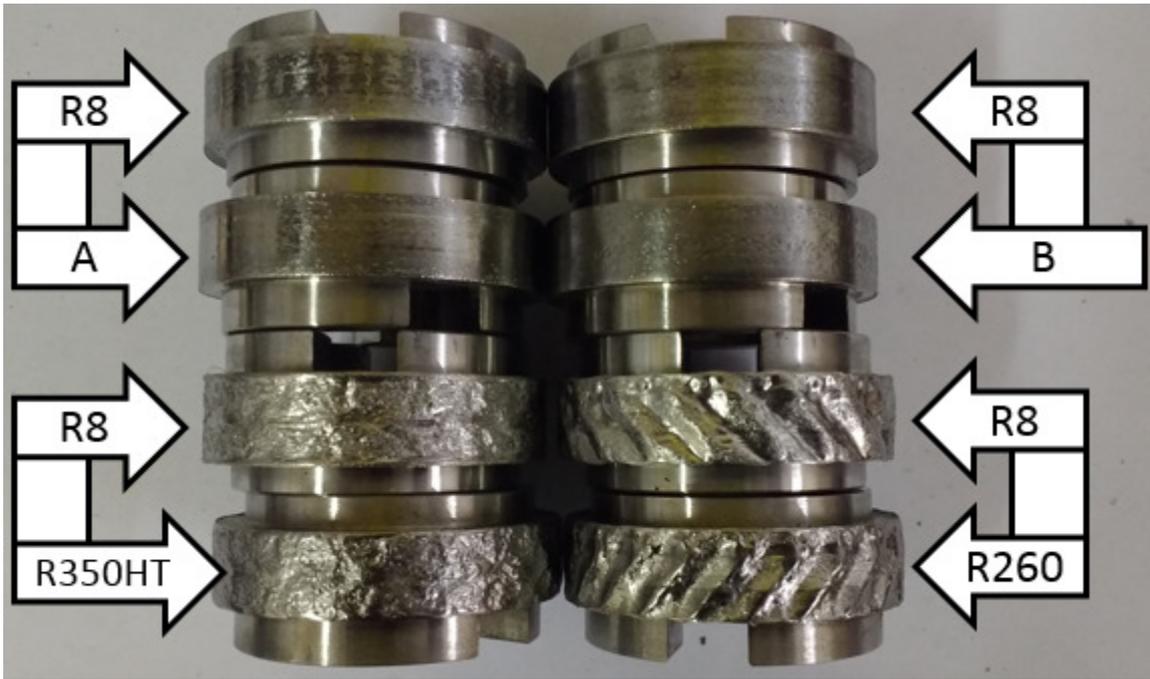
Figure 13 Image of wheel and rail discs after testing at 20% slip.

Finally figure 13 shows pairs of rail and wheel discs for the 20% slip test, while figure 14 shows images of the etched samples taken from the 20% slip test of the R8 wheel material. The notation on the images indicates the rail discs material reference, R260, R350HT, A and B. There is a peculiar phenomenon of plastic deformation which differs in each material combination and rolling conditions.
