Hasnayn, MM, McCarter, WJ, Woodward, PK et al. (2020) Railway subgrade performance after repeated flooding – Large-scale laboratory testing. *Transportation Geotechnics*, 23. 100329. p. 100329. ISSN: 2214-3912

Railway Subgrade Performance after Repeated Flooding – Large-scale Laboratory Testing

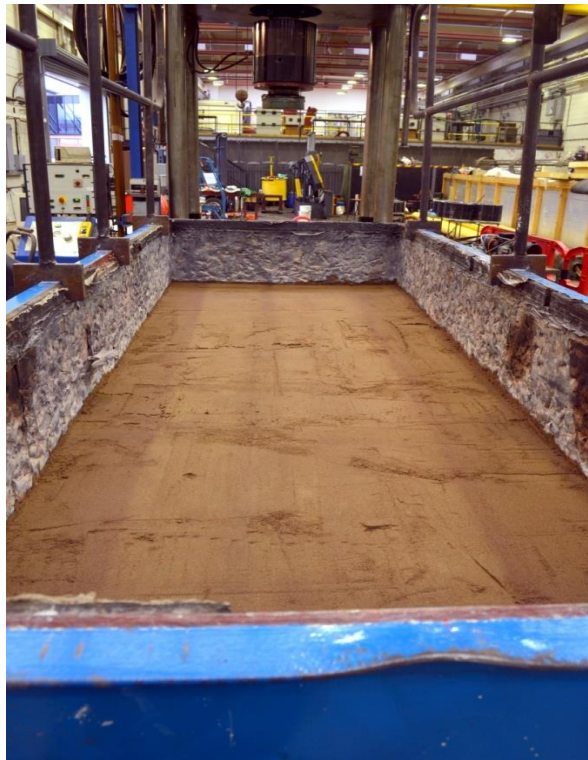
Figure 2 The GRAFT facility showing the 150mm sand blanket layer placed on clay subgrade

The track was flooded (1st event) to investigate the track behaviour without a sand blanketing layer (Hasnayn et al., 2017). After 14 weeks, the track was then prepared with a 150 mm sand-blanket to investigate its influence on track behaviour during and after the 2nd flooding event (see Figure 2). A 150mm sand blanket was placed on the subgrade according to Network Rail standard RT/CE/S/033. The optimum moisture content of sand was 12.8%.

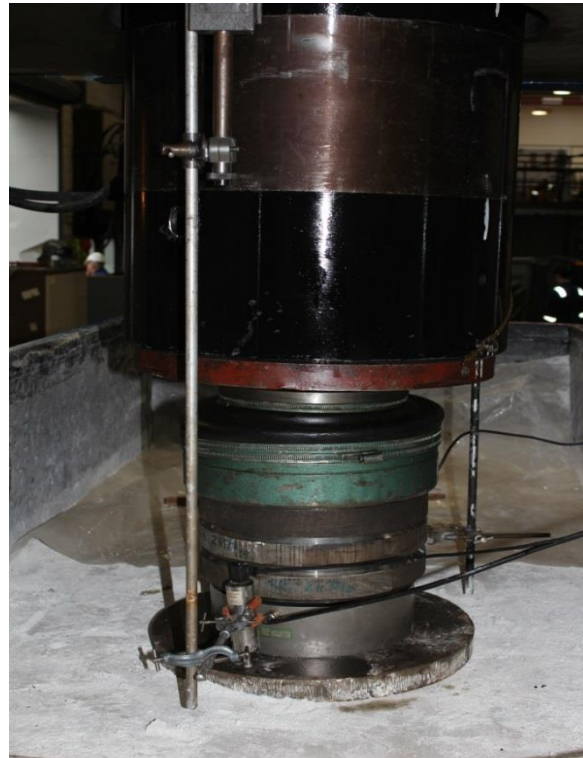
Figure 4 Plate load test set-up in the GRAFT

A plate load test (PLT) was undertaken in accordance with BS EN 1997-2:2007 to evaluate the subgrade stiffness. A series of stacked circular plates were placed in the middle of the tank which comprised a 440 mm diameter plate placed on the subgrade surface, a 400 mm diameter load-cell and a further three, 300 mm diameter plates as

shown in Figure 4. The corresponding vertical deflection of the bottom plate was measured using two linear variable displacement transducers (LVDT's). The stressed zone of influence of the PLT was considered to be approximately two times the diameter of the plate (Ping et al., 2002), hence the zone of influence of the test covered the full depth of subgrade in the GRAFT.

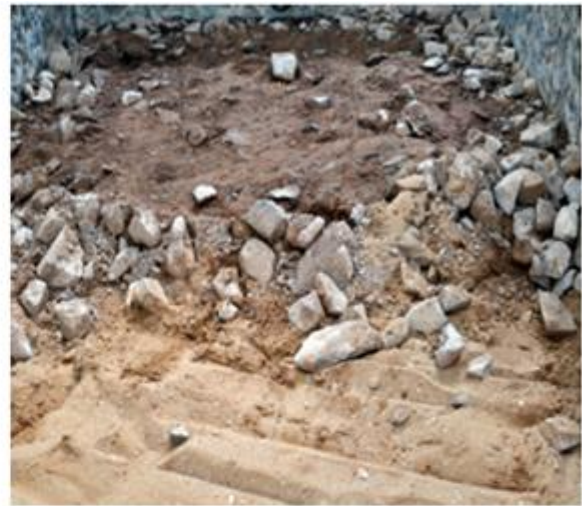
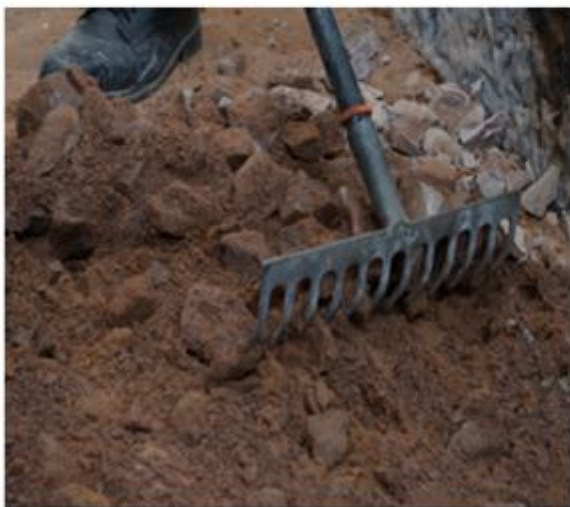
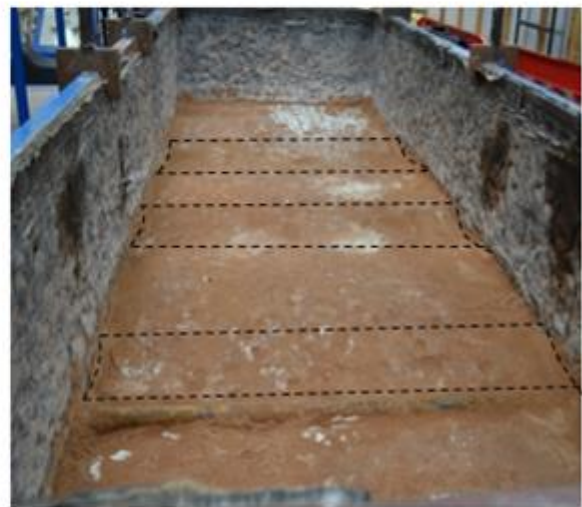
Figure 8 (a) Ballast penetration into the sand blanket after the test-Phase II, 2nd flooding, (b) clogged ballast after flooding, (c) the ballast layer after digging out from the sand blanket, and (d) settlement under three sleepers (dashed lines indicate the position of the sleepers)

Figures 8 (a) - (c) shows a layer of ballast which has penetrated into the sand blanket and Figure 8 (d) highlights the settlement under the three sleepers. In this situation, the track performance was deemed to be poor as sand-blanketing was unable to provide appropriate support to the track resulting in reduced ballast stiffness. However, sand blanketing protects the subgrade from erosion. After removal of the sand-blanket on completion of Phase-I, a noticeable settlement of the subgrade under three sleepers was observed (Figure 8). Sharpe and Caddick (2006) also reported that, on a number of occasions, sand blanketing failed to protect the subgrade from erosion.

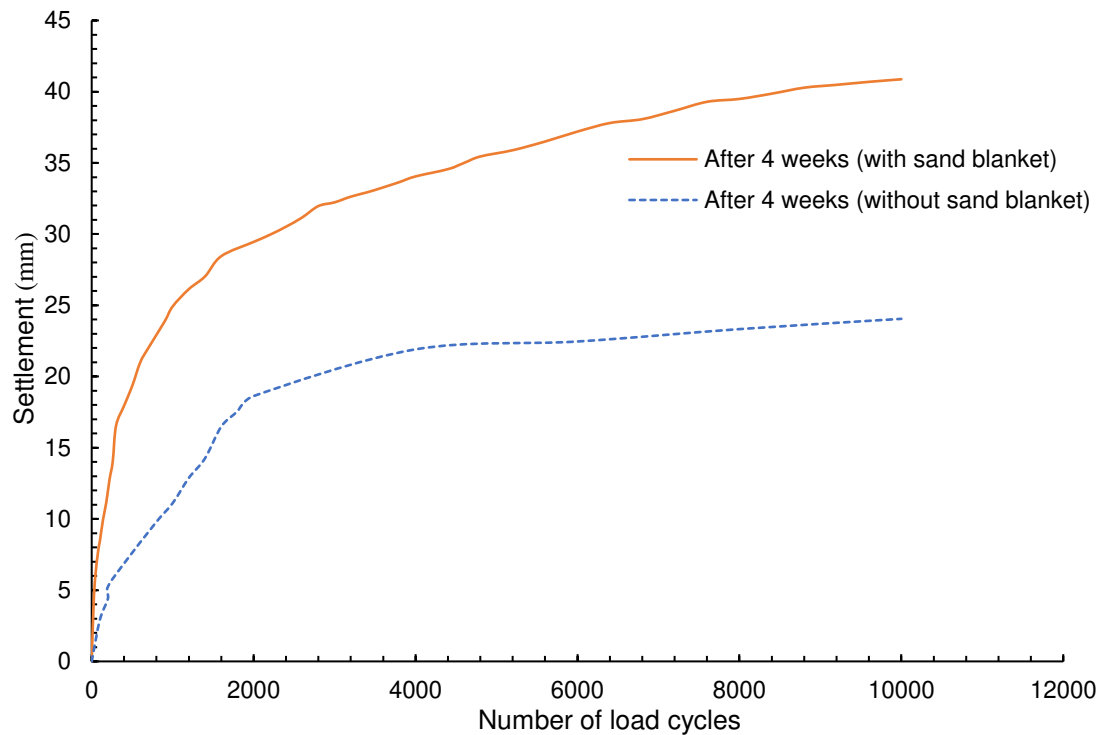
Figure 10 Phase II: Track settlement after four weeks with and without sand blanket

Four weeks from the start of Phase II, the improvement in track performance was only marginal as shown in Figure 10. The settlement decreased by $\approx 30\%$ compared to that observed at two weeks settlement. The first stage settlement was $\approx 25\text{mm}$ (1000 Cycles), whereas after 10,000 cycles the settlement was $\approx 40\text{mm}$. In comparison with

the trackbed without a sand-blanket (25mm) (Hasnayn et al. 2017). After four weeks the track settlement with the sand-blanket was approximately 60% higher.

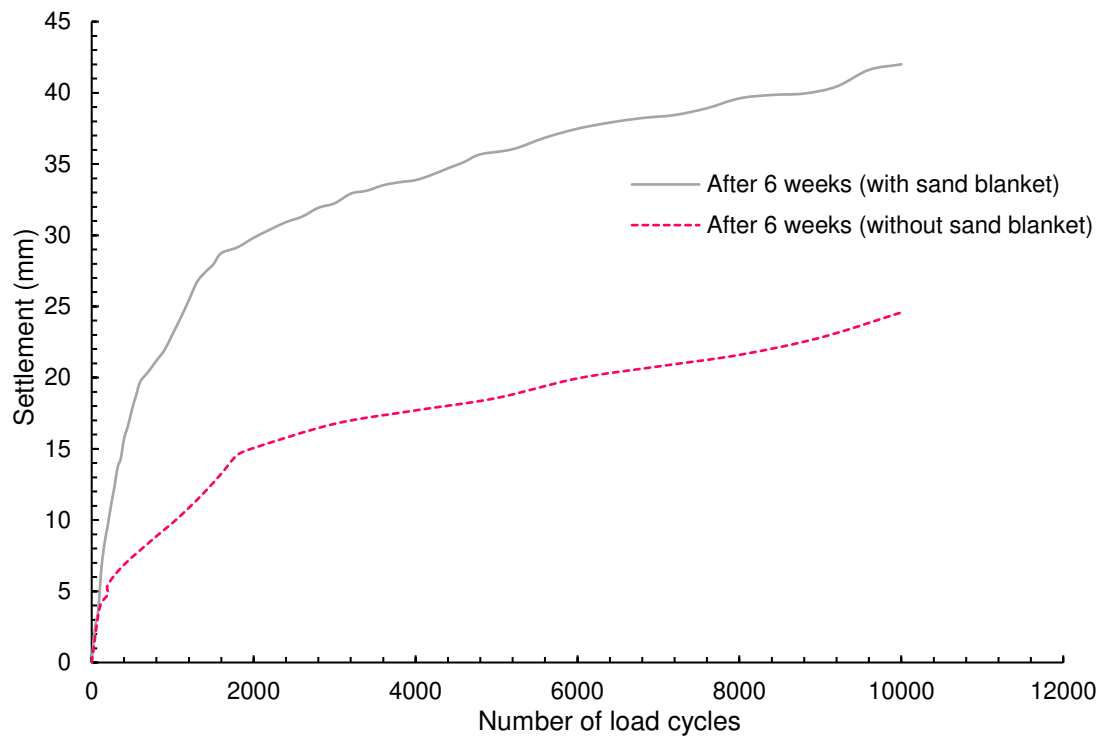
Figure 11 Phase II: Track settlement after six weeks with and without sand blanket

With reference to Figure 11, six weeks after the start of Phase-II) the settlement was similar to the previous stage at four weeks (Figure 10). However, the track settlement was almost 70% higher than the track settlement without the sand-blanket (25mm) after the same period. The settlement was measured as ≈ 42 mm after 10,000 cycles.

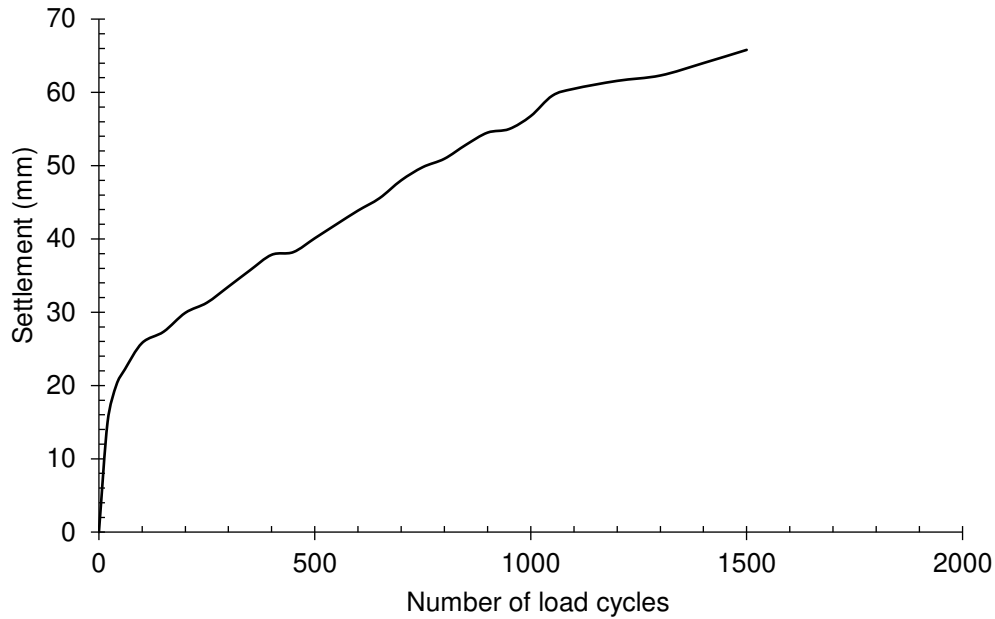
Figure 13 Phase-III: Track settlement during flood

Figure 13 presents the track settlement during loading when under flooded conditions. The first stage settlement was $\approx 20\text{mm}$ after only 50 cycles, while after 1500 cycles, the presence of water resulted in a track settlement of $\approx 65\text{mm}$ (loading applied at 1Hz).

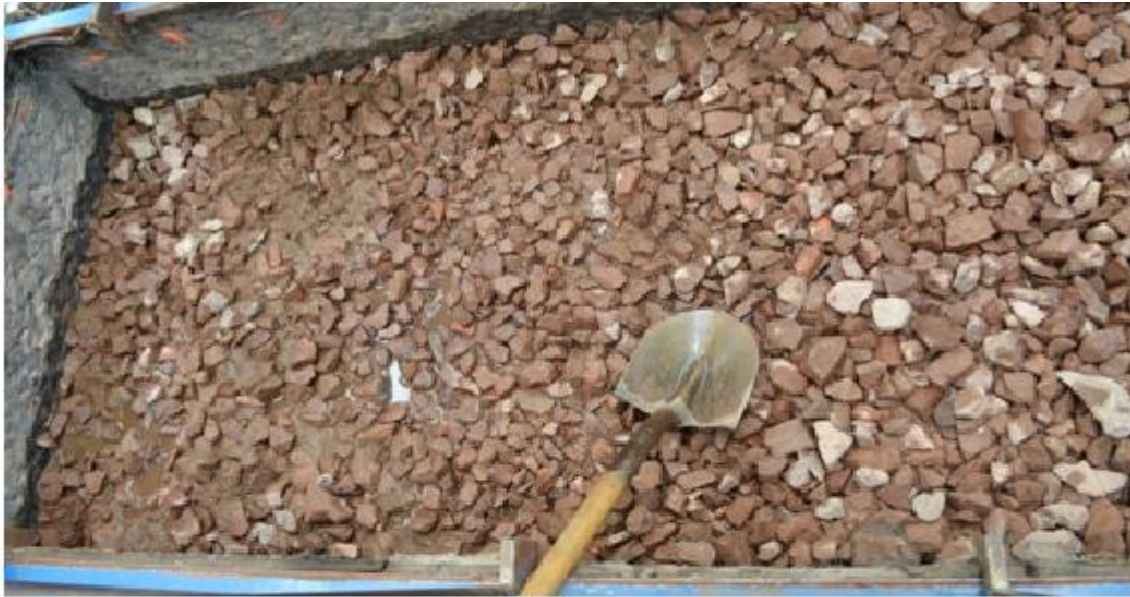
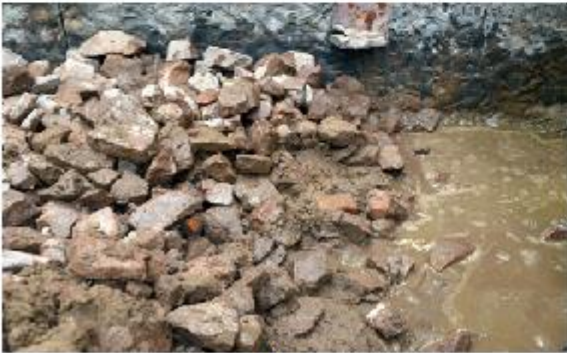
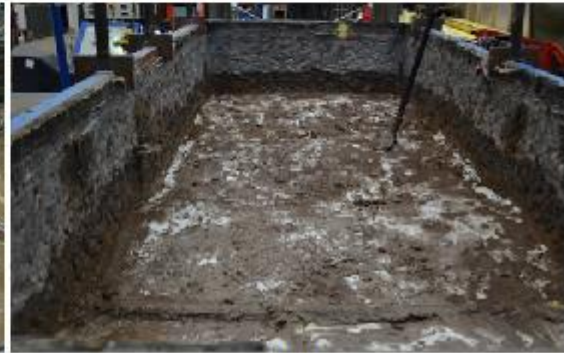
Figure 15 (a) Fine sand which has migrated into the ballast, (b) Water entrapped between the sand-blanket, ballast and subgrade and (c) Saturated subgrade surface layer

Blocked or poor drainage causes numerous track problems including ballast fouling, entrapped water and higher track settlement, some of which are illustrated in Figures 15. Wenty (2005) also observed a similar subgrade failure problem due to the development of water pockets where there was insufficient drainage.
