DYMAT 23rd Technical Meeting

Dynamic Fracture of Ductile Materials

Deformation and Rupture of Armour Grade Steel Under Localised Blast Loading

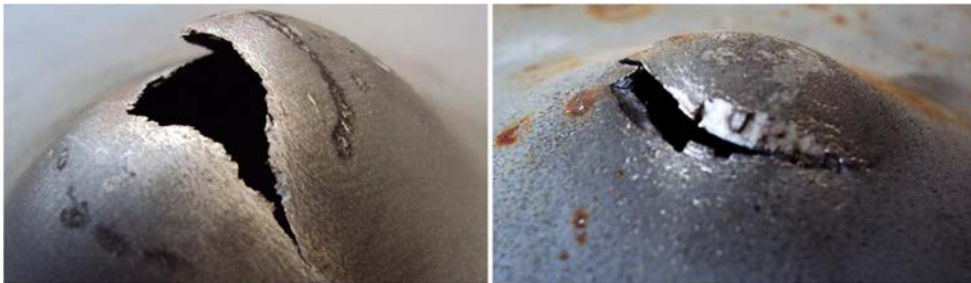
Fig. 1. Target plates ruptured under localised blast loading [11]. Left, Mild steel with tensile fracture. Right, Armour steel with cracking fracture

As part of a broader investigation into failure and rupture of materials under blast loading, Langdon et al. [11] compared the appearance of mild steel and high strength Armox 370T armour steel, ruptured under localised blast loading (Figure 1). The differences in the fracture mode of the two materials is evident. The mild steel exhibited a large thickness reduction around the fracture location and a fibrous surface appearance suggestive of tensile tearing. In contrast, the Armox 370T armour steel displayed minimal thickness reduction and an illustrious fracture surface inclined to the plate thickness, which is suggestive of brittle cracking failure mode.

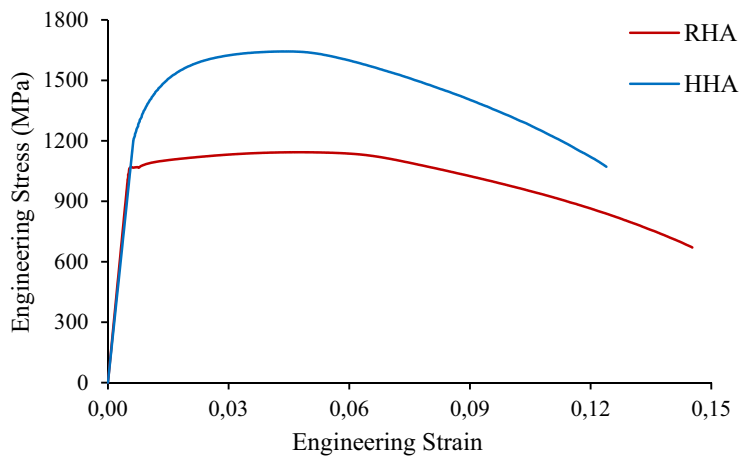
Fig. 2. Quasi-static stress vs. strain curves obtained for candidate materials

The RHA material is specified as class 1 rolled homogeneous armour by MIL-DTL-12560 [12] and represents a common class of material used in armour systems for protection against blast loading. The HHA material is specified as high hardness armour by MIL-DTL-46100E [13] for protection primarily against ballistic threats. Key material properties including the specific energy to tensile fracture (SETF), given by the area under a uniaxial stress strain curve, are provided in Table 1. Characterization of each material under quasi-static tensile loading was conducted and reported by McDonald et al. [14]. Figure 2 provides a comparison between the stress–strain curves for each material.

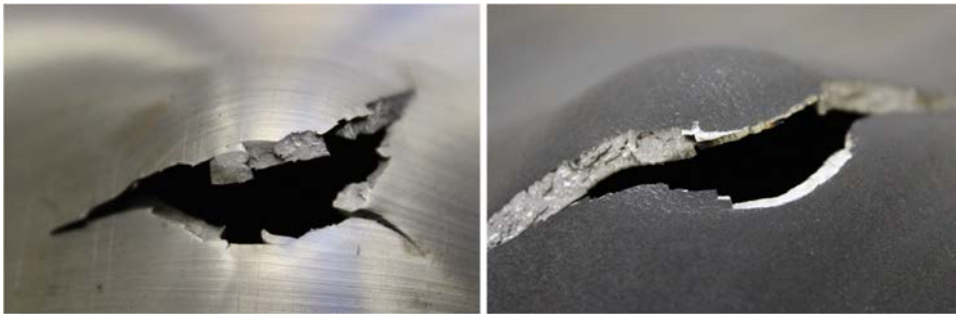
Fig. 6. Partial capping of candidate materials. Left: RHA, Right: HHA

Optical examinations of the fractured plates showed a similar fracture initiation mode in both materials. Incomplete capping of the plate with little to no localised thickness reduction was generally observed at the first occurrence of fracture (Figure 6). At the rupture threshold, the crack initiation location was generally the mid-point of the un-separated cap and had an appearance distinct to the surrounding material. The fracture surface was highly inclined to the plate thickness direction and had a smooth appearance compared to the multiple opposing shear lips along the fracture surface. In contrast to the necking and tensile tearing observed in the testing of mild steels [5-7, 14], this suggests a shear-type failure mode is dominant in both armour grade materials. This shear-type failure mode may account for the poor correlation between rupture threshold and tensile energy absorption capability highlighted in section 4.2.
