DYMAT 23rd Technical Meeting

Dynamic Fracture of Ductile Materials

Deformation and Rupture of Armour Grade Steel Under Localised Blast Loading

B. McDonald^{a,b,*}, H. Bornstein^c, G. Langdon^d, R. Curry^d, A. Orifici^a

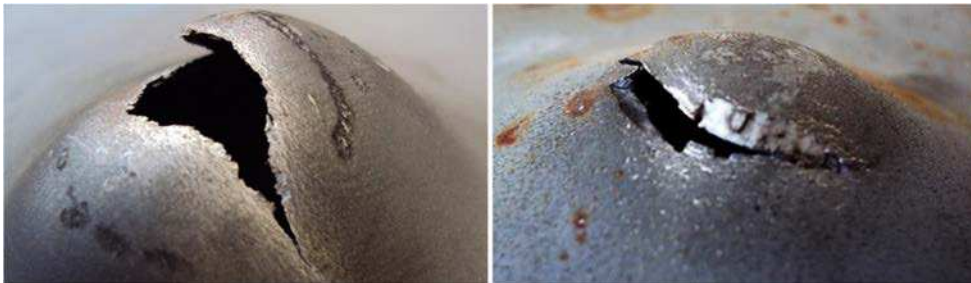
Fig. 1. Target plates ruptured under localised blast loading [11]. Left, Mild steel with tensile fracture. Right, Armour steel with cracking fracture

As part of a broader investigation into failure and rupture of materials under blast loading, Langdon et al. [11] compared the appearance of mild steel and high strength Armox 370T armour steel, ruptured under localised blast loading (Figure 1). The differences in the fracture mode of the two materials is evident. The mild steel exhibited a large thickness reduction around the fracture location and a fibrous surface appearance suggestive of tensile tearing. In contrast, the Armox 370T armour steel displayed minimal thickness reduction and an illustrious fracture surface inclined to the plate thickness, which is suggestive of brittle cracking failure mode.

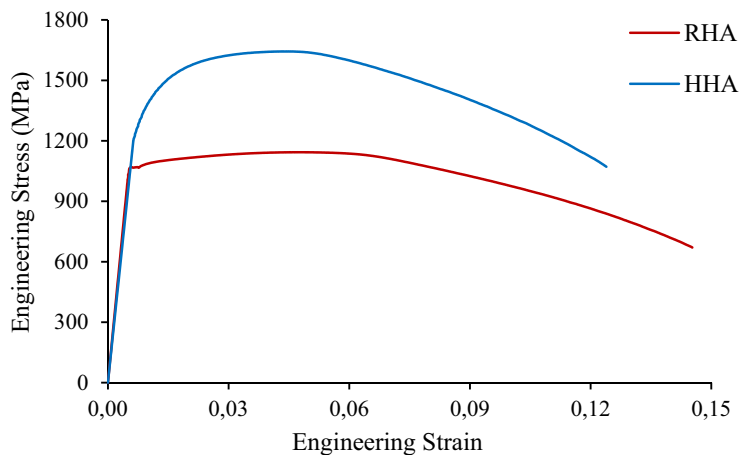
Fig. 2. Quasi-static stress vs. strain curves obtained for candidate materials

The RHA material is specified as class 1 rolled homogeneous armour by MIL-DTL-12560 [12] and represents a common class of material used in armour systems for protection against blast loading. The HHA material is specified as high hardness armour by MIL-DTL-46100E [13] for protection primarily against ballistic threats. Key material properties including the specific energy to tensile fracture (SETF), given by the area under a uniaxial stress strain curve, are provided in Table 1. Characterization of each material under quasi-static tensile loading was conducted and reported by McDonald et al. [14]. Figure 2 provides a comparison between the stress–strain curves for each material.

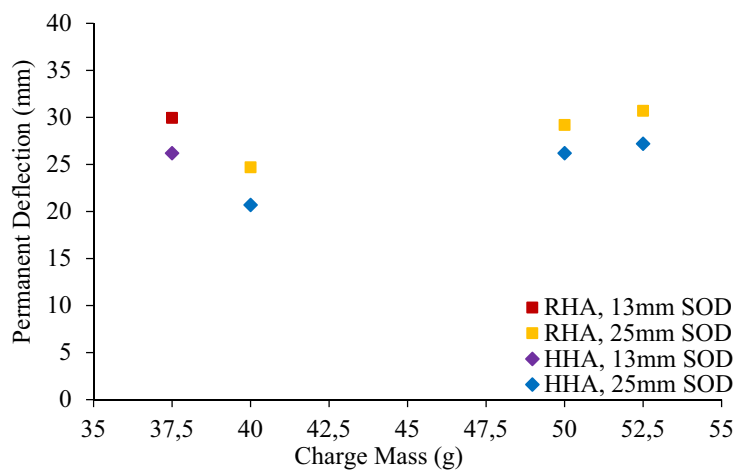
Fig. 4. Relative deformation resistance of candidate steels

The Deformation resistance of the candidate materials can be compared at four loading conditions under which both materials were tested. A comparison of the permanent deformation for each material is given in Figure 4. The higher yield strength of the HHA steel reduces the deformation between 9% and 14% compared to the RHA steel for a given loading condition. With a similar magnitude of deformation reduction for blast loading at 13mm and 25mm stand-off distances, the improvements in deformation resistance did not appear to be dependent on the degree of localisation or proximity experienced during loading. These results confirm that the HHA steel provides better resistance to deformation than the RHA steel.

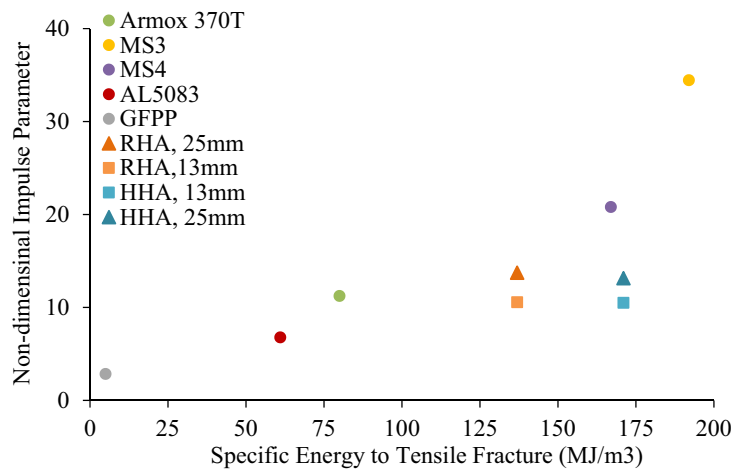
Fig. 5. Relation between non-dimensional impulse parameter and specific energy to tensile fracture for various materials

Figure 5 compares the results from Langdon et al. [11] with the HHA and RHA steel used in this investigation in terms of their SETF and non-dimensional impulse parameter at rupture. While the RHA material appears to conform to the previous relation, the HHA is clearly rupturing at a magnitude of blast loading far lower than would be predicted by its energy absorption capability.

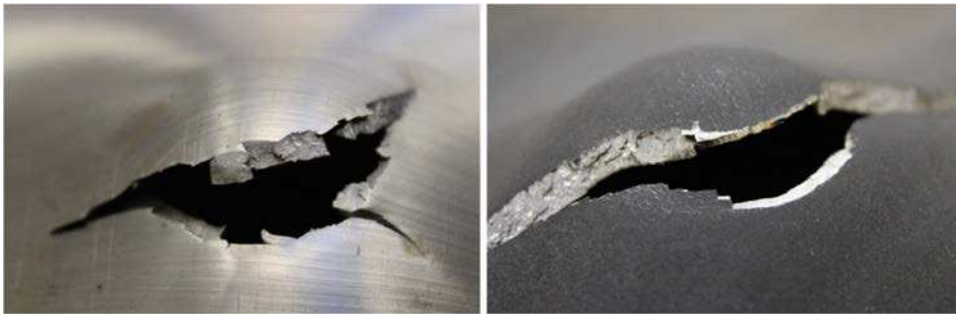
Fig. 6. Partial capping of candidate materials. Left: RHA, Right: HHA

Optical examinations of the fractured plates showed a similar fracture initiation mode in both materials. Incomplete capping of the plate with little to no localised thickness reduction was generally observed at the first occurrence of fracture (Figure 6). At the rupture threshold, the crack initiation location was generally the mid-point of the un-separated cap and had an appearance distinct to the surrounding material. The fracture surface was highly inclined to the plate thickness direction and had a smooth appearance compared to the multiple opposing shear lips along the fracture surface. In contrast to the necking and tensile tearing observed in the testing of mild steels [5-7, 14], this suggests a shear-type failure mode is dominant in both armour grade materials. This shear-type failure mode may account for the poor correlation between rupture threshold and tensile energy absorption capability highlighted in section 4.2.
