Suárez Fernández, D., Wynne, B.P., Crawforth, P. orcid.org/0000-0002-1235-8494 et al. (2 more authors) (2021) The effect of forging texture and machining parameters on the fatigue performance of titanium alloy disc components. *International Journal of Fatigue*, 142. 105949. ISSN 0142-1123

The effect of forging texture and machining parameters on the fatigue performance of titanium alloy disc components

The Mechanisms of fatigue failure in Ti-6Al-2Sn-4Zr-6Mo forged discs are investigated: the effects of forging and machining operations on fatigue are decoupled. A four-point bend fatigue testing approach enabled the crack initiation and propagation characteristics to be studied at multiple locations around the disc periphery. Fatigue performance variation (of ~60%) at different positions, and crack initiation and propagation behaviour were linked to the heterogeneous crystallographic texture - developed during upstream forging. Downstream machining processes were found to increase fatigue life, regardless of the cutting speed. However, circumferential fatigue heterogeneity, inherent from the forging stage was still evident even after machining.

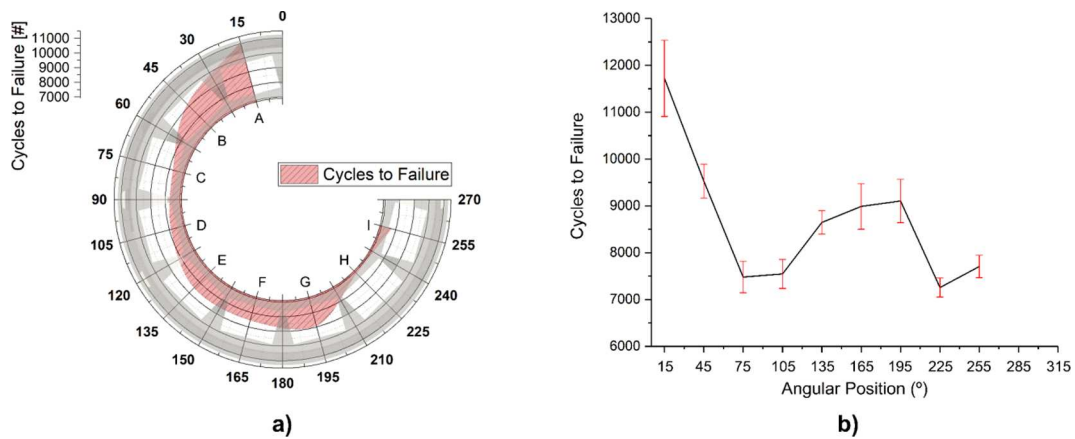
Fig. 6. Cycles to failure as a function of the radial direction for Ti-6246 rectilinear disc in the as-forged condition, shown as a; (a) Polar plot overlaid with disc section dimensions; (b) Plot of average cycles to failure and error bars (in red).

Fatigue samples extracted from disc 1 were tested under dynamic conditions provided in Table 2 until failure. The cycles to failure are plotted in Fig. 6b with error bars, in red. The error bars represent the standard error of the measurements per direction.

A total variation of up to 60% in cycles to failure was measured as a function of the disc circumferential location. Results plotted in a polar graph in Fig. 6a show a radial pattern with radial symmetry, similar to the poles found in the strain pattern induced in the cross section of the billet, during the primary forging stages

Results analysed regarding the differences in cycles to failure (in Fig. 6) seems to correlate with the texture inherited from the non-linear strain pattern developed during the β breakdown cogging stages, specifically the lower strain axis providing 180-degree symmetry, also seen in the fatigue results. Forging appears to have a direct impact on the fatigue performance of a Ti-6246 compressor disc. This direct correlation of upstream forging dictating fatigue performance has been studied for near α titanium alloys [31–33] but never been explicitly shown before in Ti-6246 discs. It is clear from Fig. 6 that the directions A and G separated by 180°, which have the best fatigue performance, are in a similar position to the 0° and 180° position poles shown in the forging DEFORM simulation (Fig. 1a). These poles represent the lower strain

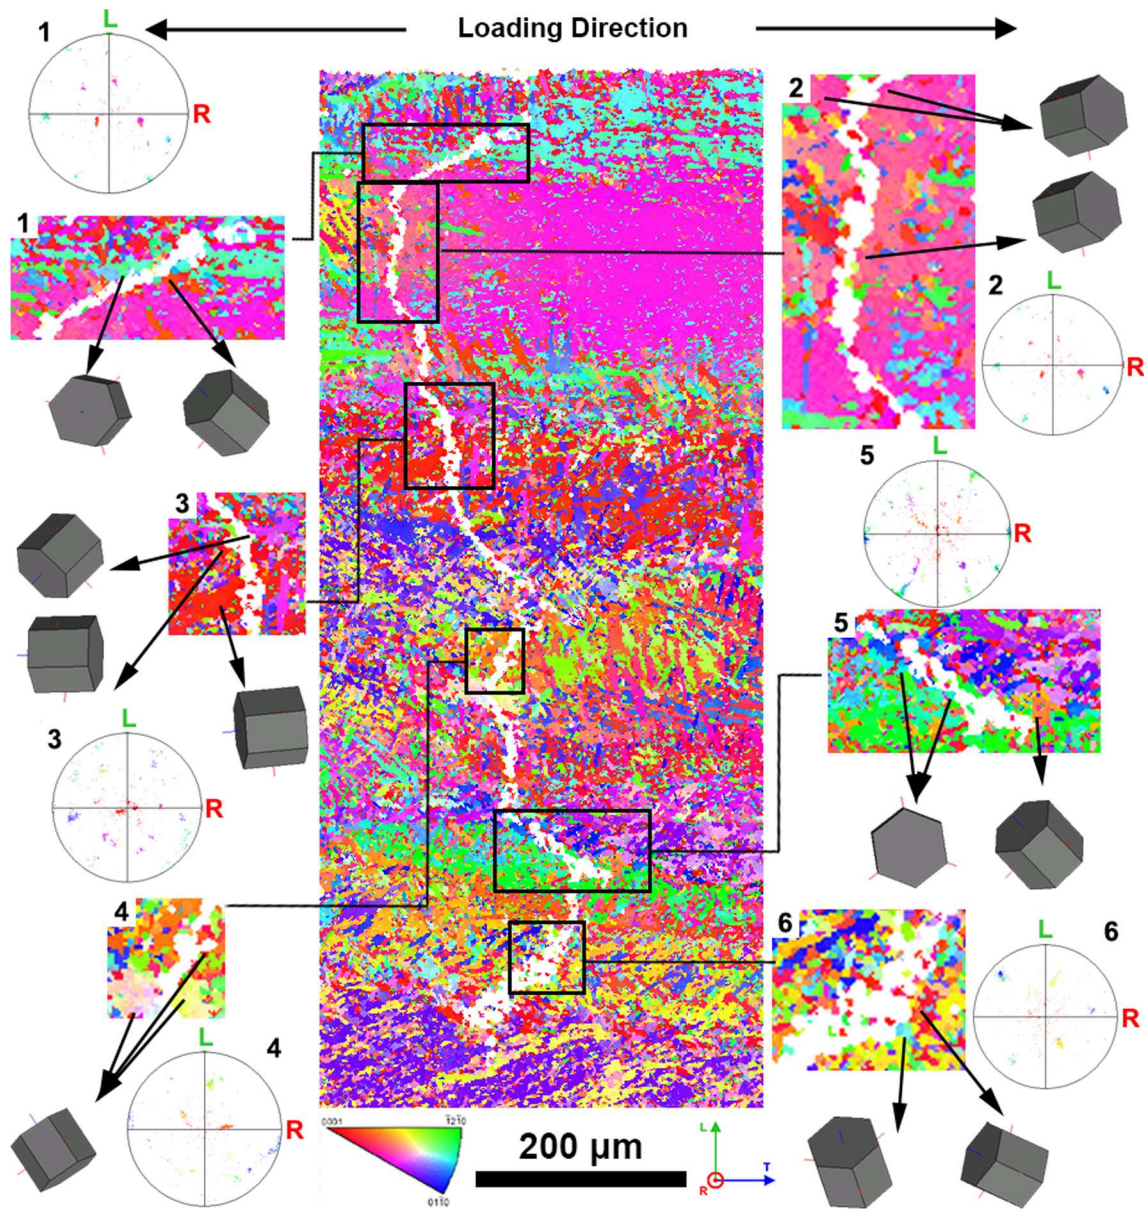
Fig. 9. EBSD map revealing the orientation of grains adjacent to the propagated crack. In the corresponding IPF colouring, the basal plane is parallel to the tangential direction of the disc (loading direction).

Fig. 9 shows detailed analysis of the crystallographic orientations at different locations along the crack. Initially, at the surface the crack is straight and perpendicular to the surface. The initial crack opening can

be related to the high stresses applied to the top surface during the beginning of the test. The first deviation appears within the first prior- β grain, however within two different crystallographic orientations developed from the 12 possible variants of the Burger's relationship. In both cases (regions 1 and 2) the main crack orientation is dictated by the relative position of the applied load and the HCP c-axis, developing basal cleavage. This is a common behaviour that is repeated in regions 3, 4 and 6.

Analysis of the local orientation of the HCP crystal as a function of the crack path geometry in Fig. 9 shows a clear trend, where in most of the cases, the crack propagation direction is defined by the relative orientation of the c-axis and the basal plane with respect to the crack path. This analysis is complemented with the study of the evolution of the Schmid factor with respect the loading direction and the prismatic slip systems (Fig. 10). This analysis shows that cracks are both deviated and arrested when they encounter secondary α unfavourably oriented prismatic slip planes relative to the loading direction. A similar result is reported by Bantounas et al. where the effect of crystallographic texture during fatigue loading (of dog bone samples) for Ti-6Al-4V is studied [41]. They observed that a fatigue crack arrested when it reached a structural unit size (macrozone) unfavourably oriented for prismatic $\{1\ 0\ \bar{1}\ 0\}\{1\ 1\ \bar{2}\ 0\}$. This same behaviour is clearly shown in the Ti-6246 compressor disc material, where crack arrest and crack path deviation has been found when the crack tip encounters these unfavourably oriented zones. Such crack arresting occurs due to the retardation of the crack propagation rate, as more energy is required to propagate the crack to lower stress locations, or by deviating the crack towards lower energetic paths, resulting in more convoluted path, and subsequently improving the fatigue crack propagation resistance of the component.

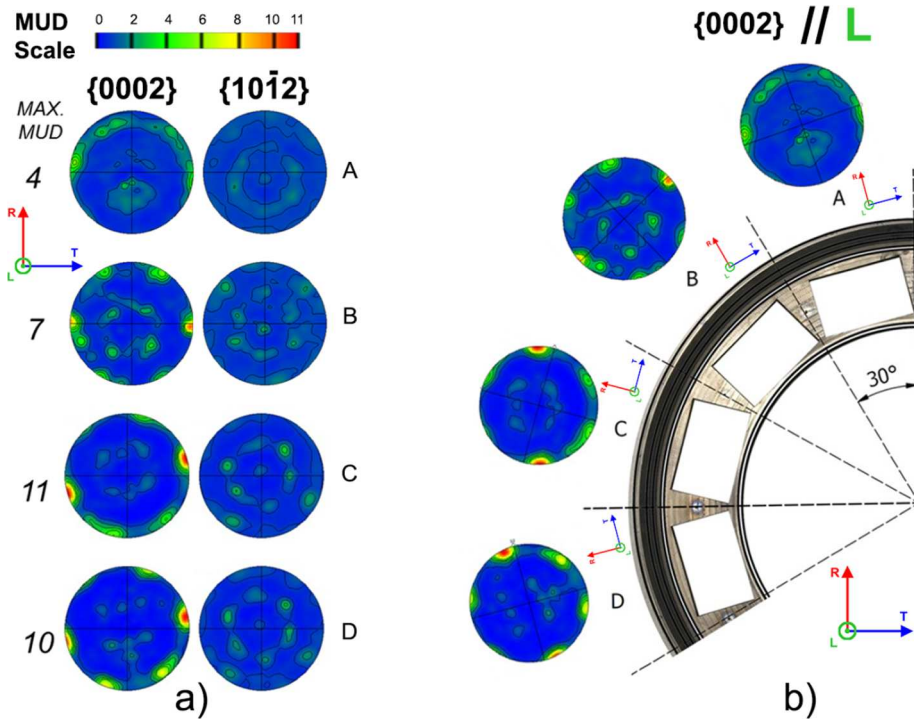
Fig. 11. (a) EBSD pole figures of the sections A-D in Ti-6246 compressor disc 1 with pole figures and (b) Representation of the pole figures under the same axes with respect to the disc.

Due to the circular symmetry shown in the fatigue results and the clear inheritance of the strain path induced during primary forging, an analysis on the texture of 1/4 the disc has been performed (Fig. 11).

Differences in texture have been found between the analysed samples, which indicate that this is the root of the difference in mechanical properties. Moreover, the texture scale (MUD) shows significant differences, with a low MUD value of 4 representing a more random texture in the best performing locations and a higher MUD of 11 in the worst performing regions. However, it is an interesting observation that even though the texture index varies as a function of the radial direction, the c-axis of the HCP crystal is orientated in the tangential direction in all the samples analysed. This could be caused by the preferential selection of the 12 possible α developed orientations from the parent β grain. This preferential variant selection could be induced by the circumferential stress and strain during the secondary forging process, leading to the β plane (1 0 1) being preferentially orientated perpendicular to the tangential axis of the disc. The influence of the external stress applied and the α variants selected during α to β transformation has been reported by Shi et al. [42]. This would lead to a preferential creation of the c-axis for the HCP α phase in the tangential direction, as seen in Fig. 11.

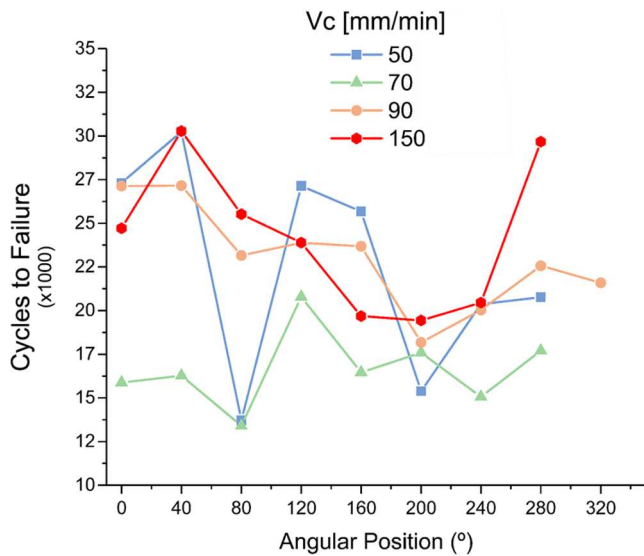
Fig. 13. Plot of cycles to failure as a function of radial direction and cutting speed of samples extracted from Ti-6246 compressor disc 2, at a range of cutting speeds.

Fig. 13 shows the cycles to failure as a function of the cutting speed and the radial location from where the samples were extracted. The first key observation of this data is that regardless of cutting speed, the variation in fatigue life as a function of radial direction is still present. This data also shows that there are specific radial locations (80° and 200° respectively) in the disc that consistently under perform with respect to the average fatigue life. These locations of low cycles to failure are common in the four cutting speeds, yet are more pronounced at the lower cutting speed range between 50 and 70 m/min. Similarly, radial locations labelled as 40° and 280° are consistently higher than the average.

It is important to note that higher cutting speeds show better fatigue performance and slightly lower variability with respect to lower material removal rates and lower cutting speeds. Another interesting point from these tests is extracted from Table 3, where the average cycles to failure per radial location is calculated as a function of the cutting speed. The best average fatigue life is shown by the material machined at the fastest speed with 24,207 cycles. A direct proportional trend can be found between faster cutting speeds and longer fatigue life. However, 70 m/min falls out of this trend showing poorer performance respect the other machining speeds.

Samples extracted from disc 2 were machined at different cutting speeds and tested under dynamic loading conditions in a 4-point bend test. The first conclusions extracted from Fig. 13 are that, even though the variability of the cycles to failure diminishes with increasing cutting speed, there remains a distinct reduction in cycles to failure at the angular positions 80° and 200°.
