Effect of High Temperature Ageing on Electromagnetic Emissions from a PIC Microcontroller

J F Dawson¹, I D Flintoft¹, A P Duffy², A C Marvin¹, M P Robinson¹

Abstract— This paper describes the effect of high temperature ageing on the electromagnetic emissions of a number of PIC microcontrollers. The aged devices show a measureable shift in the frequency of emissions. Shift in the voltage-current characteristics of the device output pins has also been observed.

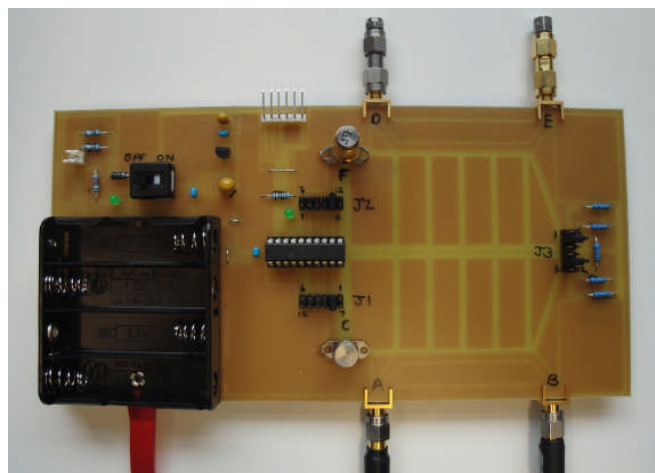
Fig. 1: The microcontroller emissions test circuit board.

The emission test board is shown in Fig. 1. The PIC is powered by 4 rechargeable AA cells via a linear regulator to remove the effect and variability due to external supply connections. LEDs are used to indicate power supply and PIC operation. The latter is flashed slowly on power up to indicate the on-chip software is operational. The PIC device chosen has an on-board clock so no additional components are required for the device to function. A number of Input/Output (I/O) pins are brought to one of two header strips near the PIC which allow them to be connected to one of two loaded tracks which each pass an RF coupler. The track loads can be selected by means of further jumpers on the right hand side of the board (Fig. 1) and schematically in Fig. 2.

In order to ensure good repeatability of the RF emissions measurement, we included RF couplers on the circuit board. These can be seen in Fig. 1 on the right hand side of the board at the top and bottom.

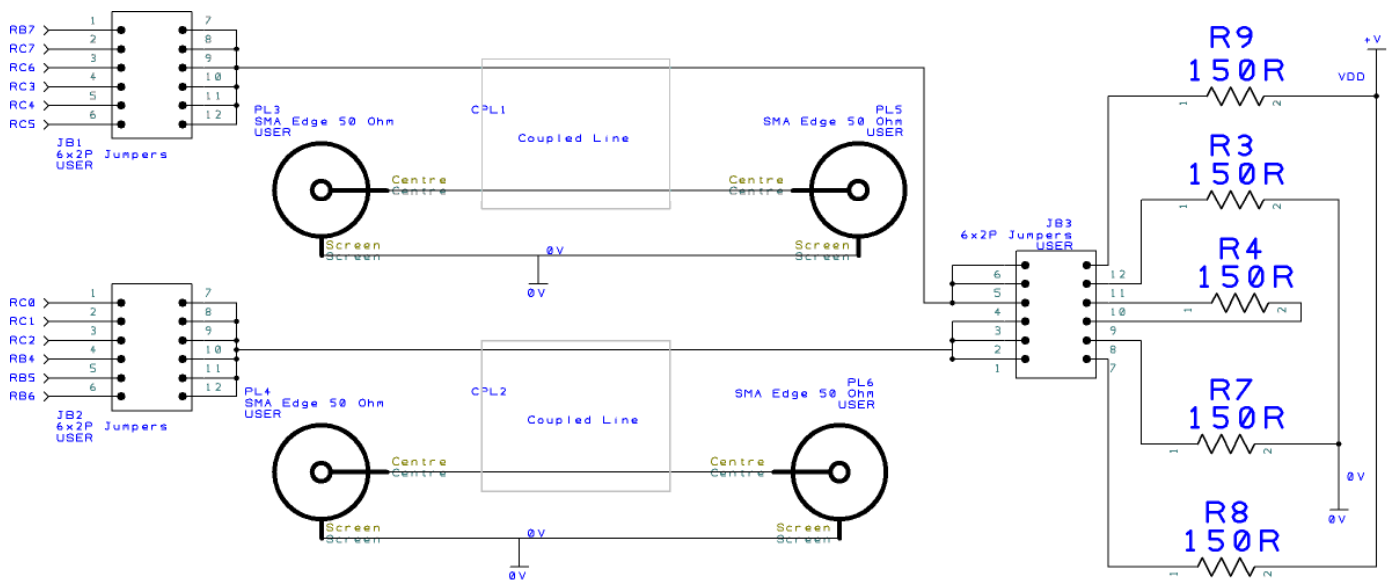
Fig. 2: PIC input/output pin connections via jumper banks and RF couplers to load selection jumpers.

An edge mounted SMA connector is provided at each end of the coupler. The couplers are also shown schematically in Fig. 2. Fig. 3 shows the detailed board layout. The coupler is designed to have a $50\ \Omega$ impedance to give a good match as the SMA connectors. An SMA connector is also attached at the PIC end of the IO track, near the PIC so the coupler can be characterised. The ground plane sections near the I/O tracks are broken to maximise the coupling to the coupler track.

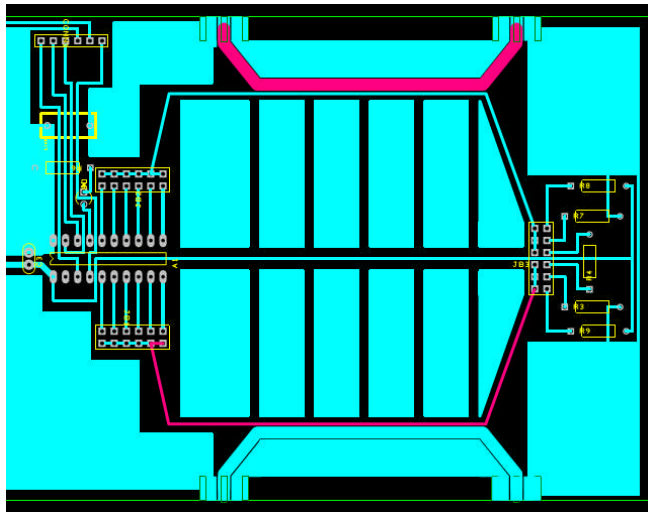
Fig. 3: Layout of the underside of the circuit board showing the RF couplers.

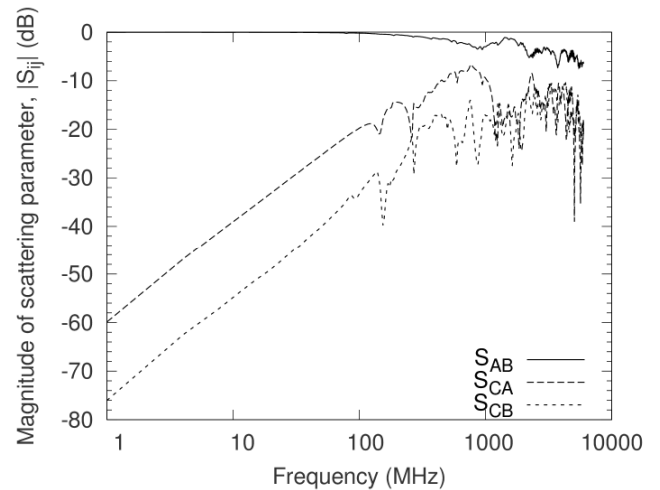
Fig. 4 shows the S-parameters of one of the couplers. Ports A (near PIC) and B (near loads) are the edge mounted SMA connectors and port C is the IO track near the PIC. The coupler has a through (A to B) loss of less than 3 dB up to 1 GHz and less than 6dB up to 6 GHz. The coupling to port C is directive and increases smoothly with frequency up to 100 MHz after which some resonant behaviour is observed as the I/O track termination resistors are not an accurate match and the physical layout adds significant inductance..

Fig. 4: Coupler performance.

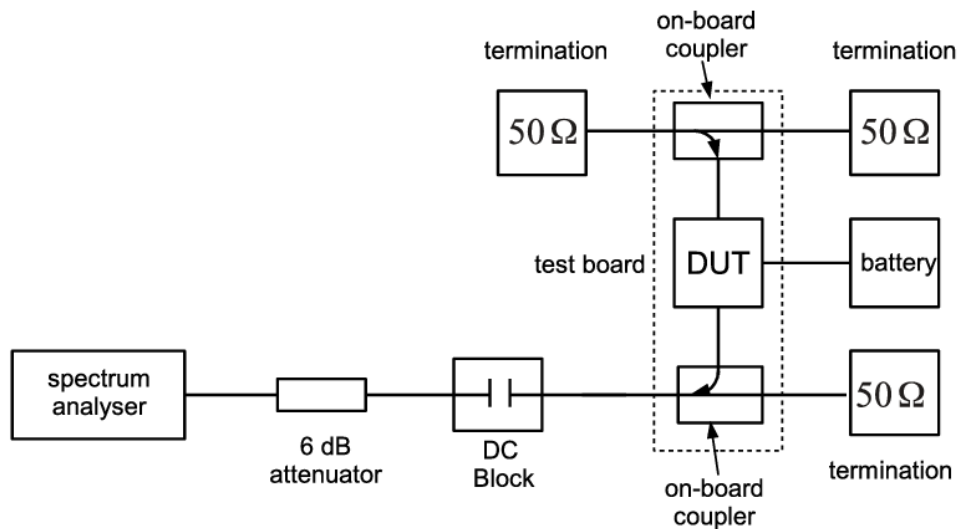
Fig. 5: The measurement system.

Fig. 5 shows the measurement set-up. In order to prevent damage to the spectrum analyser an attenuator and DC block is used. All unused coupler ports were terminated with 50 Ω loads. The emissions spectrum was measured from each device over the range 10 MHz to 400 MHz. This was the range over which emissions of a significant amplitude occurred whilst allowing enough measurement points to be achieved in a single sweep to be able to observe detail in the region of each harmonic.

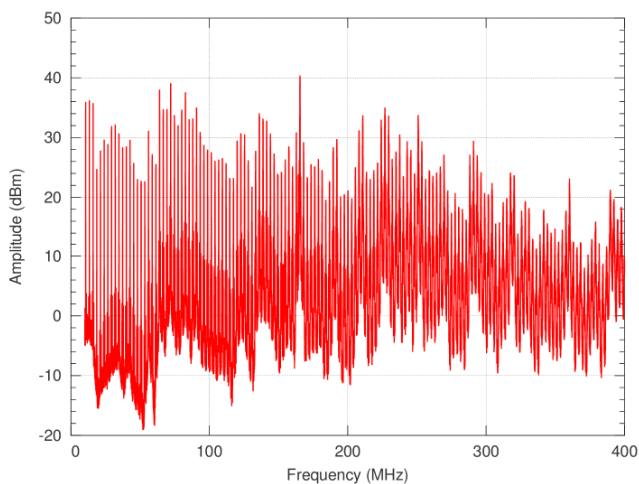
Fig. 6: The full emissions spectrum of PIC M01 from 10 MHz to 400 MHz before ageing.

Fig. 6 shows the full emissions spectrum from SMA port A, connected to IO port C pin 7 of PIC M01. As expected the spectrum consists principally of harmonics of about 2.6 MHz – the frequency at which the IO lines are toggled.

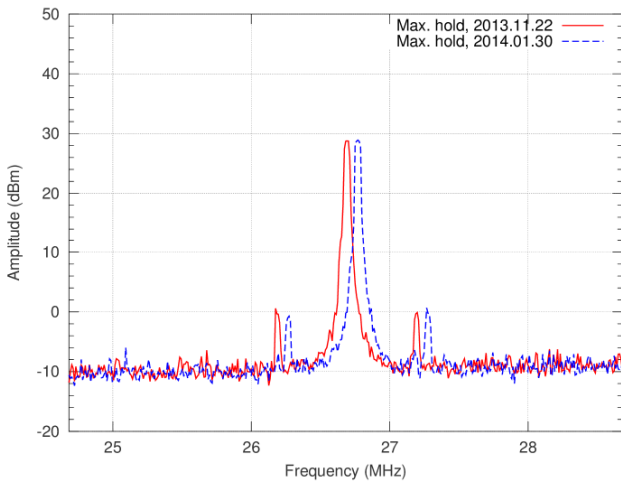
Fig. 7 shows detail around the 27 MHz harmonic before and after ageing. It can be seen that the harmonic has sidebands at about ±500 kHz. The harmonic and sidebands both shift in frequency due to the ageing process. Fig. 8 shows the detail around 99MHz where a larger shift in the harmonics can be seen due to ageing.

Fig. 7: Shift in the emission spectrum of PIC M01 about an harmonic at 27 MHz due to ageing for 1 week at 140°C. (aged = dashed line)

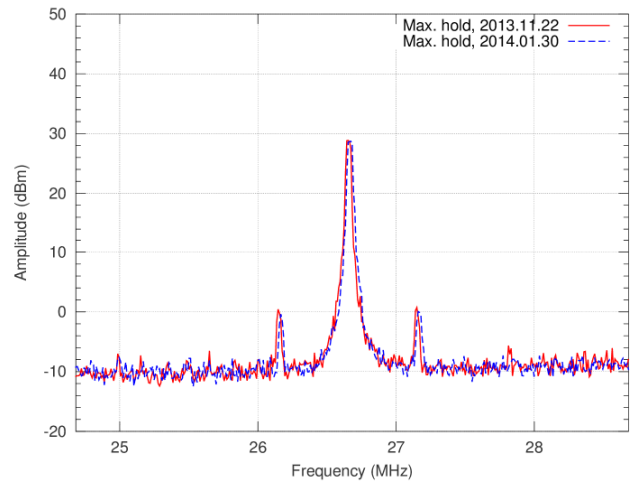
Fig. 9: Repeatability of the emission spectrum measurement of PIC M09 for the harmonic near 27 MHz for an unaged device.

Fig. 9 and Fig. 10 show the same measurements for PIC M09 taken at the same time. PIC M09 was not aged and the measurements show good repeatability.

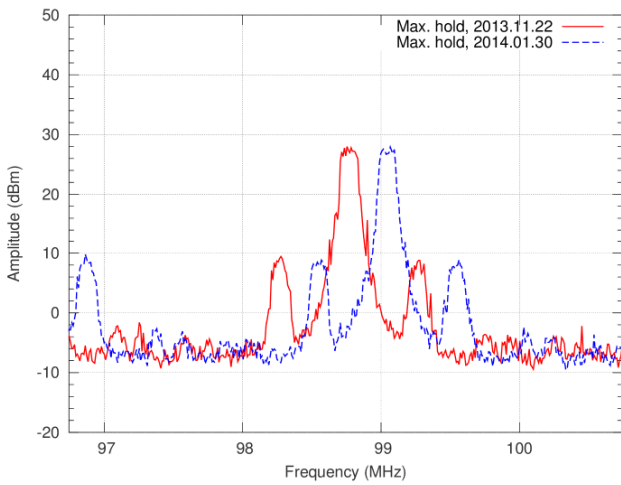
Fig. 8: Shift in the emission spectrum of PIC M01 about an harmonic at 99 MHz due to ageing for 1 week at 140°C (aged = dashed line).

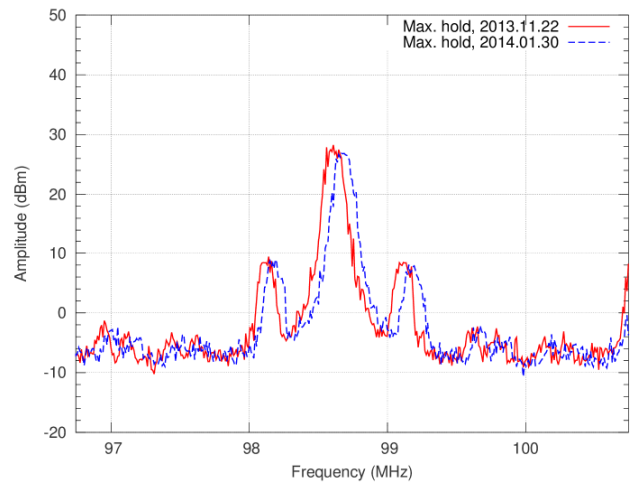
Fig. 10: Repeatability of the emission spectrum measurement of PIC M09 for the harmonic near 99 MHz for an unaged device.

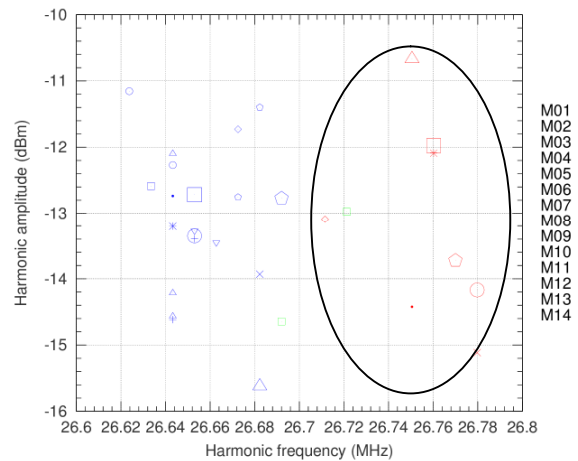
The amplitude and frequency of the harmonics around 27 MHz and 99 MHz were extracted from the data and are presented in Fig. 11 and Fig. 12. PICs M01-M08 were subject to the one week ageing period and PICs M09-M13 were not aged. PIC M14 was used for a short, 3 day, ageing test.

Fig. 11: Change in amplitude and frequency of an emissions harmonic peak near 27 MHz for 14 PICs. Blue is unaged, green aged for 3 days and red aged for 1 week (aged circled).

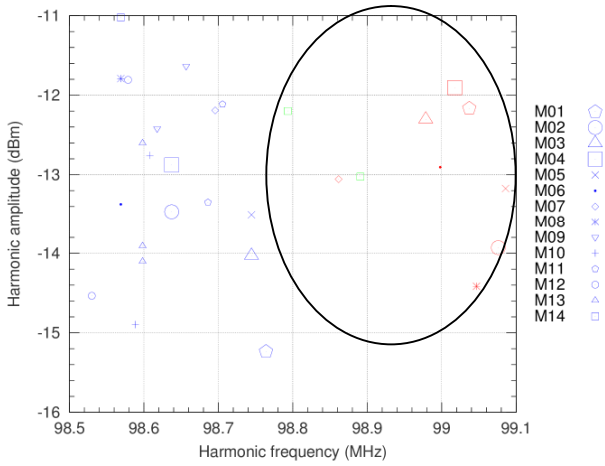
Fig. 12: Change in amplitude and frequency of an emissions harmonic peak near 99 MHz for 14 PICs. Blue is unaged, green aged for 3 days and red aged for 1 week (aged circled).

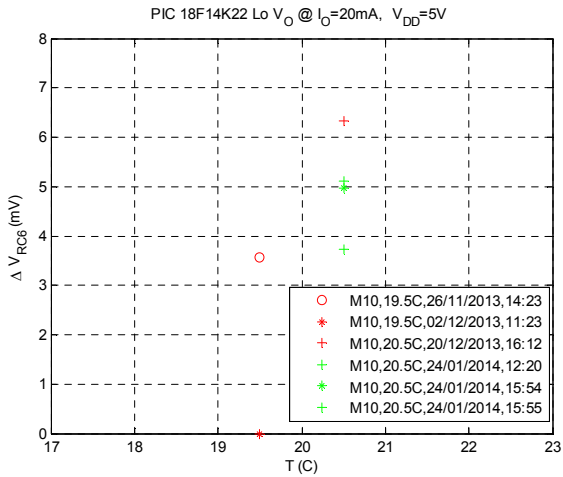
Fig. 13: Change in PIC M10 Port C pin 6 Low output voltage as a function of temperature and different measurement dates (no ageing).

The voltage/current curves were measured for port C pins 6 and 0 for each of the devices, before and after ageing. Fig. 13 shows a number of measurements of the low output voltage at a current of 20 mA for PIC M10, taken on different dates at different temperatures. It can be seen that the voltage measured varies from measurement to measurement and tends to be higher at the higher temperature. The overall variation from lowest to highest measurement is just over 6 mV. This is typical of the set of devices.

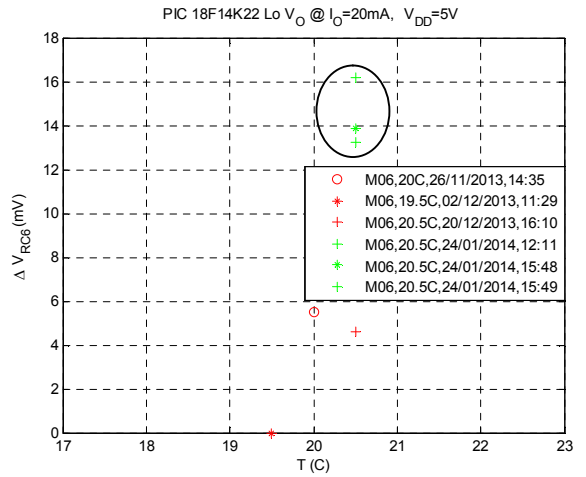
Fig. 14 compares a number of measurements for PIC M06 before and after ageing. It can be seen that the post ageing measurements show an increase in output voltage of about 10mV over those measured prior to ageing.

Fig. 14: Change in PIC M06 Port C pin 6 Low output voltage as a function of temperature and different measurement dates, before (2013 dates) and after ageing (24/01/2014) (aged circled).
