This is a repository copy of *Effects of tool coating and tool wear on the surface quality and flexural strength of slotted CFRP*.

Ashworth, S., Fairclough, J.P.A. [orcid.org/0000-0002-1675-5219](https://orcid.org/0000-0002-1675-5219), Meredith, J. et al. (2 more authors) (2022) Effects of tool coating and tool wear on the surface quality and flexural strength of slotted CFRP. *Wear*, 498-499. 204340. ISSN 0043-1648

# Effects of tool coating and tool wear on the surface quality and flexural strength of slotted CFRP

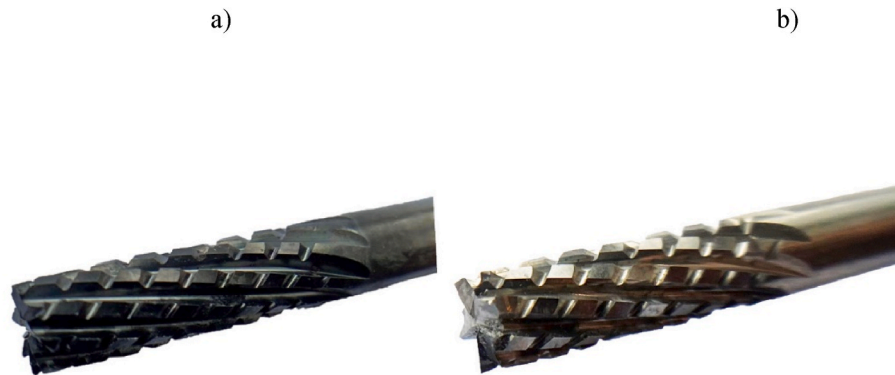
Fig. 2. a) DIA-BNC and b) uncoated BNC, Ø 6 mm tools.

A diamond coated carbide (DIA-BNC) and uncoated version (BNC) of the same tool geometry were provided by OSG Corp, Fig. 2. DIA-BNC is a double helix, fine nicked router specifically for CFRP trimming with the geometry designed to eliminate uncut fibres and delamination [12]. The uncoated, exposed tungsten-carbide version was used to exacerbate the effects of tool wear.

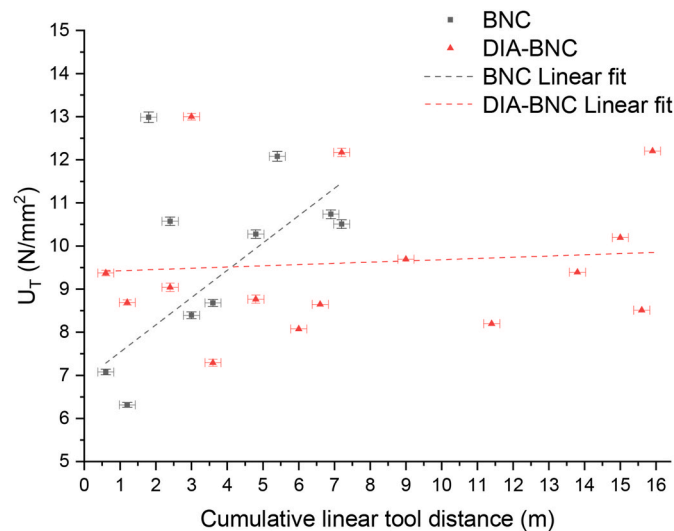
Fig. 6. Overall  $U_T$  versus cutting distance for BNC and DIA-BNC tool with linear fit to show general upward trend of  $U_T$  for increasing amounts of tool wear.

Fig. 6 shows the results of  $U_T$  for specified tool wear points. Whilst there is a general upward trend of  $U_T$ , suggesting that tool wear has occurred and meeting the expectation that worn tools produce higher cutting forces due to less edge acuity, there is a large fluctuation of  $U_T$  which is unexpected. Whilst the variation is unexpected, Engdahl [33] notes that CVD drilling tools produce a similar fluctuation in thrust force. This suggests that the tool geometry is wearing in such a way that forces increase and decrease throughout tool life.

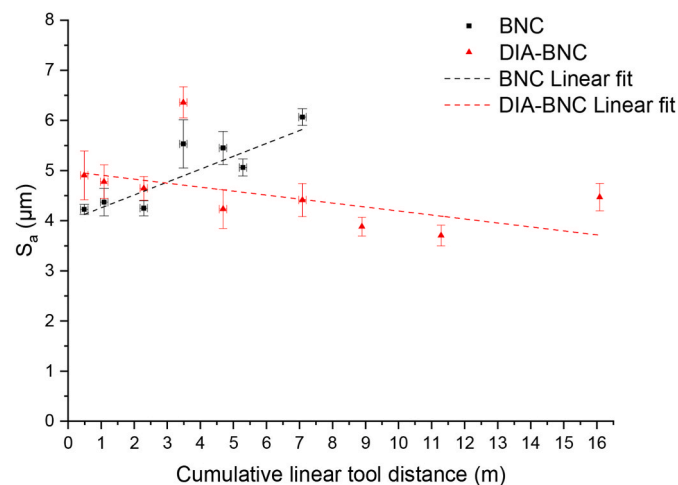
Fig. 8. Average  $S_a$  values for surfaces machined with BNC and DIA-BNC, highlighting the variable nature of  $S_a$  with an overall trend of increased  $S_a$  for increased tool wear.

The results of  $S_a$  plotted against cumulative linear tool distance, Fig. 8, show a general increase with tool wear for the BNC tool and the inverse, a decrease of  $S_a$  with DIA-BNC tool wear. It is also noted that  $S_a$  appears to both increase and decrease as cumulative linear tool distance increases. Whilst this does not meet with an expectation that  $S_a$  should always increase with tool wear, it is noted in Duboust et al. [8] and

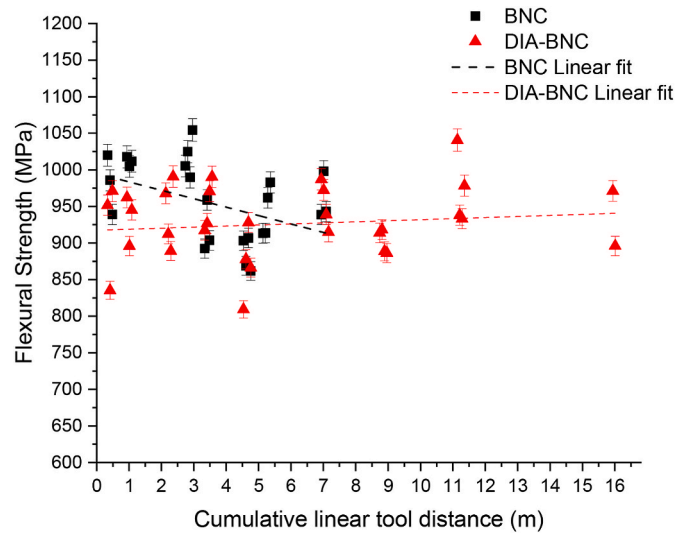
Fig. 11. Flexural strength of coupons machined with BNC and DIA-BNC tools showing decrease and increase in flexural strength for uncoated and coated tools, respectively.

The results of flexural strength changes for increased tool wear is presented in Fig. 11 with a strength reduction of up to 10.5 % reported for BNC but an increase of up to 2.2 % for the DIA-BNC tool when linear regression models are applied to results. This fits with the expectation that the uncoated tool has worn and produces increased cutting forces (Fig. 6) and statistically different surfaces exist due to wearing of the tool (Figs. 9 and 10 b)). The purpose of the coating has served its purpose in
