Rooke, J., Brunskill, H., Li, X. et al. (2023) Piston ring oil film thickness measurements in a four-stroke diesel engine during steady-state, start-up and shut-down. *International Journal of Engine Research*, 24 (4). pp. 1499-1514. ISSN: 1468-0874

# Piston ring oil film thickness measurements in a four-stroke diesel engine during steady-state, start-up and shut-down

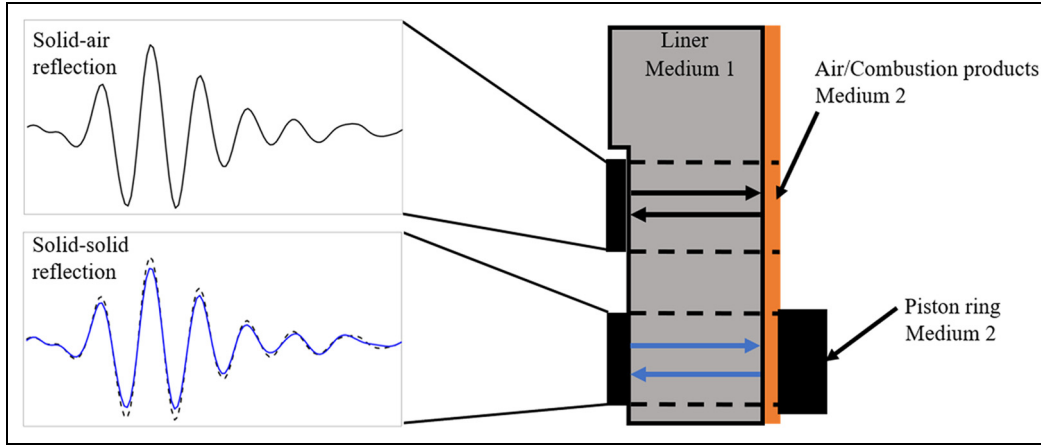
**Figure 1.** A schematic describing the ultrasonic measurement of film thickness from an engine liner mounted transducer.

The basis of ultrasonic lubricant property measurements is grounded on a piezoelectric transducer being bonded to a medium, in this case, the external surface of the cylinder liner. The transducer is excited with an electric pulse which generates a high-frequency acoustic pressure wave due to the principle of piezoelectricity. The sound wave propagates through the host medium and is reflected from the internal surface of the liner. When there is no piston ring aligned with the sensor the ultrasonic pulse is fully reflected (from the solid-air interface, black line in Figure 1) whereas when a piston ring is aligned, part of the pressure wave is transmitted through the lubricant film and part is reflected (solid-solid interface, blue line in Figure 1). This transmittance results in a reduction in the amplitude of the reflected wave. The amount of the wave amplitude reflected depends on, amongst other things, the thickness of the oil film. The proportion that is reflected relative to the incident amplitude is termed the reflection coefficient,  $R$ , and is purely dependent on the acoustic impedances

of the two media. The definition of  $R$  is shown in equation (1). At a solid-air boundary, the signal is almost completely reflected ( $R = 1$ ) and so this can be used as the reference signal ( $A_{reference}(f)$ ).

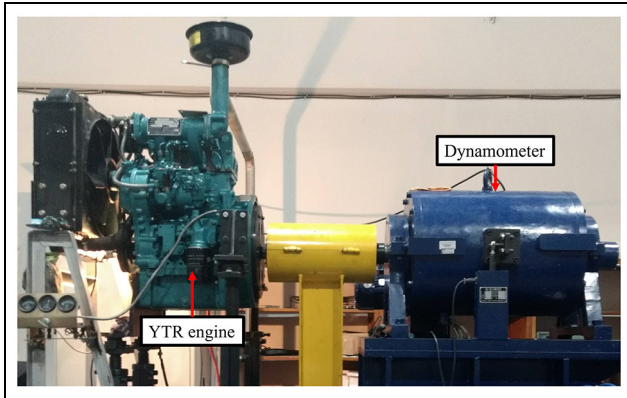
**Figure 2.** The YTRC21 I0D test engine and dyno.

The engine considered in this work is a diesel YTR engine, specifically a YTRC2110D, the two-cylinder engine is typically used in heavy-duty vehicles such as tractors. The test rig setup is shown in Figure 2 with the main specifications of this engine are shown in Table 1.

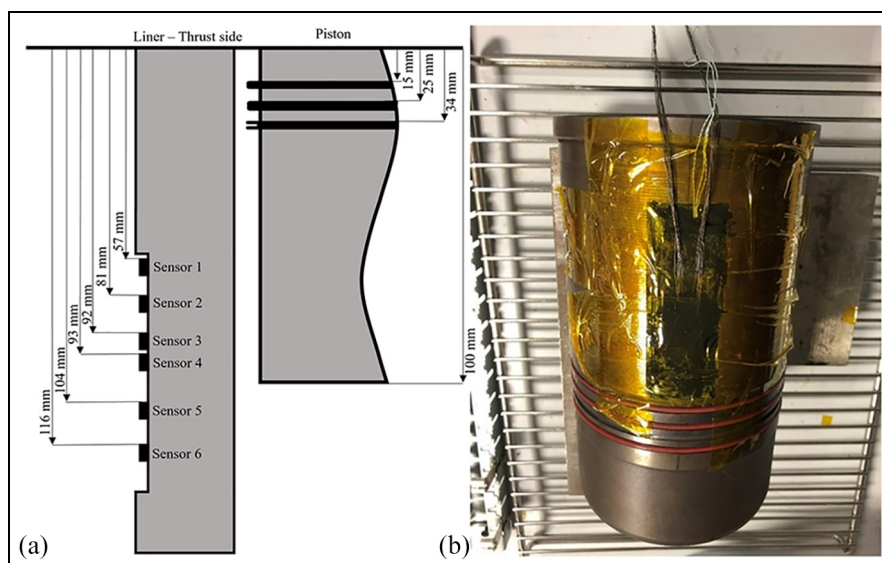
**Figure 3.** (a) Schematic of the transducer layout and (b) a photograph of the instrumented component.

the neutral axis Figure 4(a), final placement of the sensors (Figure 4(b)) positioned the sensors on the thrust side of the engine. The complete installation process required minimal modification to the engine, the only modification to the engine was the flat machined onto the external surface of the liner (see Figure 3).

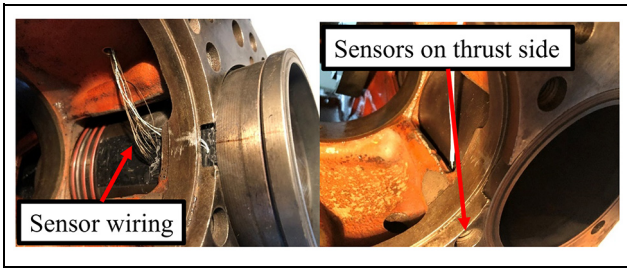
**Figure 4.** Photographs of the instrumented liner being installed into the engine. (a) cylinder liner inserted with sensors on the neutral side. (b) final liner positioning with the sensors on the thrust side.

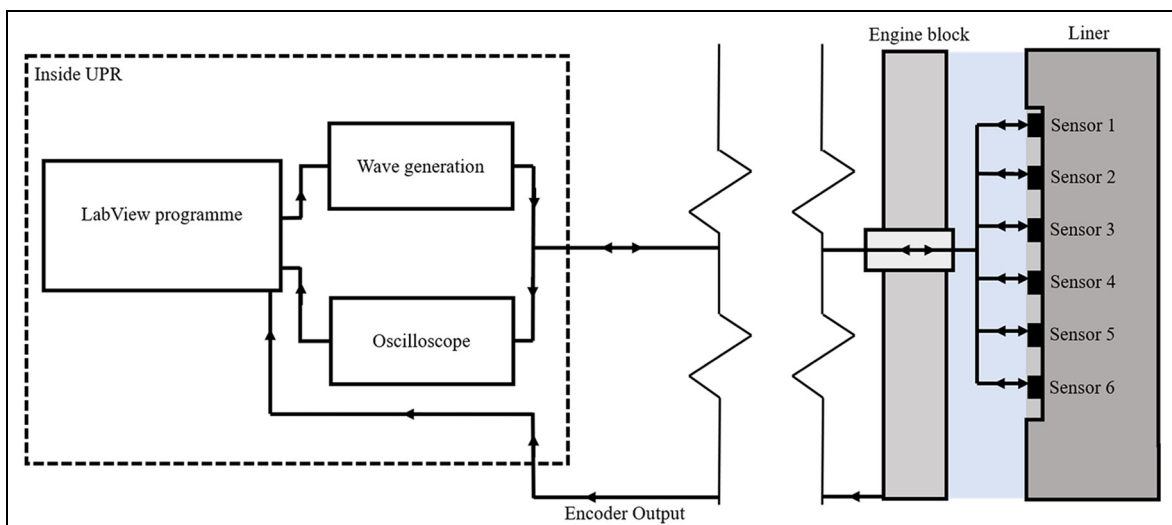
**Figure 5.** Schematic diagram of sensor layout, DAQ and signal processing equipment.

A schematic of the ultrasonic instrumentation and signal processing equipment is shown in Figure 5. An ultrasonic pulser receiver (UPR) was used to control the ultrasonic signals. Inside the UPR a card generates short voltage pulses that are sent to the ultrasonic transducers. The sensors converted this voltage to a mechanical displacement due to the piezoelectric effect and therefore propagate an ultrasonic wave through the cylinder liner. The ultrasonic wave is reflected from either the liner internal surface or the piston ring and is detected by the same sensor. The sensor converts the signal back into a voltage, which was then digitised in the UPR and shown in real-time as a time-domain

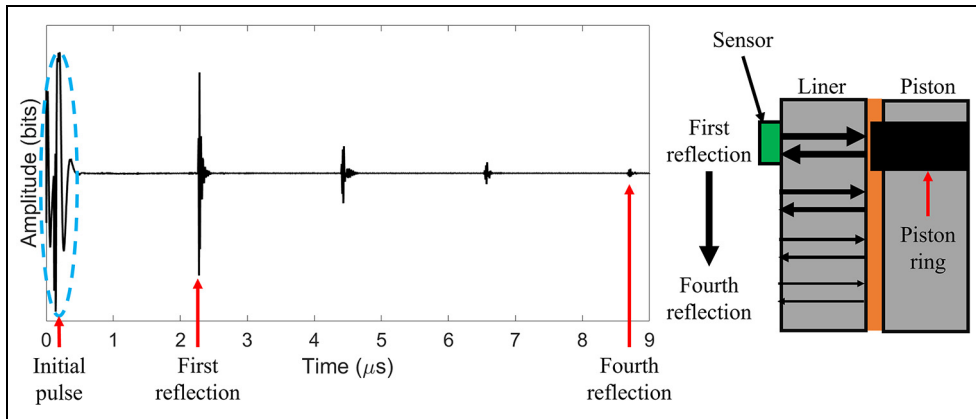
**Figure 6.** Typical A-scan of the reflected signal. Four reflections from the internal surface of an engine liner are shown. Note in the sketch the four reflections occur at the same location, yet the reflections are displayed down the liner for visualisation purposes.

A typical reflection pulse is termed an A-scan and an example is shown in Figure 6. The sound pulse initiated from the ultrasonic transducer propagates back and forth inside the liner until the energy has dissipated therefore several reflections are seen. The four reflections are annotated in Figure 6. For the data recordings the first reflection was studied, therefore only the time window relating to this pulse was recorded (see Figure 7(a)).

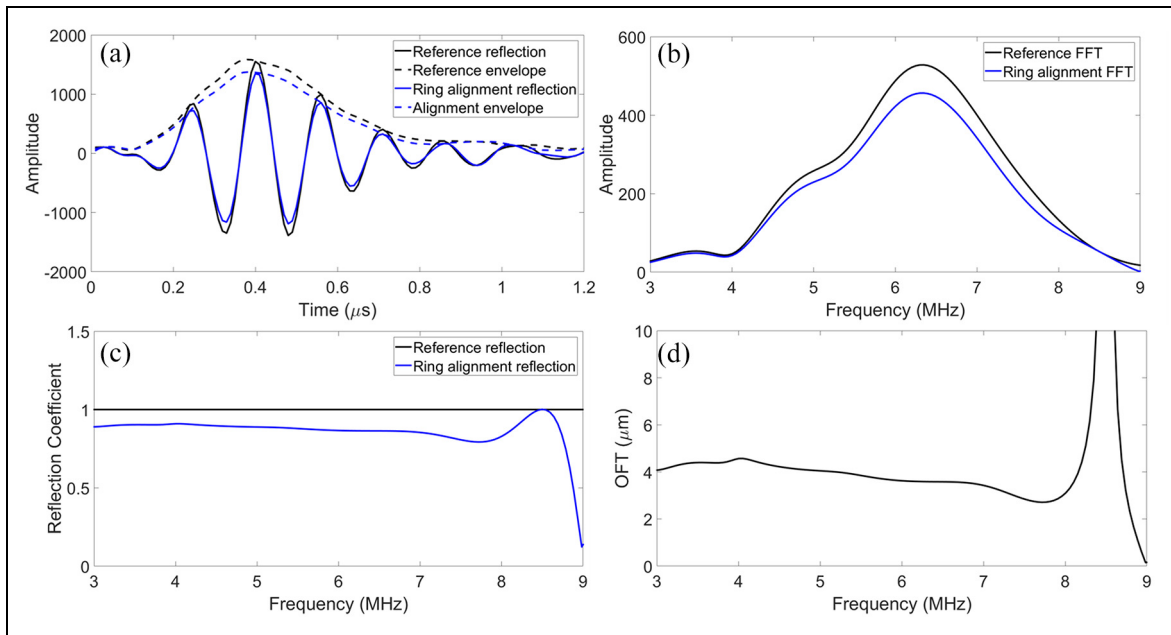
**Figure 7.** (a) Reference and ring aligned ultrasonic reflection, (b) reference and ring aligned FFT, (c) reflection coefficient with respect to frequency and (d) oil film thickness with respect to frequency.

The typical data processing steps applied to the first reflection to obtain the oil film thickness are shown in Figure 7. In this example, there is a reflection from when a piston ring was aligned with the sensor and a reflection where the piston is close to the bottom dead centre (BDC) and so remote from the sensor location which is used as a reference reflection.<sup>36,41</sup>

The time-domain response is shown in Figure 7(a) for a reference reflection and a reflection from an aligned piston ring. The fast Fourier transform (FFT) of these reflections is shown in Figure 7(b). It can be seen in both plots that the alignment of the piston ring reduces the amplitude of the reflection in the time and frequency domains, this is due to a portion of the wave

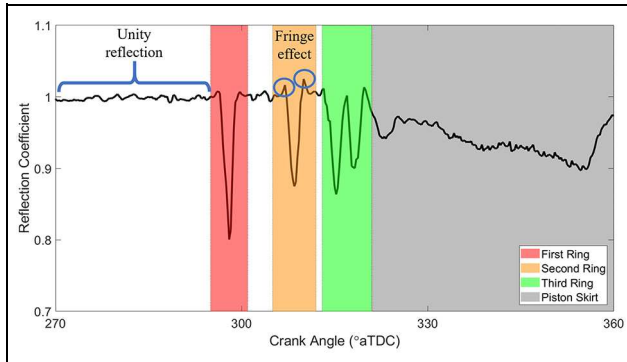
**Figure 8.** Reflection coefficient plotted as the ring pack passes over Sensor 1 during a compression stroke for an unloaded test case at 1500 rpm.

energy being transferred to the piston ring. The reflection coefficient (the amplitude of the measurement signal divided by the reference signal according to equation (1)) is calculated over the full frequency range as shown in Figure 7(c). The usable range of reflection coefficient is approximately 50% decibels (dB) of the FFT bandwidth (4-7 MHz in this case). The lubricant film thickness is then calculated (Figure 7(d)) from the reflection coefficient using equation (6). The lubricant film thickness is frequency independent so, within the bandwidth of the transducer, this should appear as a flat line. Figure 7(d) shows that this is indeed the case and so indicates the validity of the spring model equation (6).

In previous works that have applied this data processing route<sup>41,52,53</sup> there have been significant peaks at the shoulders of the ring passage (see the reduced impact of this in Figure 8 termed the ‘fringe effect’), these are anomalous (reflection coefficients greater than one are unexpected). This feature is caused by the finite size of the sensor; the beam emitted from the sensor is of similar size to the ring so that some parts of the beam will strike the ring at different times. When these reflect back there is some interference between the different parts of the signal and regions of constructive and destructive interference occur (this has been previously discussed extensively<sup>52,53</sup>). To reduce the impact of the time-delayed reflections from differing sections of the ring outside the alignment of the sensor, a novel data processing method was used to define the reflection coefficient (the peak of the Hilbert envelope relative to the peak of the reference envelope, see Figure 7(a)).

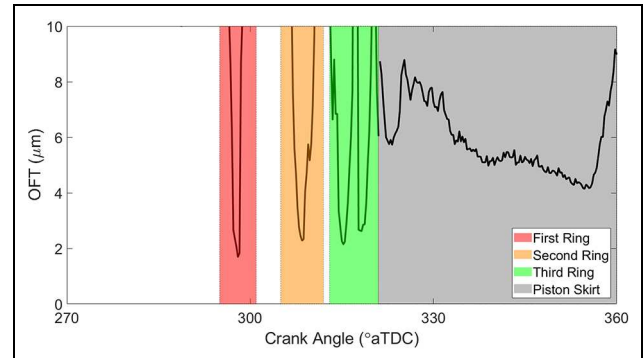
**Figure 9.** Oil film thickness, plotted as the ring pack passes over Sensor 1 during a compression stroke for an unloaded test case at 1500 rpm.

The reflection coefficient data is converted into oil film thickness (OFT) using equation (6). The materials of the ring and liner are steel and cast iron respectively, whilst the piston is made from aluminium. The speed of sound and density are defined from the equations in Table 2. The resulting oil film thickness variation over the compression stroke of Sensor 1 is shown in Figure 9.

The oil film thickness of the three rings and piston skirt can clearly be seen. In this example, the oil film is thinnest for the first compression ring ( $\sim 2 \mu\text{m}$ ) and gets progressively thicker for the scraper ring, oil control ring ( $\sim 2.5 \mu\text{m}$ ) and is thickest for the skirt (4–9  $\mu\text{m}$ ). The compression ring is expected to have the thinnest film in this stroke as this ring can be considered as a buffer between the higher pressure of the combustion chamber and the lower pressure of the crankcase. The ring is expected to be located at the bottom of the ring groove at this point in the stroke, therefore, enabling gases in the combustion chamber behind the ring leading to the ring to conform more to the liner, producing a thinner lubricant film. The thickest film, over the

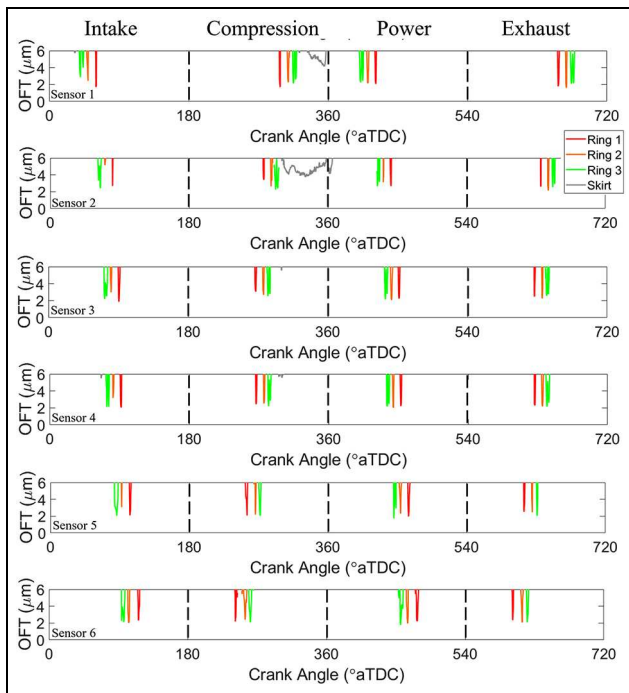
**Figure 10.** Oil film thickness determined from reflection coefficient measurements from Sensor 1 (top) to 6 (bottom) over two full revolutions of the crank covering intake, power, compression and exhaust cycles from an unloaded test case at 1500 rpm.

piston skirt, shows a progressive thinning of the film as the piston moves up the liner, this suggests tilting of the piston with the lower edge of the skirt being in closer proximity to the liner. This trend is clear from 330° to 350° CA until a sudden increase in the OFT as the piston is nearing its TDC position, as the tilting of the piston may be reversed here.

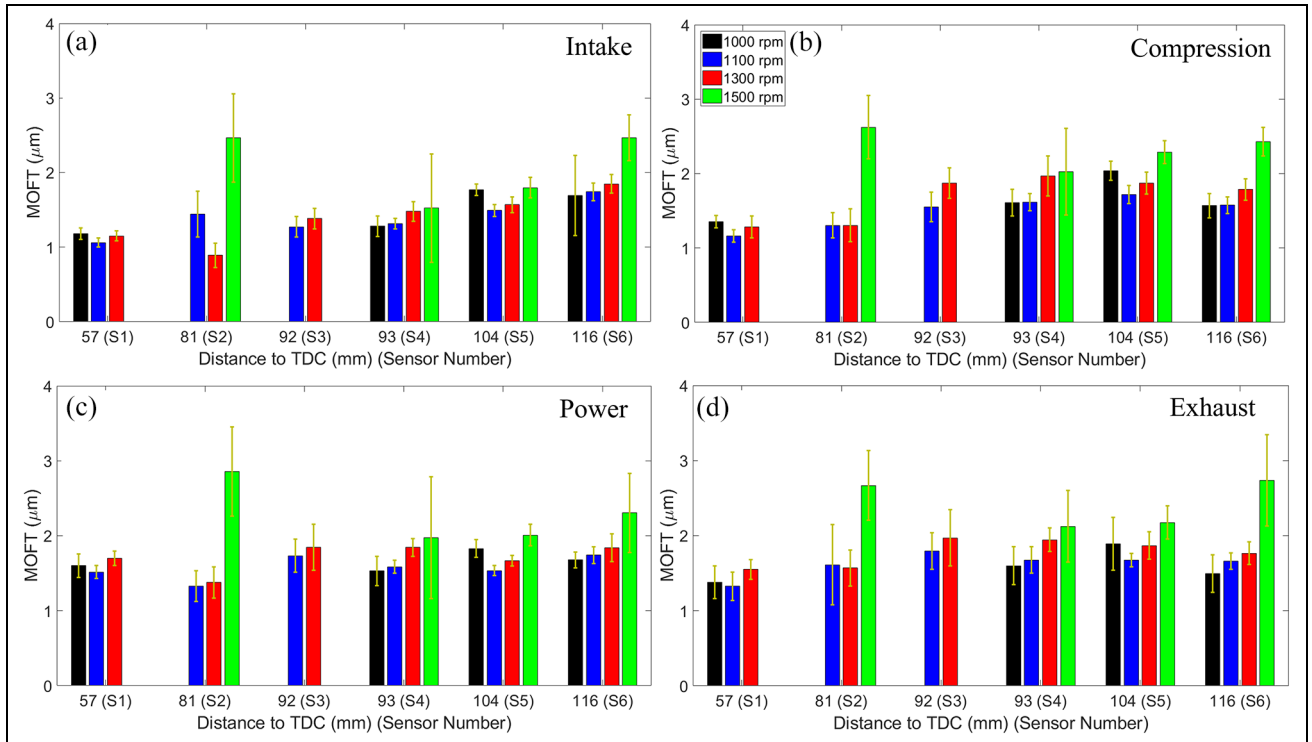
**Figure 11.** Measured lubricant film thickness for the Ring I (compression ring) over multiple strokes from an unloaded test case: (a) intake, (b) compression, (c) power and (d) exhaust.

The minimum oil film thickness (MOFT) has been extracted by isolating the minimum values each ring experienced in each stroke for every engine revolution recorded over the 2 s time interval. These values have been used to define the average MOFT and a standard deviation. The MOFT for the compression ring over each sensor is plotted at each engine speed in the four strokes in Figure 11.

The first point to note is that there is not a great deal of difference between the minimum film thicknesses in either location or with engine speed. For the First Ring at all locations, the minimum oil film

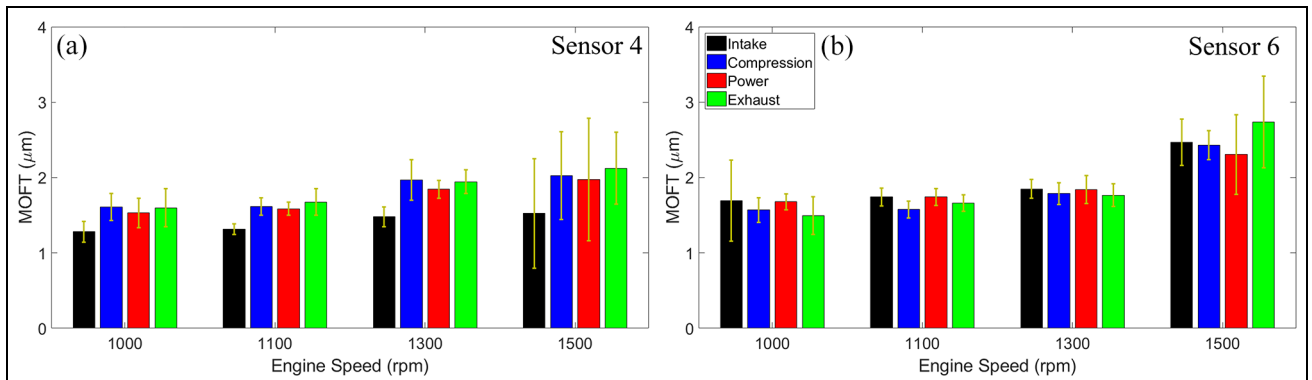
**Figure 12.** Measured MOFT for the Ring I (compression ring) in different engine strokes from an unloaded test case: (a) Sensor 4 and (b) Sensor 6.

A closer inspection of the MOFT for the compression ring over Sensors 4 and 6 is shown in Figure 12 to

Figure 12 shows the peculiar trend that Sensor 4 consistently led to a marginally thicker lubricant film during the compression and exhaust strokes whilst for Sensor 6, a marginally thicker OFT is generally present in the intake and power strokes. The compression ring experiences complex motion through each engine stroke and as the sixth sensor is significantly closer to the BDC than Sensor 4, this may have caused the opposing trends as the piston ring motion and thus OFT may have varied by the last sensor. In general, at mid-stroke an upward stroke is expected to produce a thicker film, as during an up-stroke the first ring is the first to pass the sensing region therefore they may be a bow wave of oil, or an excessive quantity of lubricant left on the liner. Alternatively, on a downward stroke, the compression ring is the final ring over this sensing area post the oil control ring that will have directed excess oil into the crankcase. These factors indicate the trend like those seen for Sensor 4, therefore the cause of these trends for Sensor 6 requires further study.

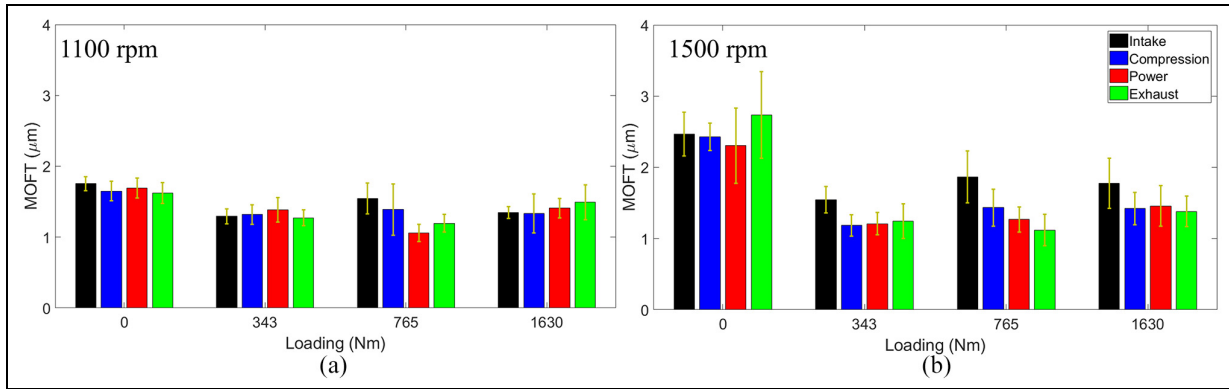
**Figure 14.** MOFT for Ring I (compression ring) in each engine stroke at various loading levels for Sensor 6: (a) 1100 rpm and (b) 1500 rpm.

A contrast of the MOFT in each stroke at the four engine loading levels is shown in Figure 14 for two engine speeds, 1100 rpm and 1500 rpm.

It is clear again that the zero loading test cases produced a greater MOFT than at any loading level with the film thickness halving from an increase from 0 Nm to 343 Nm loading at 1500 rpm. Although further increasing of the engine loading has a marginal effect on the MOFT with a slight increase with greater loading. The unloaded MOFT in each stroke of Sensor 6, Figure 12 showed the down-stroke to have a marginally

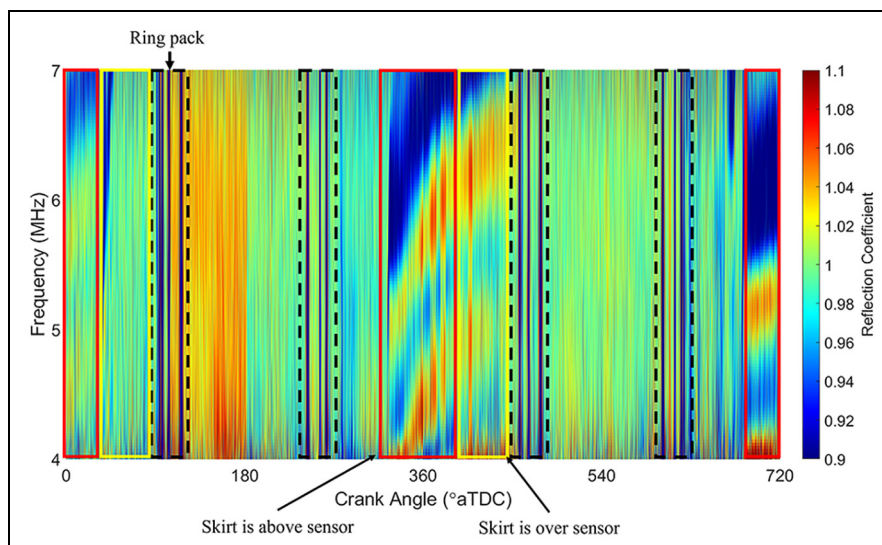
**Figure 15.** Loaded spectrogram of Sensor 6 from 1100 rpm at 343 Nm loading.

The spectrogram in Figure 15 shows a complex pattern over the 720° CA range, however, the ring pack is visible in each piston stroke via a series of drops in the reflection coefficient. There are also frequency varying resonant dips around the TDC of the piston (360°, 720° CA) whilst there is no equivalent at the BDC (180°, 540° CA). Furthermore, the resonant bands differ at each TDC, the combustion TDC shows a varying frequency band whilst the intake/exhaust TDC shows consistent bands over a shorter CA range. A closer inspection of the spectrogram from a ring pack and the pattern covering the combustion TDC from Figure 15 are highlighted in Figure 16.

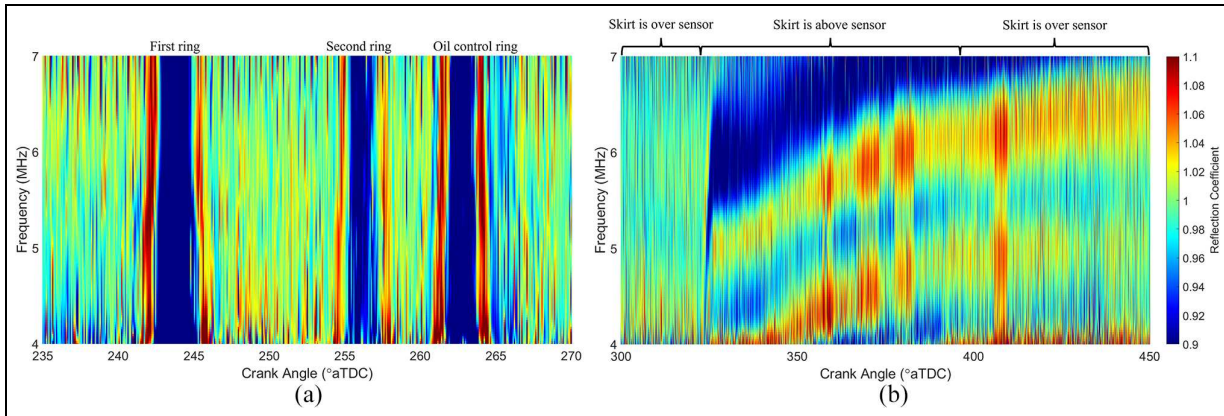
**Figure 16.** Loaded spectrograms from Sensor 6 at 1100 rpm and 343 Nm loading: (a) a ring pack and (b) time varying resonant frequency bands.

The frequency independence of the reflection coefficient over the sensor bandwidth is visible in Figure 16(a) by a consistent reduction over the frequency range. In addition, the minor fringe effects seen in Figure 8 is also present, indicated via the red band on

either side of the ring. The first, second and upper rail of the control ring are visible while the lower rail is only present to a lesser extent (light blue) showing a smaller drop in reflection coefficient.

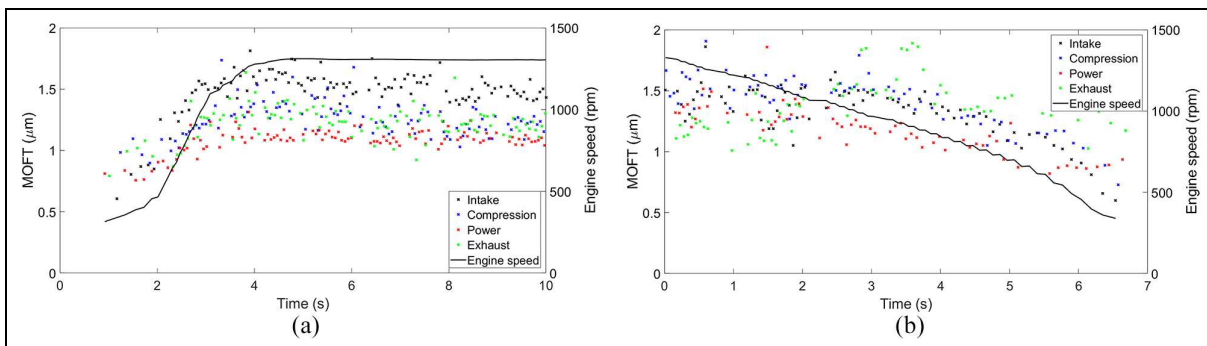
**Figure 17.** Engine (a) start-up and (b) shut-down, for Sensor 6 at 1300 rpm and (a) 343 Nm, (b) 765 Nm loading. The four engine strokes are identified in various colours.

The start-up test case in Figure 17 reveals that it took 2 s between the first detected ring passage and a consistent MOFT being achieved whilst a consistent engine speed was not achieved for a further 1.5 s. A steady build-up of the lubricant film thickness is shown over this period with the four strokes diverging, leading to the intake stroke having the thickest film whilst the thinnest is consistently seen in the power stroke which is similar to the steady-state MOFT for these conditions in Figure 13. The absolute MOFT recorded in either the start-up or shut-down was  $0.6\ \mu\text{m}$ . The liner used in the YTR engine had a manufactured internal surface roughness of  $3\ \mu\text{m}$ , it is therefore unlikely that a fully formed oil film was achieved in this stage.

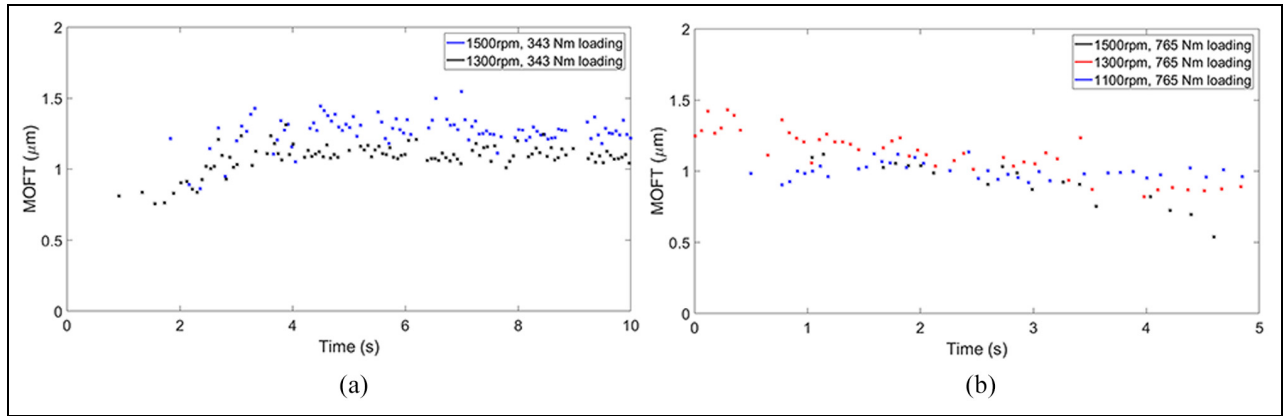
**Figure 18.** MOFT for the first compression ring at constant loading for a range of engine speeds during the power stroke: (a) start-up and (b) shut-down.

The steady-state testing indicated that a greater MOFT was achieved at higher engine speeds in each engine stroke, which is consistent with the engine start-up in Figure 18, and somewhat consistent in the shut-down tests in Figures 18 and 19 excluding the shut-down from 1500 rpm. However, the opposing trend is observed in the start-up test for the intake stroke in Figure 19. Although these increases were all minor and the greatest variation was around  $0.75\ \mu\text{m}$ .
