Devilat, B.M., Lanuza, F., Mane, M. et al. (2024) Advanced documentation technologies for people-centred preparedness and re-construction in Bela, India. *Disaster Prevention and Management: An International Journal*, 33 (5). pp. 480-501. ISSN: 0965-3562

# Advanced documentation technologies for people-centred preparedness and *re-construction* in Bela, India

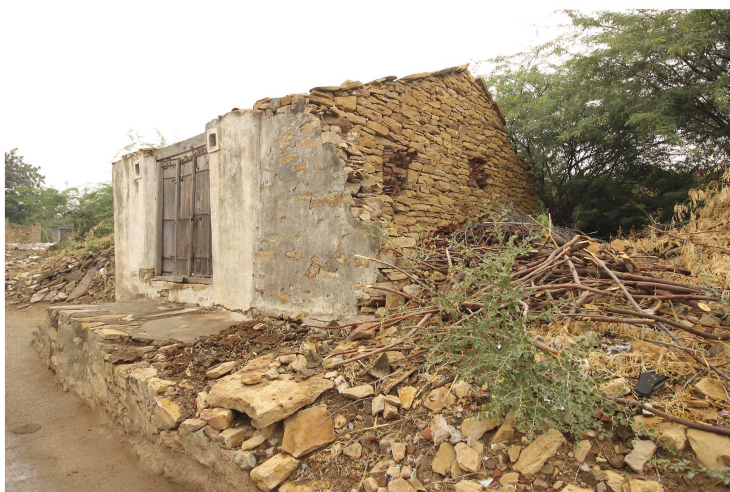
**Plate 1.**  
A dwelling damaged  
by the 2001 Bhuj  
earthquake in Bela,  
India. November 2021

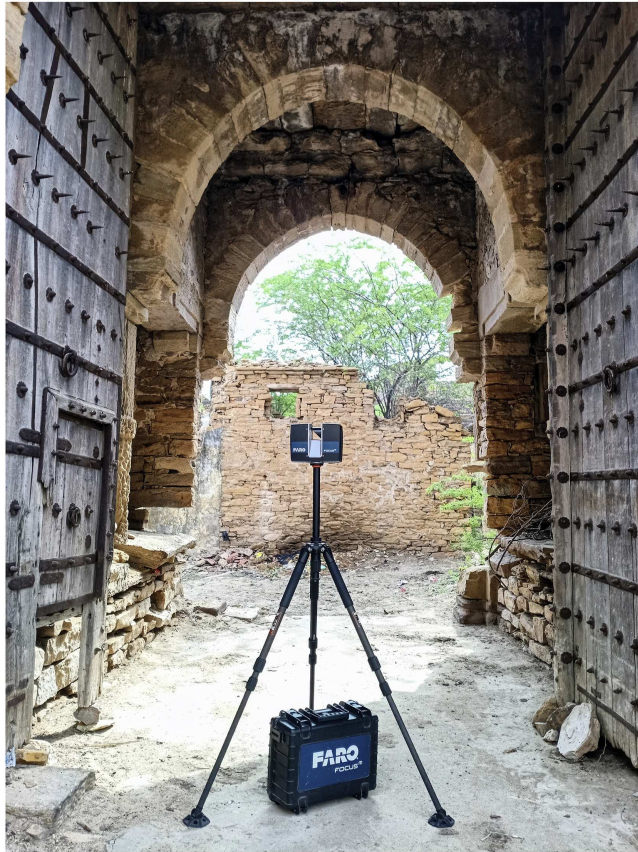
**Plate 3.**  
3D laser scanner  
capturing data on-site.  
July 2021

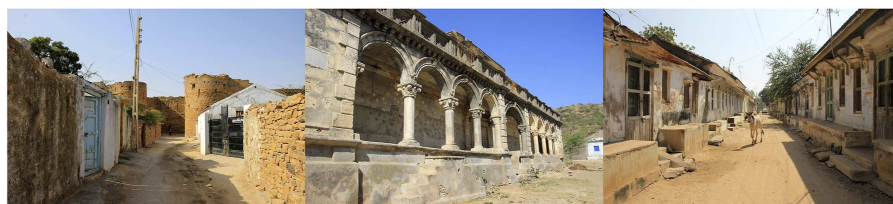
**Plate 4.**  
Glimpses of the  
construction  
typologies in three  
of the 11 potential  
villages identified  
during the  
reconnaissance field  
trip. From left to right:  
Bela, Roha and Moti  
Khakhar.  
February 2021

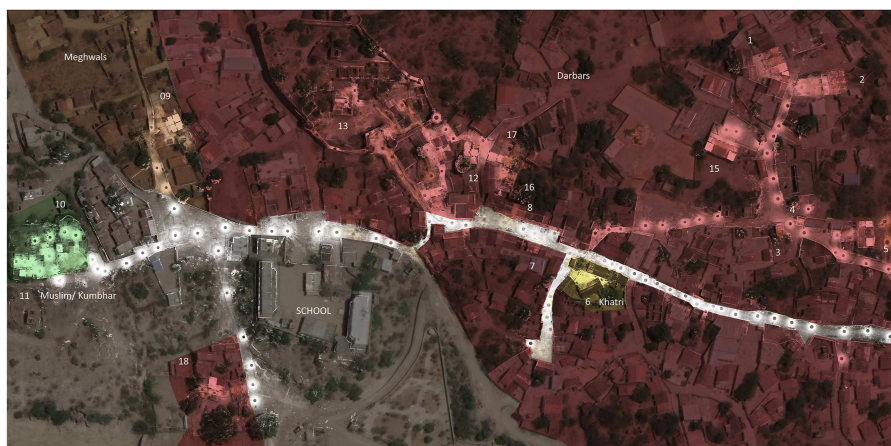
**Plate 8.**

Plan of Bela, mixing the aerial photograph with the 3D laser-scanned area (in white), indicating the casts present in the central area of the village and the buildings documented. 2021

As mentioned earlier, the first approach to community engagement was made during the reconnaissance trip to inquire regarding the residents' interest. The second approach consisted of semi-structured interviews conducted in preparatory stages and during the 3D data capture. The interviews were mainly associated with the 18 buildings interiorly documented in 3D (Table 1). The interviewees represented five traditional neighbourhoods in the village, each corresponding to one specific community, most located in the historical area (Plate 8).
