This is a repository copy of *Tensile strength of incipient rock discontinuities*.

Shang, J, Hencher, SR and West, LJ (2015) Tensile strength of incipient rock discontinuities. In: Schubert, W and Kluckner, A, (eds.) Future Development of Rock Mechanics: Proceedings of the SRM Regional Symposium EUROCK 2015 & 64th Geomechanics Colloquium. EUROCK 2015& 64th Geomechanics Colloquium, 07-10 Oct 2015, Salzburg, Austria. Österreichische Gesellschaft für Geomechanik . ISBN 978-3-9503898-1-4

# Tensile strength of incipient rock discontinuities

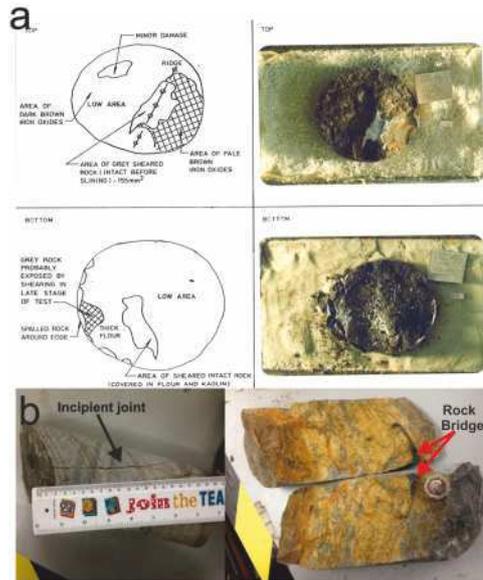
Figure 1. Rock cores containing incipient rock joints. a Light rock bridge is revealed after shearing test, b incipient rock joint broken open using geological hammer; intact rock bridges are indicated by red arrows.

Degree of incipency of rock discontinuities should not be neglected as it influences the overall strength of rock. Figure 1a presents an example of joint incipency provided by Hencher when shearing a rock core. Light rock bridge segment is revealed after shearing test. Another incipient

joint is shown in Figure 1b, intact rock bridges indicated by red arrows are shown after breaking along this fracture with geological hammer.

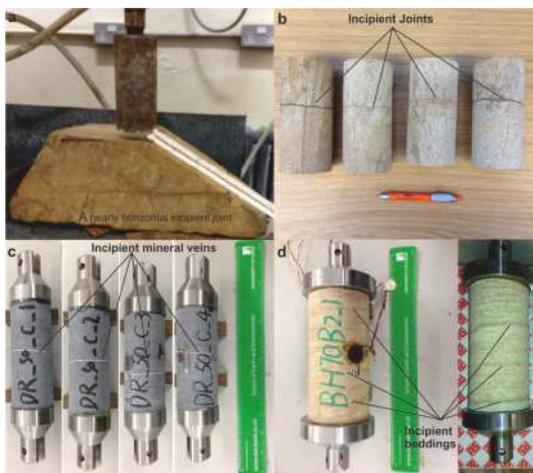
Figure 2. a Sandstone specimens drilled perpendicular to a horizontal incipient joint within a sandstone block, b prepared sandstone specimens with incipient joints, c prepared siltstone specimens with incipient mineral veins, d prepared sandstone specimens with incipient beddings.

Specimens with horizontal incipient discontinuities including joints, bedding and mineral veins were prepared for the tests. Figure 2 illustrates the process of specimen preparation and some prepared specimens. As mentioned above, cores were drilled perpendicular to these incipient fractures as illustrated by Figure 2a. Two sets of specimens were obtained as shown in Figure 2b-d. The first sets comprised siltstone specimens (50 mm and 70 mm in diameter) containing mineral veins. The second set comprised sandstone specimens (70 mm in diameter) containing incipient bedding planes and joints.

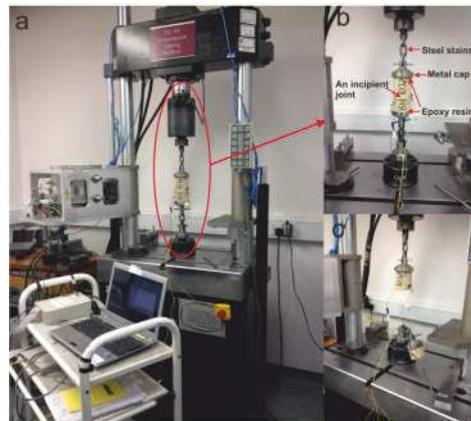
Figure 3. a General view of apparatus set up, b specimen containing an incipient joint during the process of direct tension, c failure pattern of this specimen after direct tension test.

A servo-controlled loading machine with the capacity of 250 KN was used for the direct tension tests (see Figure 3). Steel chains were used to connect rams and prepared specimens to reduce bending and torsion effects. Sandstone specimens were cemented to metal caps using araldite resin with tensile strength of more than 20 MPa. For each test, specimens were loaded uniformly at a constant rate of 40 N/s until the sample failed following the direction of ISRM (1978).

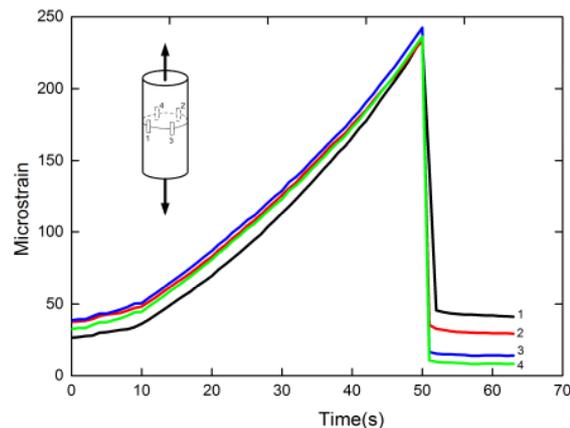
Figure 4. Apparatus setup verification.

In order to verify the validity of apparatus setup, preliminary work was carried out similar to the work of Okubo (1996) and Hashiba (2014). Four strain gauges were affixed to intact sandstone specimens as illustrated by Figure 4. Figure 4 also presents curves of micro-strain vs. time demonstrating consistent strain at the four measurement locations, which provides some confidence in the alignment of the testing set-up as used for the subsequent uniaxial tension tests.

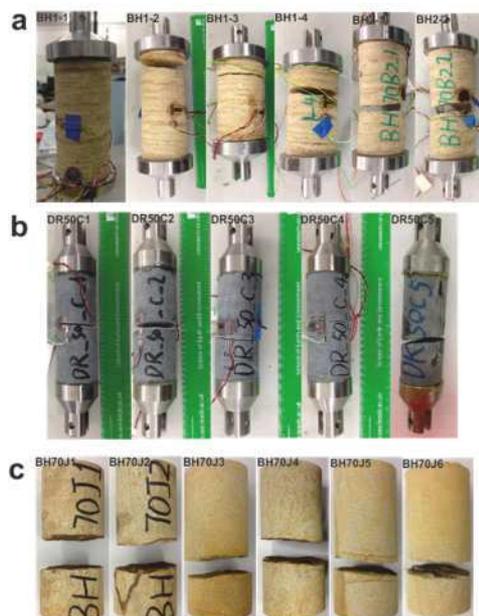
Figure 5. Failure patterns of specimens containing incipient rock discontinuities during the direct tension test. 5a Sandstone specimens broken along weakest geological bedding planes, 5b specimens broken along mineral veins, 5c specimens containing broken along incipient joint planes.

Figure 5 shows failure patterns of incipient geological discontinuities under direct tension. It can be seen that specimens tested normally broke along incipient discontinuities.
