Maggiolini, E., Tovo, R., Susmel, L. et al. (2016) Crack path and fracture analysis in FSW of small diameter 6082-T6 aluminium tubes under tension-torsion loading. *International Journal of Fatigue*, 92 (2). pp. 478-487. ISSN: 0142-1123

Crack path and fracture analysis in FSW of small diameter 6082 aluminium tubes under tension-torsion loading

Abstract

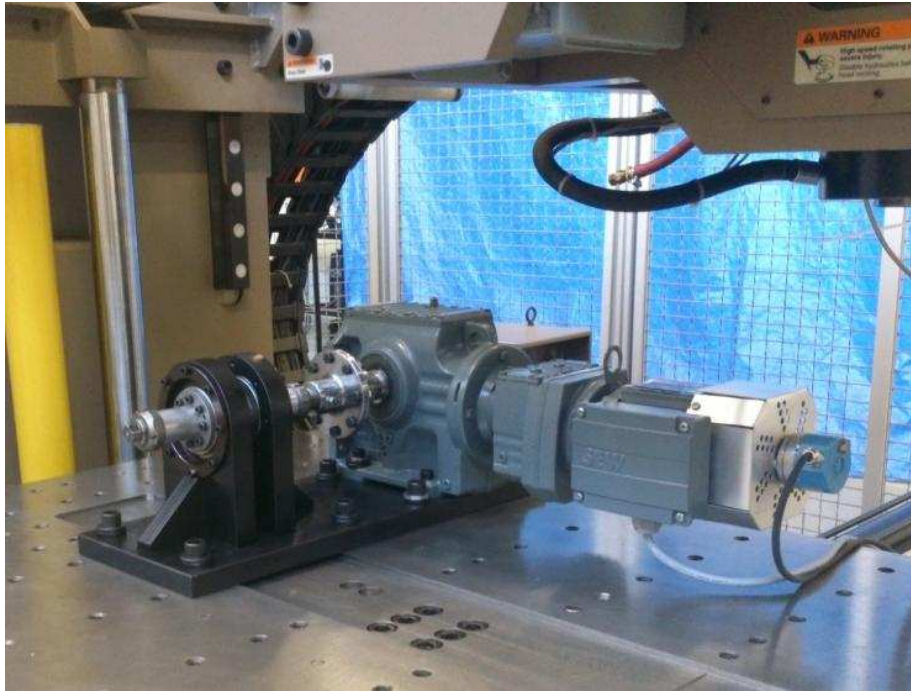
Figure 1 Illustration of a tube specimen in position ready to be welded.

1 An MTS I-STIR™ Process Development System provided the foundation for this work, which
2 involved coupling a worm gear motor with a tube support system for the welding process, and
3 integrating the drive system control with that of the I-STIR platform (see Figure 1). As noted
4 above, it is important in FSW of small diameter tubes, where provision for run-on and run-off
5 tabs cannot be provided, not to leave any hole in the joint line after extracting the tool at the end
6 of the welding process; the resulting hole in the joint would act as a very significant weld defect,
7 given the relative sizes of the tool pin, tube diameter and tube wall thickness. A tool with a self-
8 retracting pin was therefore also designed and developed for this particular FSW application.
9

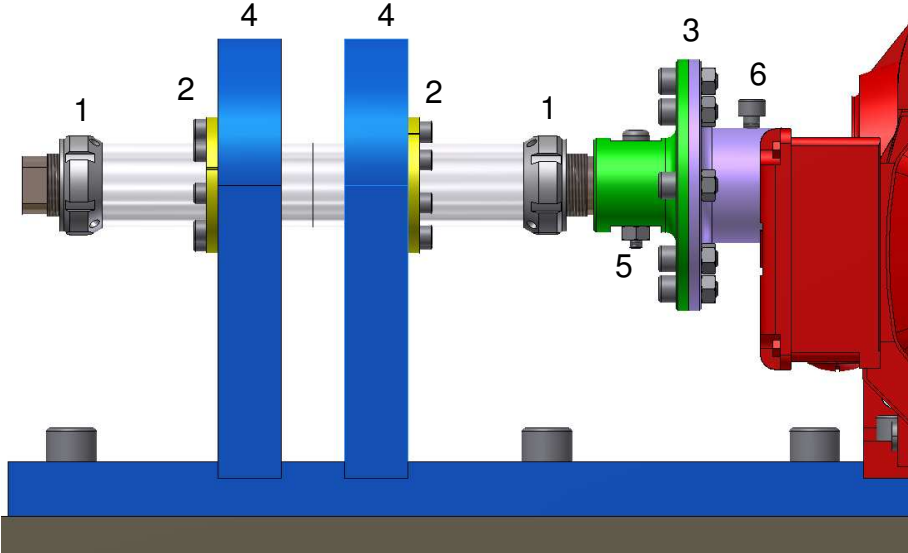
Figure 2 Schematic diagram showing the various components in the tube clamping system.

1 threads on the release bolts which necessitated replacement of a number of these bolts during
2 the production run of 100 specimens); difficulty in achieving an even clamping force on the
3 tubes caused by differences in ID of the tubes and by different out-of-round measurements both
4 of which lead to distortion of the tube during setup. The sequence of events during welding is
5 outlined in Figure 3 and it should be noted that it was found necessary to machine the tube OD
6 to 37.5 mm to improve the tube alignment during set-up.
7
8
9
10

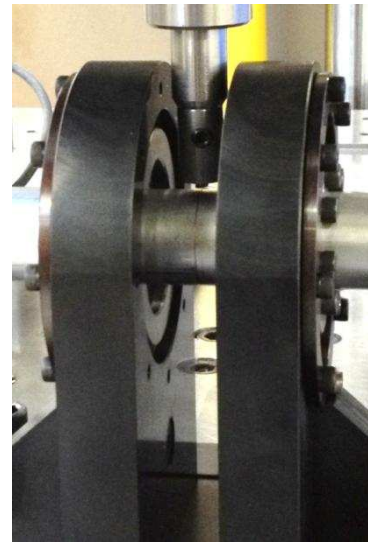
- 4
5
6
7
8
9
10
11
12
13
14
15
16
17
18
19
20
21
22
23
24
1. Pin moves toward weld centreline
 2. Pin touches tube for zero reference of plunge depth
 3. Start spindle rotation
 4. Plunge pin and shoulder
 5. Ensure shoulder in contact with pipe
 6. Initiate pipe rotation
 7. Rotate pipe 720° to achieve good surface finish (2 full revolutions)
 8. Initiate pin retraction after 630° rotation keeping pipe rotating to eliminate exit hole
 9. Retract shoulder

25 Figure 3 Sequence of events required in making a sound FS weld in the 6082-T6
26 aluminium tubes.
27
28
29
30

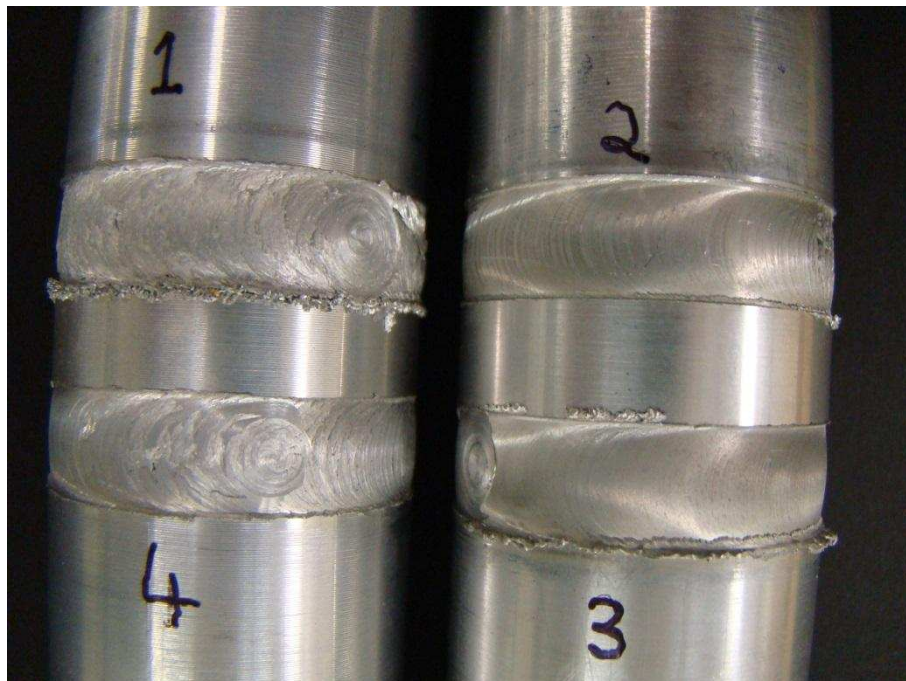
57 Figure 4 Influence of the weld process parameters of plunge depth, rotational feed rate
58 and tool rotational speed on the quality of weld surface finish.
59
60
61
62
63
64
65

11
12
13 The weld process used force control on a small diameter tool shoulder of 10 mm rotating at 600
14 rpm, an optimised rotational tube feed rate of 50 mm/min, and a tool pitch angle of 2°. It was
15 found necessary to weld the tube through a rotation of 720°, i.e. two complete revolutions, in
16 order to achieve a good surface finish; the first pass improves the uniformity of shoulder contact
17 and hence the second pass improves the surface finish. In optimising the tool geometry, the pin
18 penetration depth was initially set to approximately 85% of the nominal tube wall thickness and
19 the quality of the resulting weld was evaluated via metallographic examination after welding. A
20 pin length of 2.45 mm was found to work very effectively with a plunge depth of 2.5 mm to
21 ensure adequate shoulder contact. Figure 4 and the associated information on weld process
22 parameters in Table 1 demonstrate the influence of the tool rotational feed rate, tool rotational

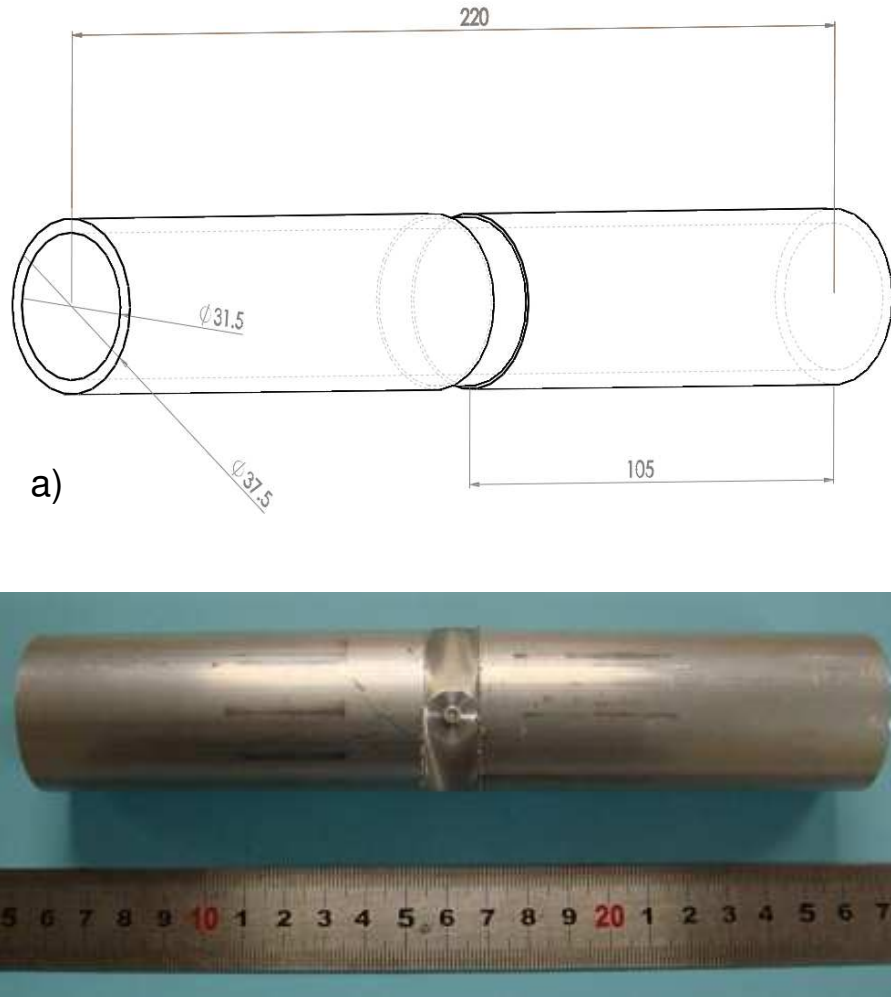
Figure 5 a) Approximate dimensions of the tubular fatigue specimens. b) Image showing a typical welded specimen.

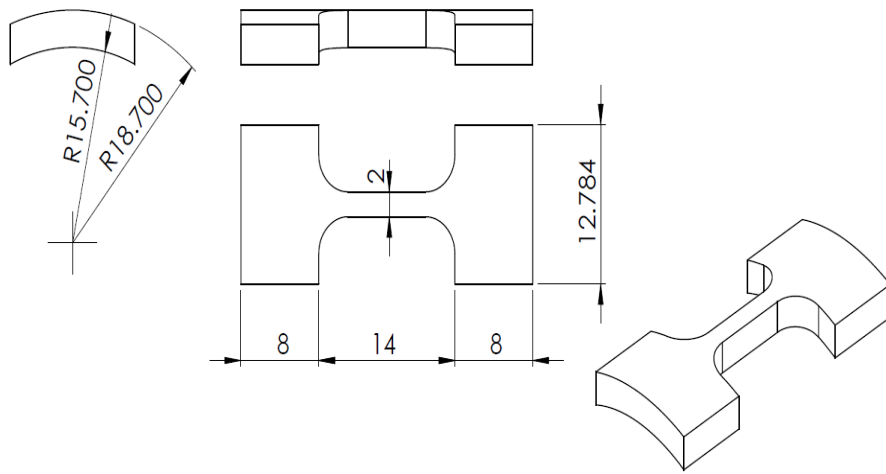
Figure 6 Microtensile specimen geometry; the curved surface requires support during clamping and testing.

45 0.67 reported for FS welds in 3 mm thick plates of 6082-T6 [15]. The microtensile specimens
46 were polished in order to observe where failure occurred and this was found to be in the weld
47
48
49
50
51
52
53
54
55
56
57
58
59
60
61
62
63
64
65

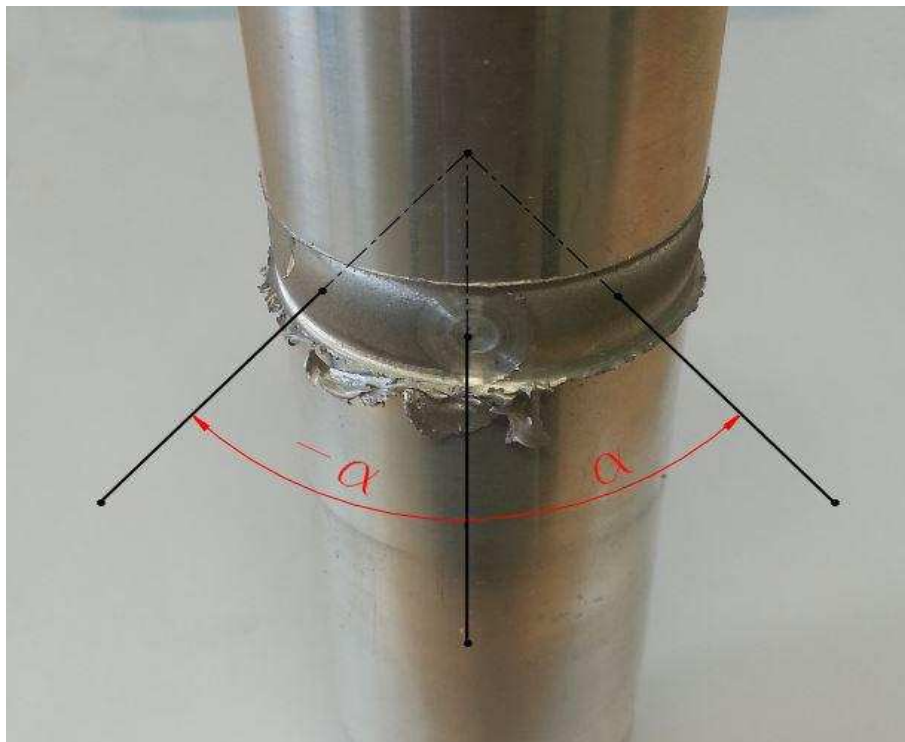
Figure 7 Coordinate system used to define the crack initiation sites.

29
30 To assist in this fractographic analysis, crack initiation sites were defined in terms of their
31 angular position relative to the stop-start position in the weld, given as 0° in Figure 7 where the
32 advancing side of the weld is towards the top in the figure, and the retreating side is towards the
33 bottom. The procedure adopted in documenting the crack path and defects was to record the
34 entire fracture surface using digital images and then to identify crack initiation points and any
35 other interesting features for closer inspection using scanning electron microscopy. Crack
36 initiation was primarily closely associated with the slight undercut at the edge of the weld zone
37 arising from the tool shoulder, but could occur on either the advancing or retreating side of the
38 weld, which exhibit individual variations in values of hardness and residual stress. Table 5
39 gives the location of crack initiation for all the specimens tested in tensile fatigue. In the two

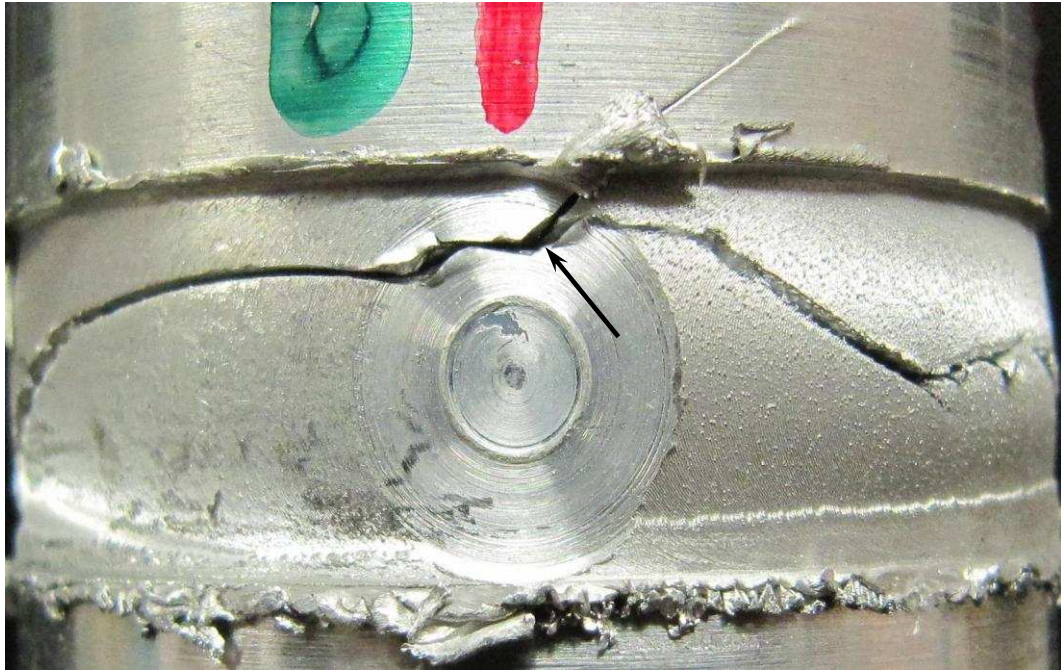
Figure 8a Crack initiation site (marked with arrow) in specimen T4 tested in torsion at $R = -1$ with a shear stress amplitude of 75 MPa.

15 Certain of the in-phase tension-torsion specimens, e.g. IPh8 and the torsion specimens, e.g. T4
16 exhibited crack initiation coincident with the stop-start position, as shown in Figures 12 and 8a,
17 respectively. Torsion fatigue specimens occasionally showed classic shear crack bifurcation
18 under torsion loading with $R = -1$ and Figure 13 shows an example of this type of cracking
19 where crack initiation has also occurred at the stop-start position. Table 8 summarises the crack
20 location information for all specimens and shows that for the 62 specimens where this
21 information was obtained, 50% of cracks initiated at the advancing side, 39% at the retreating
22 side and 11% at other positions in the weld.
23
24
25
26
27
28
29
30
31
32
33
34

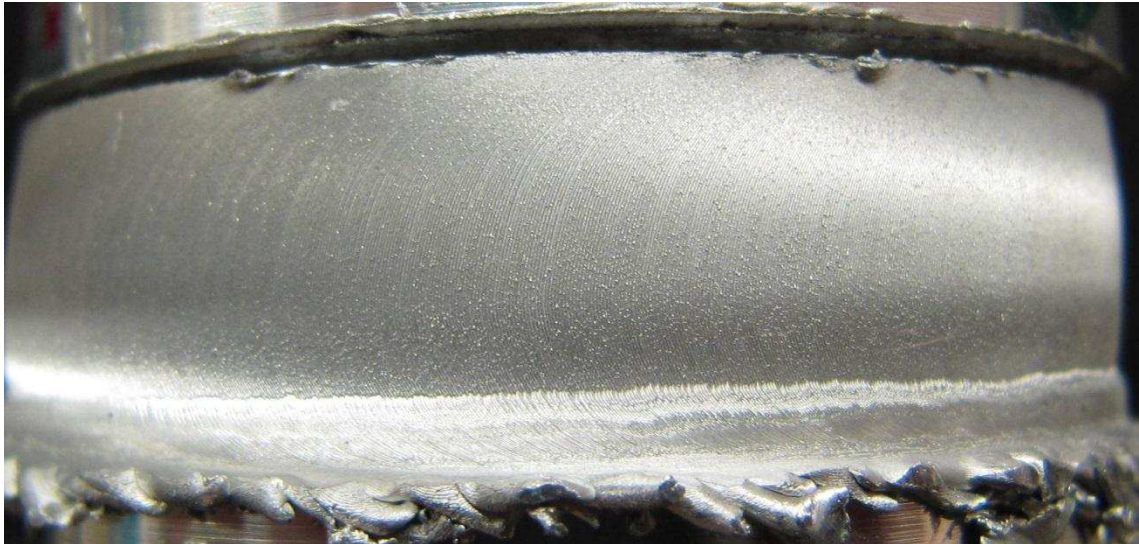
Figure 8b Crack initiation site in specimen T22 tested in torsion at $R = -1$ with a shear stress amplitude of 133 MPa. The crack runs around the undercut groove on the advancing side of the weld. This is the most common mode of failure in both tension and torsion fatigue specimens.

10
11 Table 6 presents the data for the torsional specimens, and it should be noted that the torsional
12 loading damages the fracture surfaces and usually makes impossible post-hoc determination of
13 the crack initiation point around the circumference. The torsional data indicates a significant
14 influence of both stress ratio R and shear stress amplitude on the position and crack path
15 associated with crack initiation. Thus under torsional fatigue loading with $R = 0$, crack initiation
16 occurred on the retreating side in all welds examined, whilst under reversed loading with $R = -1$
17 crack initiation predominantly occurs on the advancing side. Under torsional loading, at the two
18 lowest shear stress ranges used in both $R = 0$ and $R = -1$ loading, the crack path does not
19 follow the undercut zone at the sides of the weld, but instead shows a more classical shear
20 crack initiation at an angle of approximately 45° (see the two images given in Figure 8).

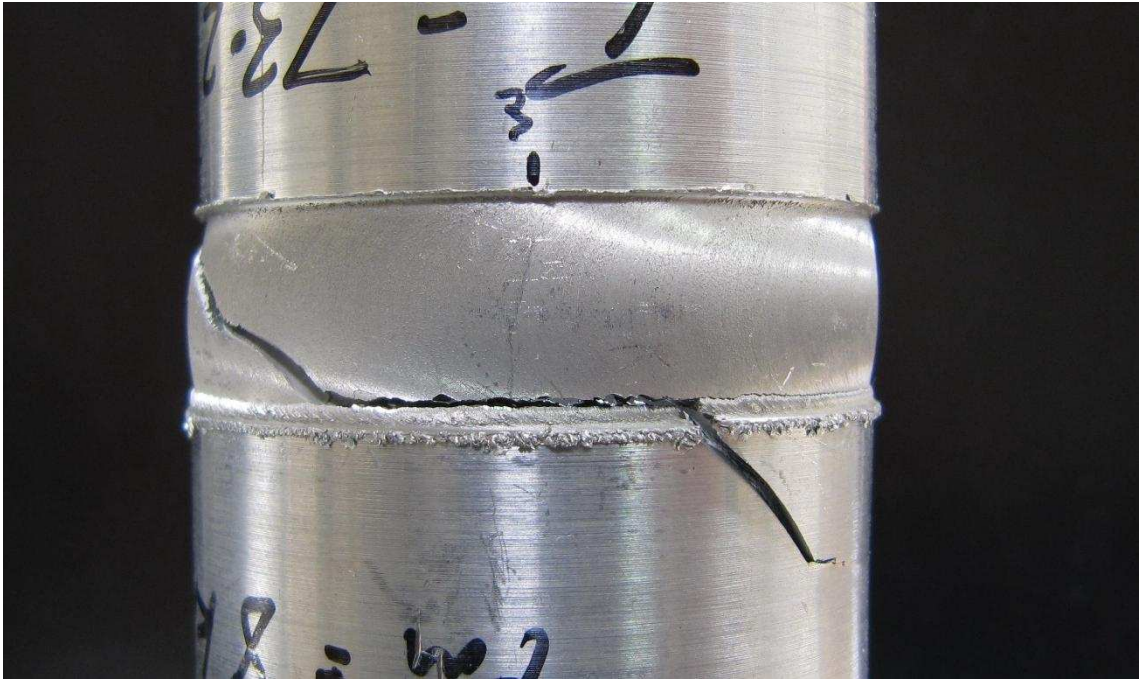
Figure 9 In-phase tension-torsion fatigue test (IPh21) showing that the crack has initiated along the tool shoulder groove on the retreating side and then moved across to the advancing side of the weld.

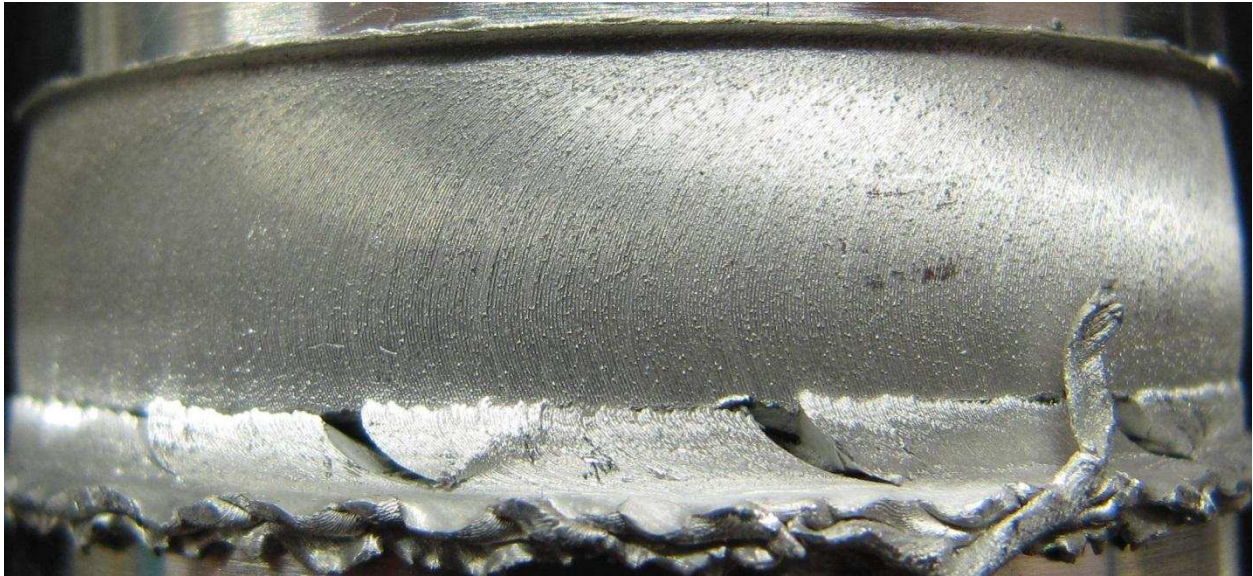
Figure 10 Multiple crack initiation sites observed in torsion fatigue at $R = 0$. This image shows specimen T23.

1 (67 MPa). Figures 10 and 11 show examples of such multiple initiation sites. It can also be
2 observed that the number of cracks initiated appears to increase as the applied shear stress
3 decreases and hence the fatigue life increases. A problem with those specimens that displayed
4 multiple crack initiation but that did not completely fracture, was that the primary initiation site
5 could not be determined because of the difficulty in separating the specimen at the appropriate
6 place, e.g. Figure 11.
7
8
9
10
11
12
13
14

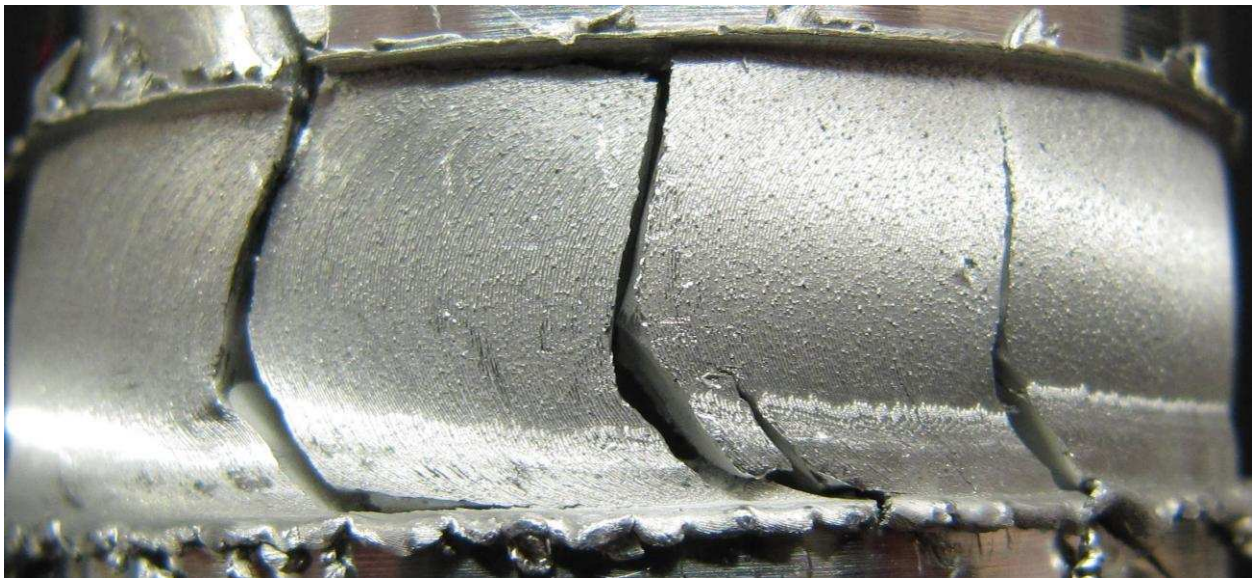
Figure 11 Multiple crack initiation appears to be exacerbated at lower torsional stress and hence longer fatigue lives. This image shows specimen T16.

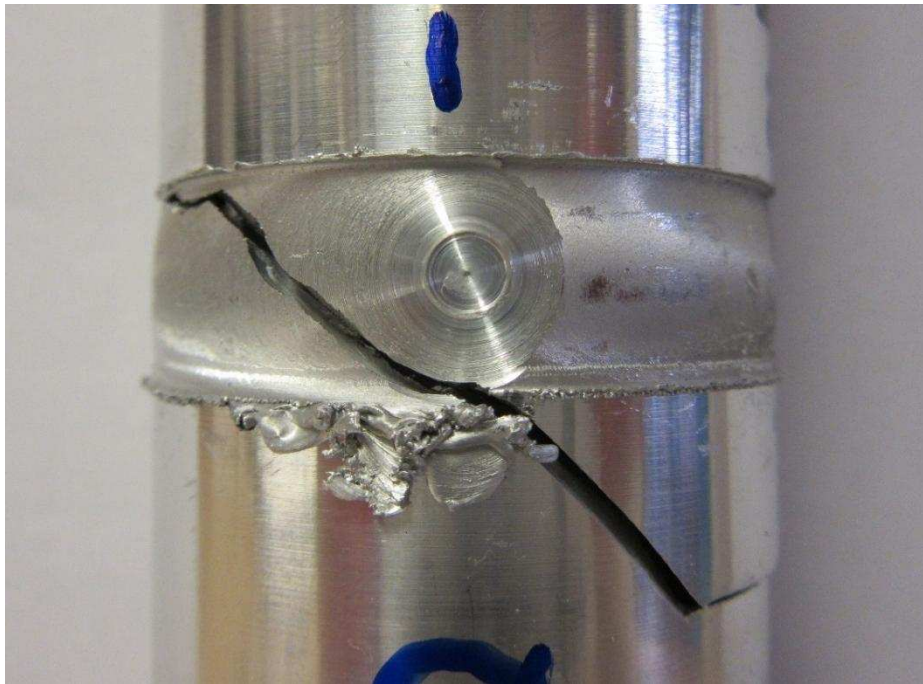
27 Figure 12 Certain tension-torsion specimens showed crack initiation associated with the
28 stop-start position. This is specimen IPh8.
29
30

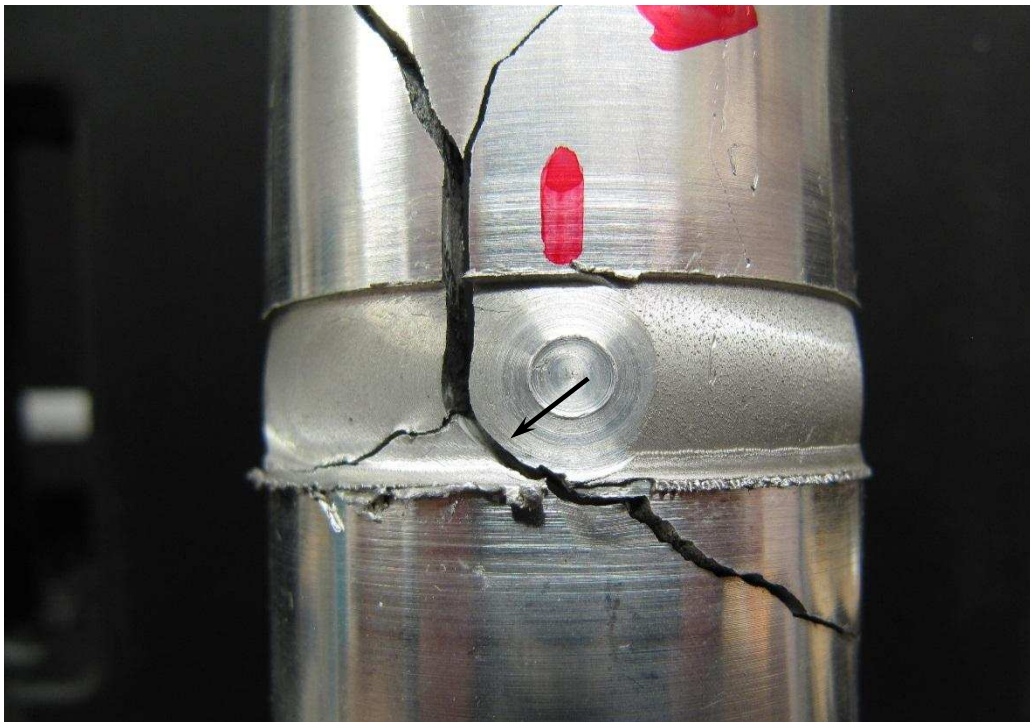
57
58 Figure 13 Specimen T6 which showed classic shear crack bifurcation. The arrow marks the
59 crack initiation site which is also associated with the stop-start position.
60
61
62
63
64
65

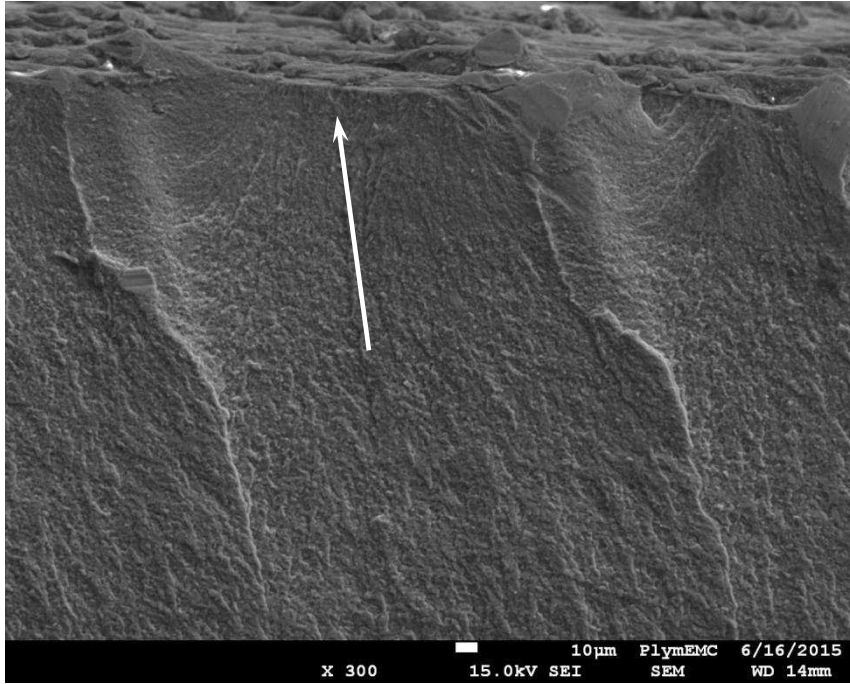
25 Figure 14 SEM fractograph showing crack initiation (arrow) between surface tool marks in
26 tensile fatigue specimen W121. The small white bar at the bottom of the picture
27 is a 10 μm marker.
28
29
30

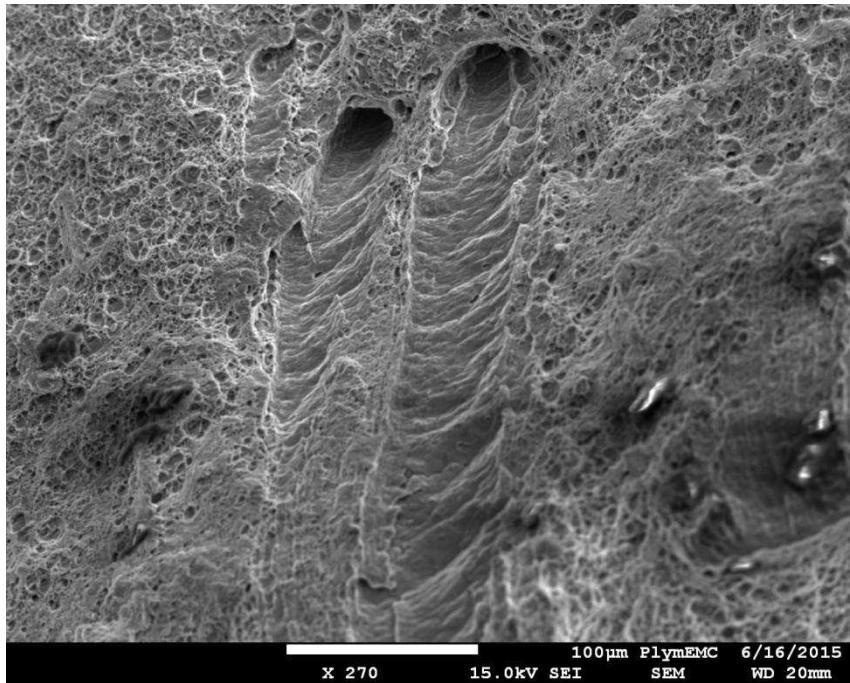
55 Figure 15 Wormhole defects on the fast fracture region of tensile fatigue specimen W117.
56 As expected the fracture mechanism is microvoid coalescence.
57
58
59
60
61
62
63
64
65

35 In specimens that had not experienced significant surface damage during torsion or reversed
36 tension loading, it was generally straightforward to locate the primary crack initiation site,
37 although where multiple cracks of similar size had occurred the fracture surfaces could not be
38 easily exposed. Crack initiation generally occurred at the surface undercut caused by the tool
39 shoulder at either advancing or retreating sides of the weld, and this is demonstrated in Figure
40 14 (tensile fatigue specimen W121) where ratchet marks are present on the fracture surface
41 that correspond with the tool shoulder marks, and a small fatigue crack has initiated between
42 these marks (indicated with an arrow). Occasional wormhole defects, which are a relatively
43 common form of FSW defect, were observed on the fracture surface (see the tensile fatigue
44 specimen W117 shown in Figure 15). The mechanism by which such defects are formed

45 reflects the details of the plastic mixing process during friction stir welding and has been
46 described in reference [20] which also summarises other forms of FSW defect.
47
48
49
50
51
52
53
54
55
56
57
58
59
60
61
62
63
64
65

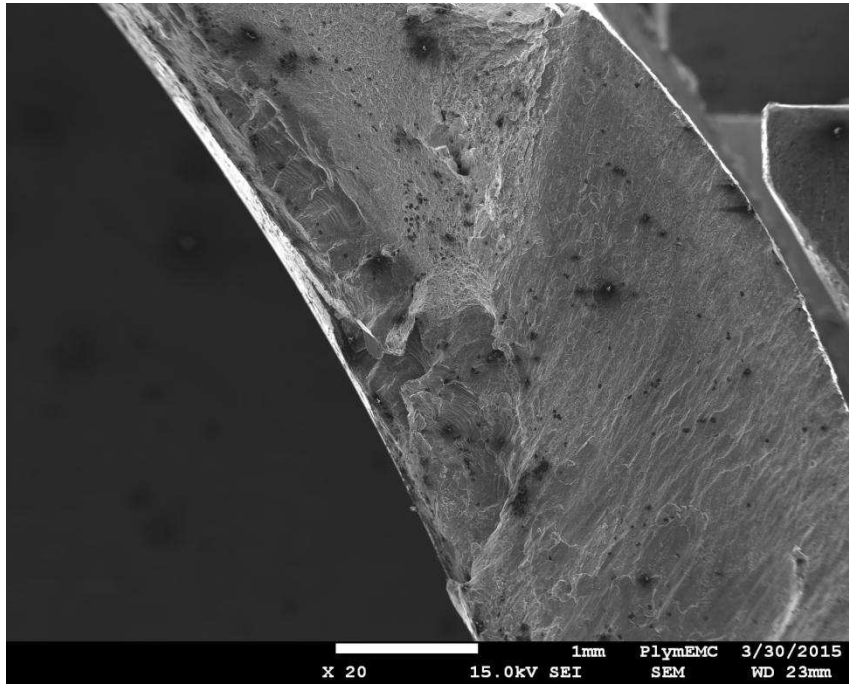
Figure 16 Clear evidence of initiation of the primary fatigue crack from the outer edge of specimen IPh2 can be seen at the upper right hand corner in this image.

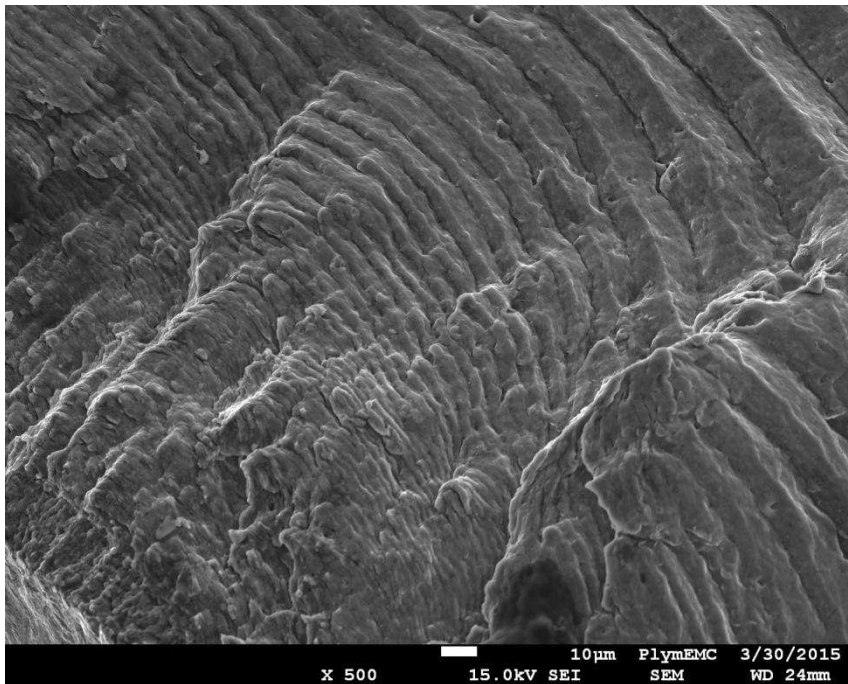
Figure 17 A smaller secondary site of fatigue crack initiation is present at the inner edge of tube specimen IPh2 in the lower left corner of this image.

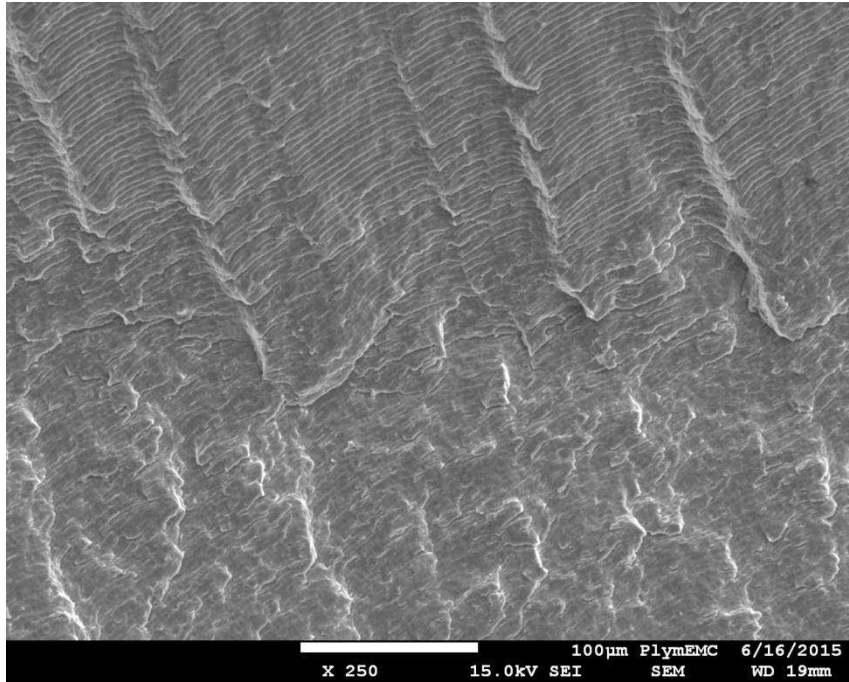
26 Figure 18 The mechanism of fatigue crack growth was by ductile striation formation; this
27 image shows the fracture surface on tensile fatigue specimen W130 and the
28 crack growth direction is from the bottom of the image to the top.
29
30
31

1
2 The specimens tested under biaxial tension-torsion loading were more interesting, as although
3 parts of the fracture surfaces had suffered damage from contact during crack growth, certain
4 specimens indicated that although the primary crack had initiated at the outside of the tube (in-
5 phase tension-torsion specimen IPh2 - Figure 16), smaller secondary cracks had sometimes
6 formed at the inner surface later in the fatigue process (IPh2 - Figure 17). Figure 17 also
7 demonstrates that the formation of this secondary crack occurred at a late stage in the fatigue
8 process because the fracture surface fairly quickly starts to reflect the underlying 'onionskin'
9 structure in the weld zone, reflecting high levels of applied load and hence high growth rates.
10 Where fracture surfaces were undamaged, the mechanism of fatigue crack growth could be
11 observed to be ductile striation formation as shown in Figure 18 (tension fatigue specimen

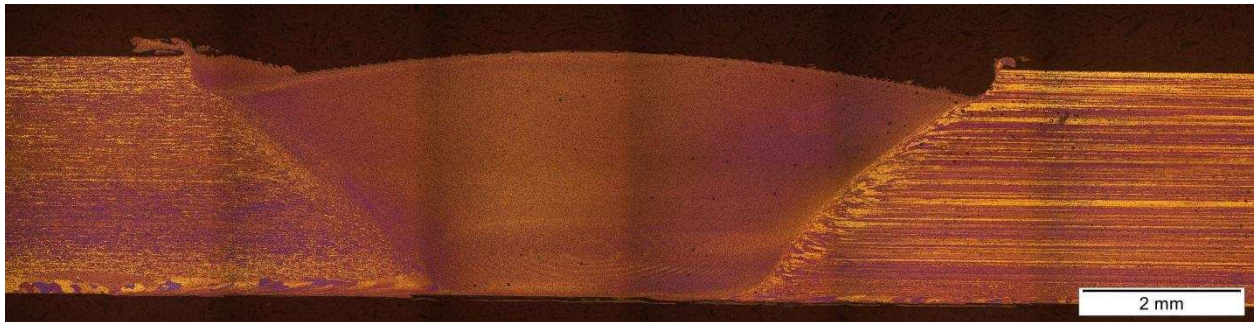
46 Figure 19 Polarised light metallographic montage showing the complete weld zone in
47 specimen T6 tested in torsional fatigue.
48
49
50
51
52
53
54
55
56
57
58
59
60
61
62
63
64
65

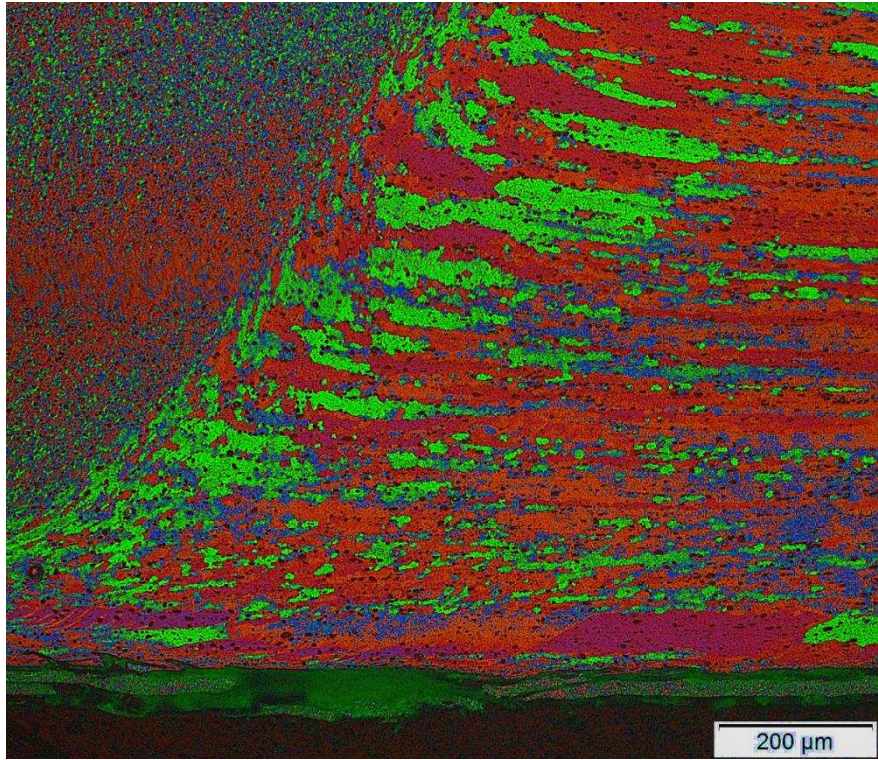
Figure 20 Polarised light micrograph showing the edge of the weld at 100x magnification.

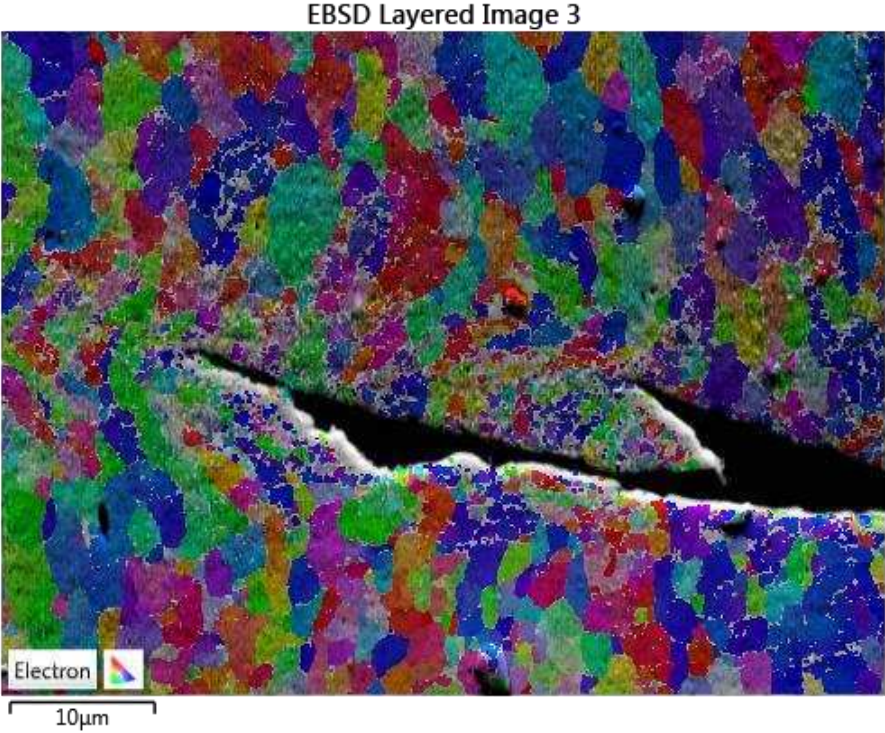
Figure 21 EBSD image showing the crack tip region in specimen T6 at 2,000x magnification.

30
31 Ultimately, it is intended to evaluate the microstructure and crack path using polarised light
32 microscopy and electron back-scatter diffraction (EBSD) in a scanning electron microscope, but
33 this work has not yet been completed. Figure 19 shows a polarised light metallographic
34 montage that shows the complete weld zone for the torsion specimen T6. Individual regions of
35 the microstructure can be examined at higher magnification (Figure 21). This can also be done
36 for cracked specimens, although it entails polishing back the surface to provide a flat region for
37 etching, and the etching process trends to attack crack edges preferentially. This is where
38 EBSD has a distinct advantage over light microscopy, although it also requires a flat surface in
39 order to adequately index the microstructure and the plastic deformation that surrounds cracks
40 can therefore lead to a loss of resolution. Figure 21 shows a typical EBSD image of the crack

41 tip region in specimen T6 at 2,000x magnification and a fairly good resolution of the
42 microstructure has been obtained to within a distance of about 10 μm from the crack edge. The
43 interesting point that this image does not make clear is whether grain refinement has occurred
44 due to plastic strain in the zone near to the crack tip, or whether this apparent effect merely
45
46
47
48
49
50
51
52
53
54
55
56
57
58
59
60
61
62
63
64
65

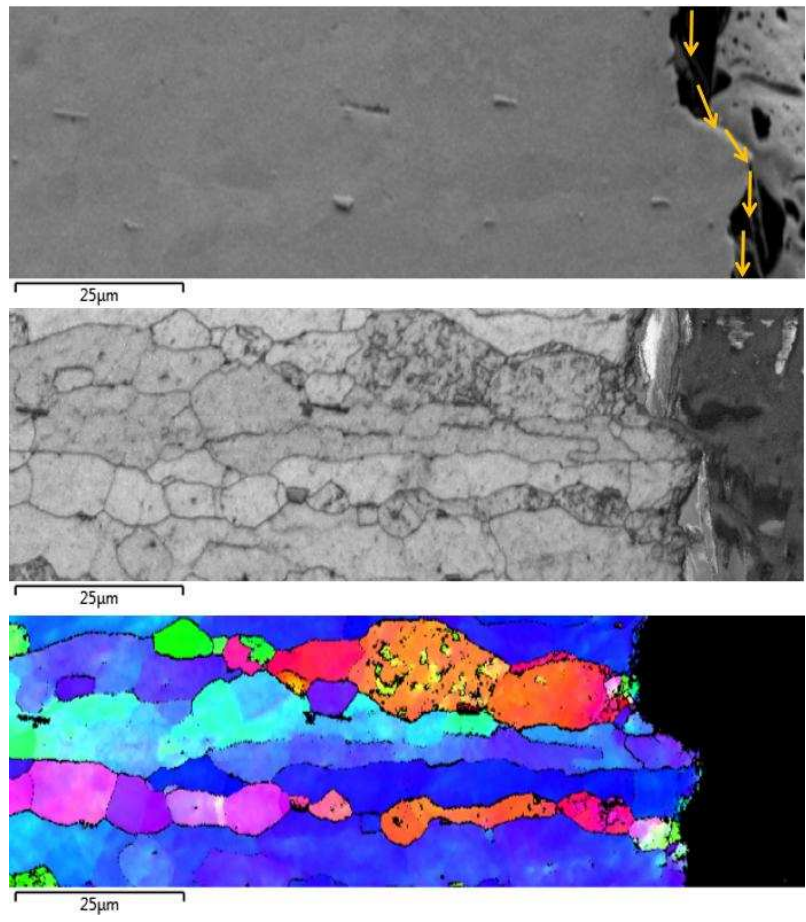
Figure 22 EBSD images of crack growth through the thickness of the tube wall. This shows is the heat-affected zone on the parent plate side of the crack and the crack growth direction is indicated in the top image.

1 reflects a loss of data in this heavily deformed region. The EBSD image shown in Figure 22
2 contains the crack initiation region in specimen IPh-1, looking at the crack growing down
3 through the tube thickness. The crack has initiated and grown along the tool shoulder undercut
4 on the advancing side of the weld and the grain structure reflects the heat-affected zone (HAZ)
5 on the parent plate side of the crack. The direction of crack growth through the tube thickness
6 is shown by the arrows in the top image.
7
8
9
10
11
12
13
