Assessment of Overheating Risk in Gynaecology Scanning Rooms during Near-Heatwave Conditions: A Case Study of the Royal Berkshire Hospital in the UK

Hannah Gough ^{1,*}, Samuel Faulknall-Mills ², Marco-Felipe King ³ and Zhiwen Luo ⁴

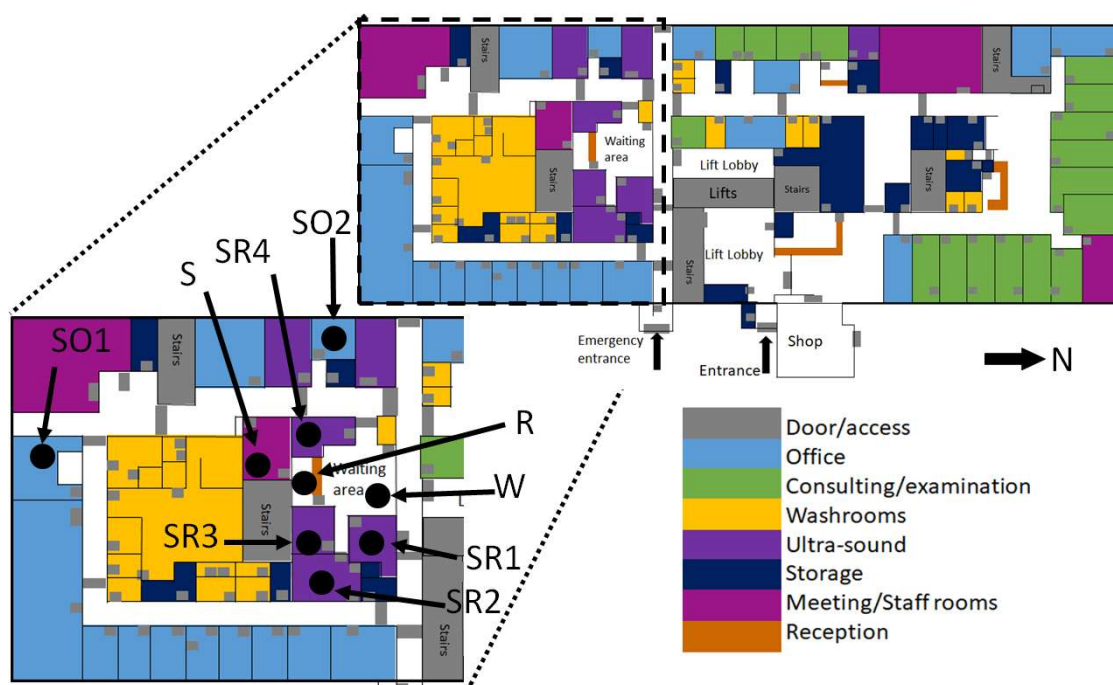
Figure 2. Floor plan of level 2 of the Maternity and Gynaecology building, colour coded by room use. Total area: 2162.52 m². Cutaway shows the focus area of the study and the symbols for sensors and locations are described in Table 1. The map is based on building plans provided by RBH.

The focus area of the study was the waiting/reception area (capacity: 20–30 people) and staff break room (capacity: 10 people) associated with the ultrasound scanning rooms (6 rooms, 4 sealed, 2 naturally ventilated) on Level 2, the ground floor (Figures 1 and 2). The only rooms with windows are the ones directly connected to the building façade, in this case, the two staff offices (Figure 2, marked as SO1, SO2 respectively). Only the scanning rooms without direct natural ventilation (four) are monitored. These are positioned within the centre of the building (Figure 2). Room 3 (Marked as Sensor SR3) has air-conditioning available to use, with a portable air-conditioning unit also being deployed (unknown date of deployment and operation times) in the waiting room in front of the reception desk (Figure 2). Sensor naming convention is shown in Figure 2. Occupants of these areas include admin, cleaning, and clinical staff (all day), patients and pregnant patients (<5 h stay), all of whom will be negatively affected by high indoor temperatures [40]. Varying environmental conditions have also been reported across the entire floor and building (Figure 2).

Table 1. Symbols used for sensors, room size and location within the test area. Locations are shown in Figure 2.

Natural ventilation is not a viable solution in this area of the RBH, due to the central position of the at-risk scanning rooms within the building (Figure 2). Also, within heatwave conditions, it is expected that air-pollution also increases, adversely affecting those with respiratory conditions [18]. Refs. [24,45,46] highlight that there are few examples of innovative natural ventilation/passive cooling strategies being used in hospital buildings, due to risk-adverse procurement and tight budget constraints. Noise may also prevent windows and doors from being opened. Whilst this study has focused on temperature, other factors, such as airflow, moisture, and odour also influence thermal comfort and may also need to be considered for specific patient groups. Other more complex ventilation solutions are described in [45].

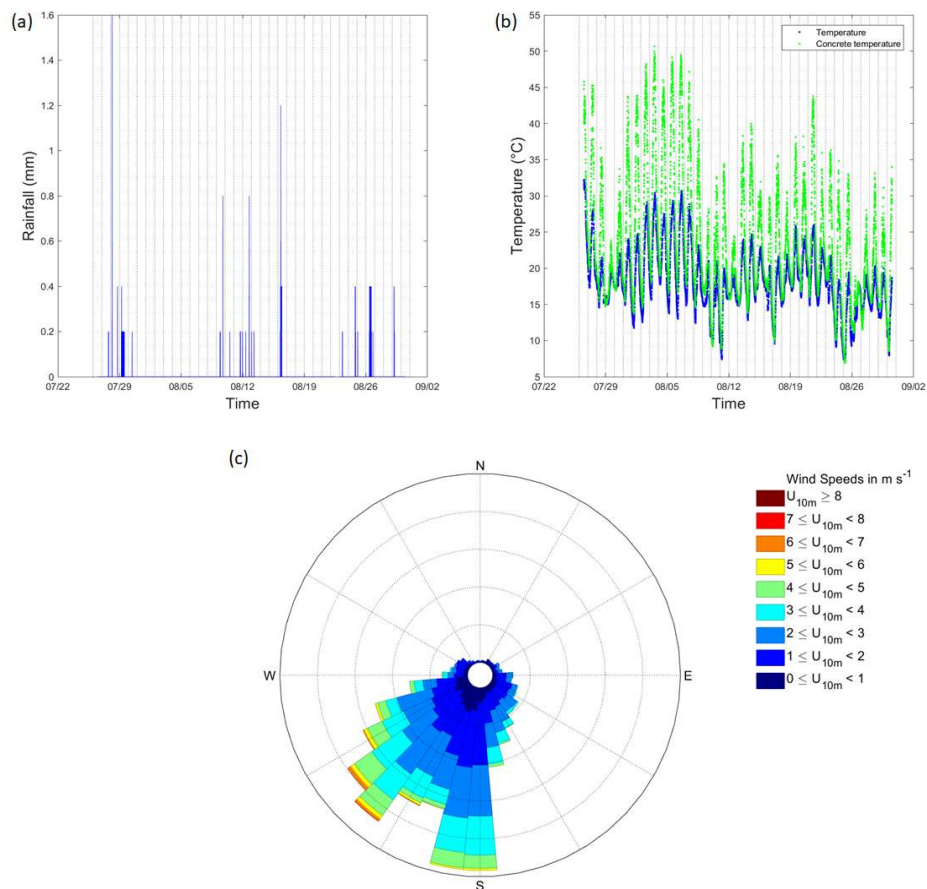
Figure 5. Observations from UoRAO for the study period. (a) rainfall, (b) temperature and concrete temperature, and (c) wind direction and 5-min wind speed at 10 m (meteorological standard). Vertical grey lines denote midnight of each day.

Reference external temperatures were measured at the University of Reading's Atmospheric Observatory (UoRAO), also at five-minute intervals as part of the automated system (accuracy: 0.1 °C). The temperature of concrete was also logged. The climate conditions of Reading can be classed as temperate. UoRAO is approximately 1.5 km as the crow flies from the Maternity and Gynaecology building (Figure 4). For details on the experimental set up of the UoRAO and measurements available see [41]. Whilst this distance is small, the external temperatures around the hospital site may be slightly warmer due to the urban heat island effect. Figure 5 details the background weather conditions throughout the campaign, with little rain being recorded (Figure 5a). Low wind speeds (95 % were $<6 \text{ m s}^{-1}$) were recorded throughout the study period and for most of the study period, the wind direction remained within the prevailing sector for the area (Figure 5c).

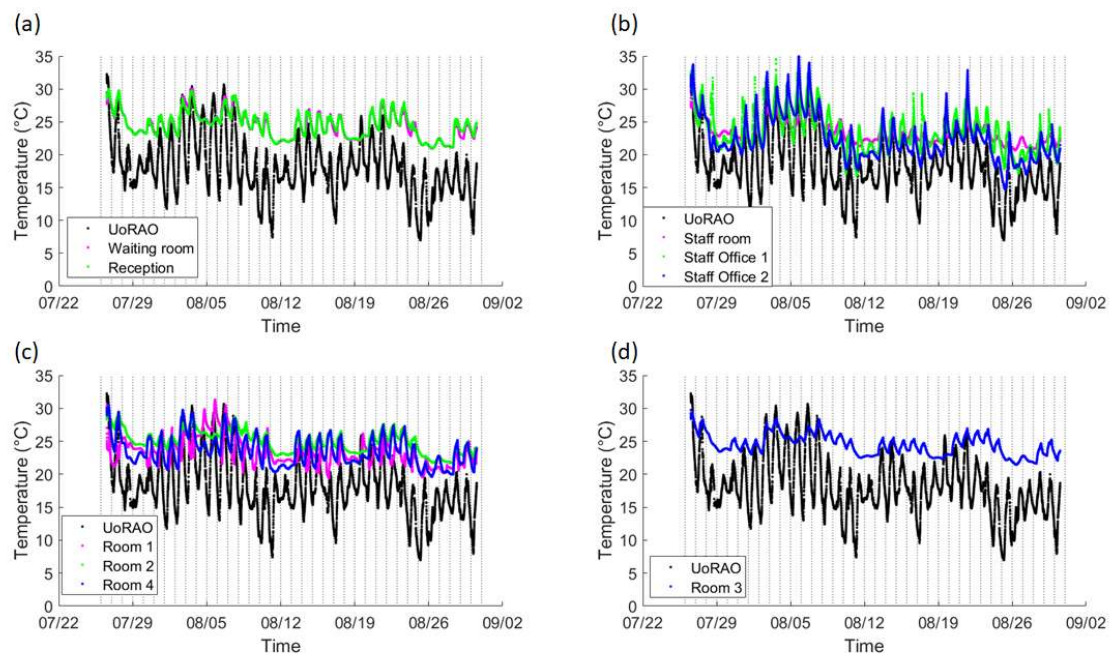
Figure 6. Overview of the temperatures recorded for the entire study period. Vertical lines denote midnight of each day. For clarity, similar rooms are plotted on one subplot, (a) Observatory (UoRAO), waiting room and reception, (b) UoRAO and Staff room and offices, (c) UoRAO and the naturally ventilated scanning rooms (Room 1,2,4) and (d) UoRAO and room 3, the air-conditioned room. All plots have the same axis.

A diurnal cycle is present for all rooms, with more extreme temperatures being seen in the Staff offices, due to them being located on the building's exterior (Figure 2, Figure 6b). The staff offices are also where the lowest indoor temperatures are recorded during the evenings, due to the rapid release of heat from the building's surface and potential ventilation. The waiting room and reception area (Figure 6a) both record similar conditions due to them being linked, with the waiting room having lower minimum temperatures due to it being closer to the main entrance (automated sliding double doors ~1.5 m across) and the effect of the temporary air-conditioning unit (Figure 2). The staff room also displays a similar trend, though with larger daytime spikes due to the lack of ventilation because of closed doors for privacy and security reasons (Figure 7b). The ultrasound scanning rooms all show slightly different behaviours, with room three displaying lesser peaks due to the use of air-conditioning, but even with air-conditioning, there is still a notable peak throughout the day, suggesting the current unit is struggling to maintain temperatures, even in the smallest scanning room (Figure 6c,d and Table 1).

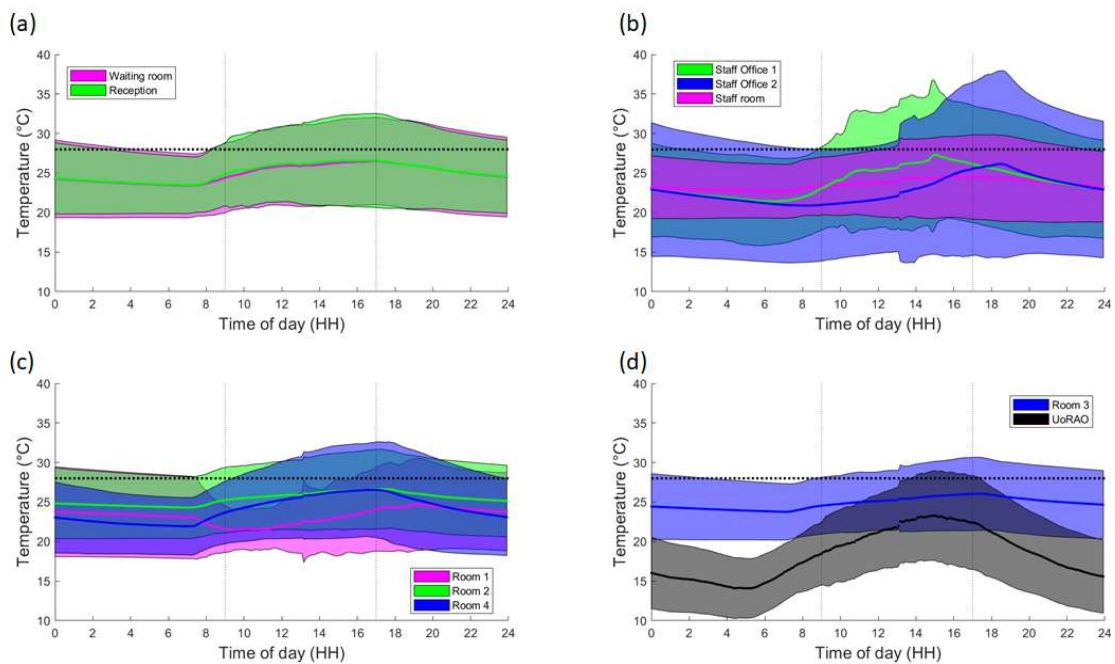
Figure 7. Time-averaged trend of weekday temperatures within the rooms. Line denotes the mean temperature per five minutes, with the shading denoting three standard deviations. (a) Waiting room and Reception, (b) Staff offices and the Staff room, (c) Rooms 1, 2 and 4 and (d) Room 3. Note that for clarity the UoRAO data is on plot d). Clinic hours are highlighted by the dashed vertical lines. The CIBSE threshold of 28 °C is shown in the thick horizontal dashed line.

Removing the weekend data and averaging over all weekday data further highlights the differing behaviour of the scanning rooms throughout clinic times (Figure 7c,d). On average staff office 1 experiences a peak in mean temperatures at around 15:00, whereas Staff office 2 peaks between 18:00 and 19:00 (Figure 7b, Figure 8b), with some of the highest maximum temperatures (30–35 °C) being recorded here (Figure 9b). This is most likely due to the solar gain of those offices. Based on room positioning time of year, Staff office 1 would have maximum solar gain between 11:00–14:00 (south-facing) and Staff office 2 (west-facing) 16:00–19:00. Staff office 2 also experiences the lowest temperatures, which is a concern for the winter months, as, despite windows being closed, it is a similar temperature to UoRAO temperatures during the evening (Figure 7b). More research into occupant adaptation and behaviour is required.

The staff room has a peak in temperature at around 14:00, linked to anthropogenically created heat from lunch breaks between 12:00 and 14:00 (Figure 7b, Figure 8b). The waiting room and reception areas experience a slow rise in temperature throughout clinic times (Figure 7a), with maximum temperatures occurring most frequently between 12:00 and 17:00, in part due to the presence of people (Figure 8a). This rise in temperature is less steep than the scan rooms (Figure 7c) due to the proximity to the entrance doors, less equipment, and the influence of the portable air-conditioning unit installed within the waiting area.

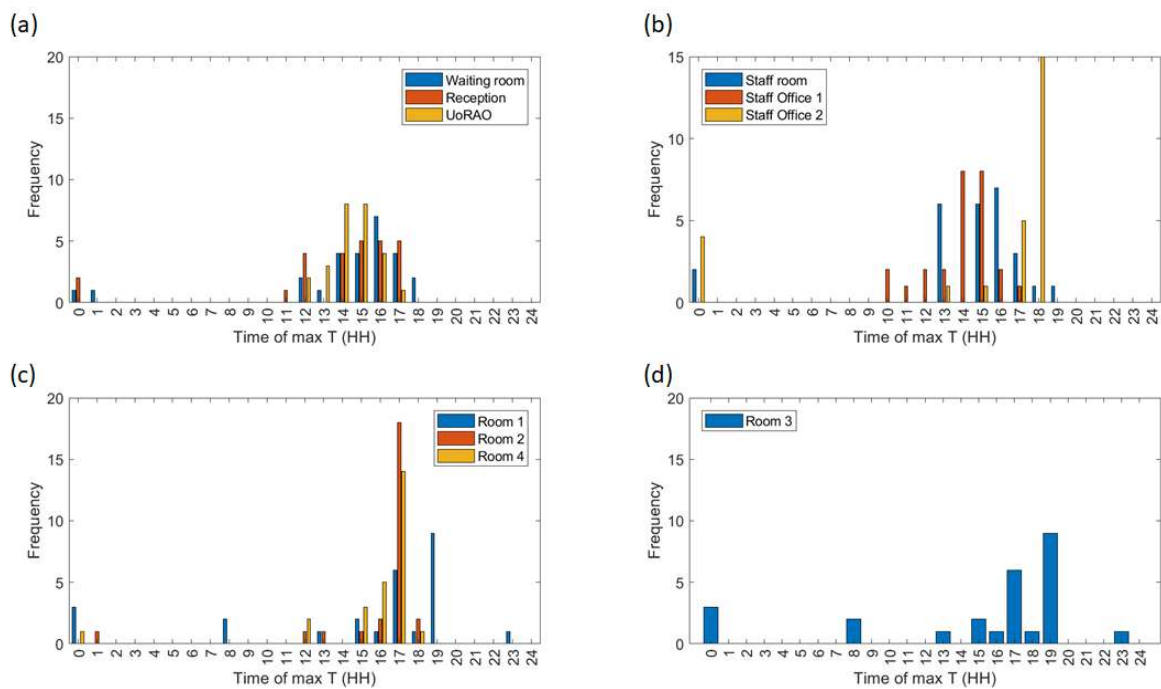
Figure 8. Hours in which the maximum daily temperatures recorded on the weekdays occur (Figure 9). For clarity, similar rooms are plotted on one subplot, (a) Waiting room, Reception and the observatory (UoRAO), (b) Staff room and Staff offices, (c) Room 1, 2, 4 and (d) Room 3. All plots have the same axis.

A large variation is seen in the daily average temperatures for scanning rooms 1, 2, and 4, with all tending towards a peak in mean temperatures at 17:00 (Figure 8c), an accumulation of high external temperatures, waste heat from equipment and anthropogenic heat (Figure 7c). Scan room 3's mean temperature is kept fairly constant due to the air-conditioning unit (operated by staff, with heat extracted to the roof) with its most frequent daily maximum temperatures being 1–2 °C lower than the other rooms (Figure 9c,d). Differences between rooms 1, 2, and 4 are likely due to differing usage patterns, size, staff preference, location of different equipment, and differing structure (Figure 2). The time of the daily maximum temperatures of Scan room 3 is slightly later than the other rooms, due to the air-conditioning unit being turned off after clinic hours and the room returning to equilibrium (Figure 8d).
