Hu, Y., Guo, L.C., Maiorino, M. et al. (7 more authors) (2020) Comparison of wear and rolling contact fatigue behaviours of bainitic and pearlitic rails under various rolling-sliding conditions. *Wear*, 460-461. 203455. ISSN 0043-1648

Comparison of wear and rolling contact fatigue behaviours of bainitic and pearlitic rails under various rolling-sliding conditions

Abstract: Rolling-sliding wear experiments were performed to investigate the wear and rolling contact fatigue (RCF) behaviours of a premium pearlitic rail (PH), a carbon-free bainitic rail (BH) and two standard pearlitic rails (U71Mn and U75V). The wear regime and RCF damage evolution of the PH and BH materials in terms of $T\gamma/A$ (i.e. creepages and contact pressures) were compared and analyzed. The high-hardness BH steel presented a wear resistance similar to U71Mn and U75V rail materials, whereas lower wear rate was shown by the PH steel. Concerning the RCF performance, the damage of BH steel (comparable to U75V) was more severe than that of PH steel (comparable to U71Mn). Finally, with the increase in creepages and pressures, the wear and RCF damage of both PH and BH steels increased. These information could prov

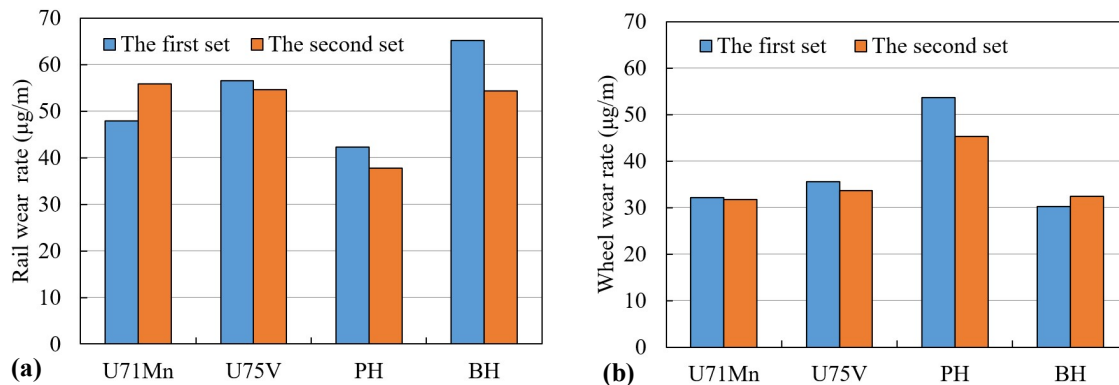
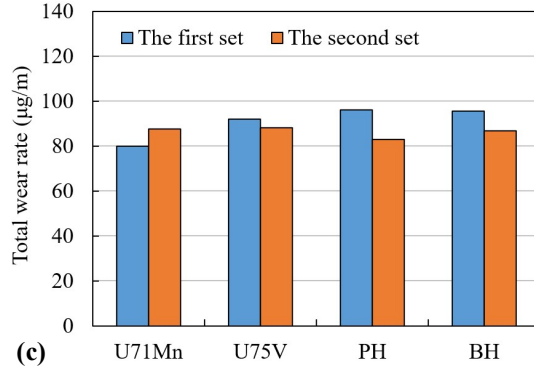
Fig. 4. Wear rates for different rail materials (1%, 1500 MPa): (a) rail; (b) wheel; (c) total.

Fig. 4 presents the wear rates (mass loss (μg) per rolling distance (m)) for different rail materials. Under the same contact condition (creepage 1%, pressure 1500 MPa), the PH rail steel exhibits the best wear resistance (Fig. 4a) due to its high bulk hardness, whereas the wear losses of U71Mn, U75V and BH rail steels are similar and severe, although the BH steel features the largest bulk hardness. Notably, the wear loss of the C-class wheel appears to be related to its coupled rail material and, accordingly, the wheel running against the PH steel shows the largest wear rate (Fig. 4b). It potentially supports the results in the literature [42-44] that increasing the hardness of pearlitic rails would increase the wheel wear loss. Besides, the four sets of experiments present a similar total wear loss, which is in the range of $80 \mu\text{g}/\text{m} \sim 100 \mu\text{g}/\text{m}$ (Fig. 4c).

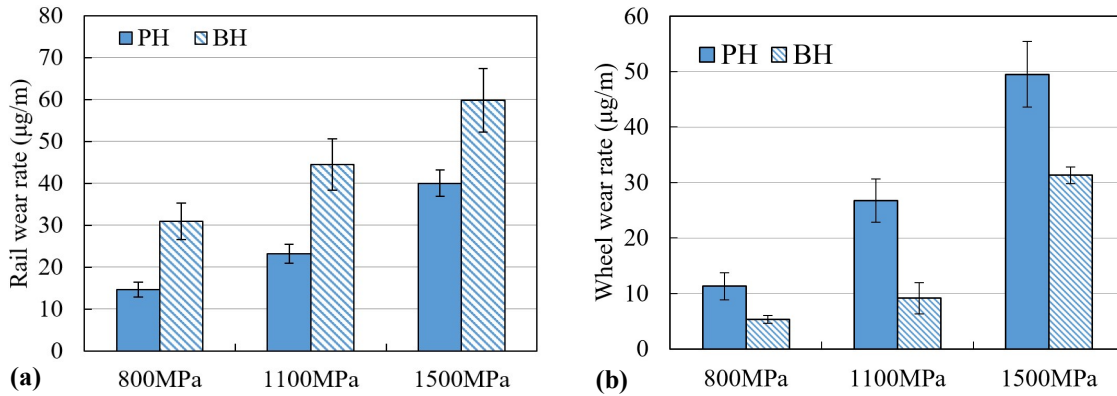
Fig. 5. Wear rates as a function of contact pressure (creepage 1%): (a) rail; (b) wheel; (c) total.

Fig. 5 shows the wear rate variation with contact pressures for experiments related to the C-class-PH pair and the C-class-BH pair. Under the same creepage condition (1%), the wear rates of both PH and BH rail steels, the associated wheel wear rates and the total wear rates increase with the rising contact pressure. Compared with PH rail steel, the BH rail steel displays a poor wear resistance (Fig. 5a), but relatively low wheel wear rates are shown for C-class-BH pairs under any contact pressure condition (Fig. 5b). A similar result was drawn in the literature [35] that the carbon-free bainitic rail was friendly to the matched wheel. Besides, there is no significant difference in the total wear rate between the two sets of pairs (Fig. 5c).

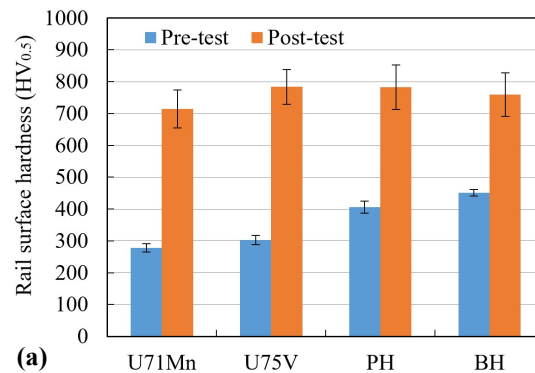
Fig. 7. Rail surface hardness before and after experiments: (a) changing with rail materials (creepage 1%, pressure 1500 MPa); (b) as a function of contact pressure (creepage 1%); (c) as a function of creepage (pressure 1500 MPa).

The surface hardness evolution of rail discs before and after experiments is shown in Fig. 7. The rail discs have undergone significant work hardening during rolling-sliding. The post-test rail surface hardness values of the rail materials across all experiments increase up to 700 HV_{0.5} ~ 800 HV_{0.5}. Fig. 7a shows similar post-test surface hardness values for the four types of rail steels, although their pre-test hardness' are significantly different. The post-test surface hardness' of PH and BH rail steels under different pressures also show similar values (Fig. 7b). On the contrary, a visible effect of creepage on the work hardening of BH steel can be observed in Fig. 7c: the post-test surface hardness of BH steel at a small creepage of 0.2% is much lower than that at larger creepages.

The similar fibrous structure on the topmost layer of the four rail materials may be the main reason for the similar post-test surface hardness (Fig. 7a). The discontinuous “film-like” RA and the transformation induced plasticity (TRIP) effect make the compatible deformation capacity of BF-RA-martensite crystal structure in bainitic steel better than that of cementite and ferrite in pearlitic steel, resulting in a relatively thin deformation on BH rail steel (Figs. 12,13).

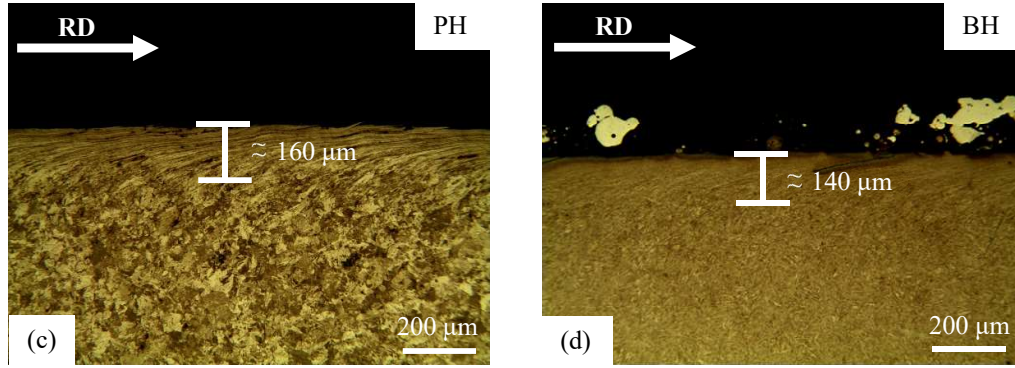
Fig. 12. Plastic deformations of different rail materials (creepage 1%, pressure 1500 MPa): (a) U71Mn; (b) U75V; (c) PH; (d) BH.

The sub-surface of rail discs shows varying extents of plastic deformation during cyclic loading, as illustrated by Fig. 12. The deformation extent of pearlitic rail steels seems to be closely related to their bulk hardness. For example, at 1% creepage and 1500 MPa contact pressure, the deformation thickness of the PH steel (Fig. 12c) with high bulk hardness is visibly lower than that of the standard U71Mn and U75V steels (Fig. 12a,b). Furthermore, the plastic deformation of BH steel (Fig. 12d) with typical bainitic structure is relatively thin as well (about 140 μm). It is well known that plastic deformation is one of the major driving forces to promote the work hardening of pearlitic steels. The lower deformation extent may be the main reason to explain why PH and BH steels were less work hardened than other materials in Fig. 8a.

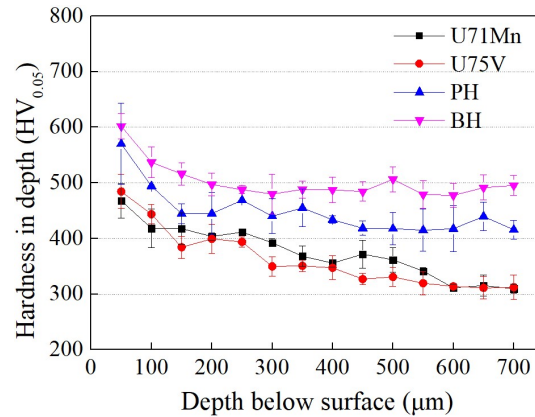
Fig. 15. Hardness variations for different rail materials in depth (creepage 1%, pressure 1500 MPa).

Plastic flow and residual stresses generated and accumulated on the rail surface layer during the deformation. The plastic flow raised the elastic limit, whereas residual stresses suppressed plastic flow. The combined effect was marked as “work hardening” [47]. The hardness variation of the four rail steels, as a function of the distance from the contact surface, was measured at intervals of 50 μm as shown in Fig. 15. A decrease in hardness with increasing depth from the surface can be observed. At the same depth, the hardness of BH rail steel is higher than that of U71Mn, U75V and PH, whereas, due to the high bulk hardness of BH steel, it’s work hardening extent is lower than the pearlitic rails. The work hardening of pearlitic materials is related to dislocation density and ferrite grain refinement during the deformation [48], whereas the work hardening of bainitic materials is connected to the density of mobile dislocations in BF, the strain-induced transformation of RA to martensite and the refined size

significantly increased with the increasing contact condition (creepage and pressure, i.e., $T\gamma/A$). Specifically, as the $T\gamma/A$ increased from 0.321 N/mm² up to 30.084 N/mm², the surface damage of PH steel transformed from ratcheting (Fig. 11a) to peeling and ploughing (Fig. 11c), and the plastic deformation thickness increased from 80 μm up to 200 μm (Fig. 13a). Meanwhile, the formation of a fibrous structure induced by the refinement and rearrangement of pearlite grains resulted in the appearance of work hardening from the inside of the material toward the contact interface (Fig. 15).
