This is a repository copy of *Water jet erosion performance of carbon fiber and glass fiber reinforced polymers*.

Water Jet Erosion Performance of Carbon Fiber and Glass Fiber Reinforced Polymers

Keywords: water jet erosion; composite materials; vacuum infusion process; wind industry

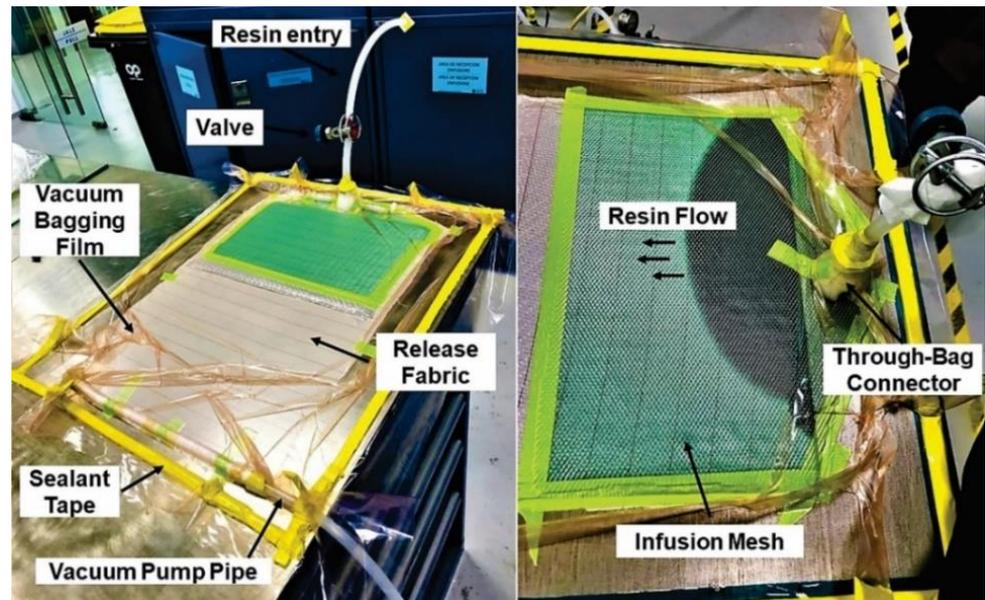
Figure 1. RI process for the manufacture of composite materials.

CFRP and GFRP plates were obtained from the Vacuum Infusion Process (VIP), as shown in Figure 1 [18,19]. This process is considered as closed mold. For the manufacture of the carbon fiber sheet, 8 layers of bidirectional carbon fabric (0/90° fabric) were used, and 9 glass layers of bidirectional glass cloth were used for the glass fiber. For both cases, a mixture was made with 304.6 g of epoxy resin Epolam 2015 and 90.9 g of hardener Epolam 2015. Bidirectional fabrics were placed on a previously polished metal plate, in order to obtain a smooth finish. Additionally, a release fabric and an infusion mesh were placed to help unmold the laminate, in this way the resin flows through the fibers that were sealed inside a vacuum bag. Finally, an inlet valve for resin injection and a suction connection for the vacuum pump were installed. At the conclusion of the RI process, 4-millimeter flat sheets of carbon fiber and glass fiber were obtained. Figure 2a,b show the optical microscopy of the surface of the samples of the sheets obtained from carbon fiber and glass fiber, respectively; in both cases the bidirectional tissue is observed (0/90°). In the glass fiber image, the presence of the polymer matrix based on epoxy resin is much more visible. Some samples of carbon fiber and glass fiber were covered with polyester resin (Gelcoat) to determine its behavior during the liquid erosion test. The average thickness of coating was 0.56 mm (Figure 3). This coating has the function of protecting the surface of the composite materials against UV rays. The application of the Gelcoat was carried out with a brush cured at room temperature.

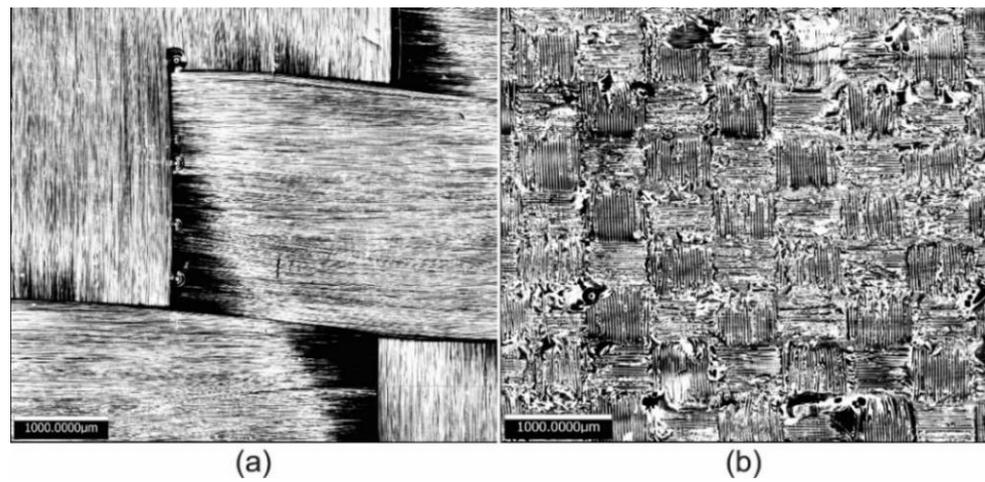
Figure 2. Optical microscopy of (a) carbon fiber and (b) glass fiber sheets.

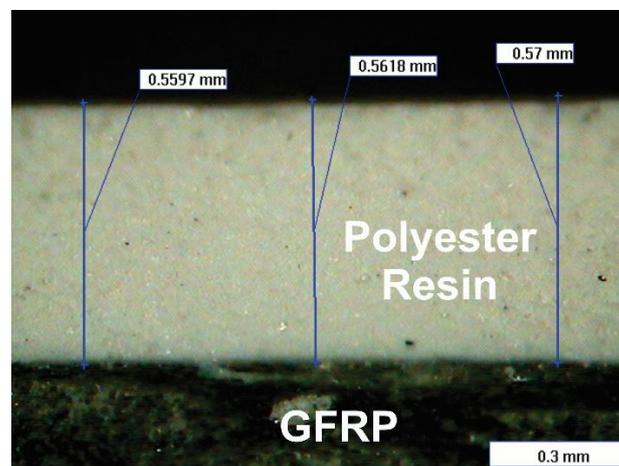
Figure 3. Cross section of glass fiber reinforced polymer and coating of polyester resin.

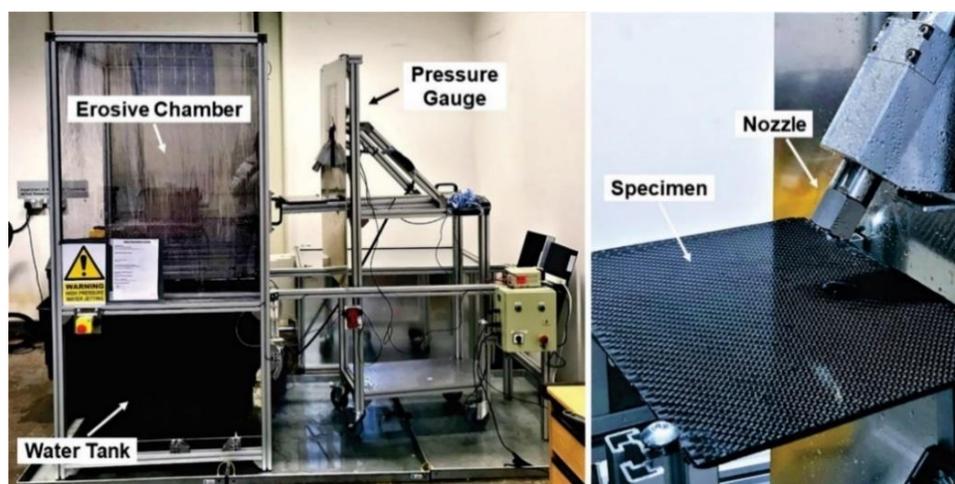
Figure 4. Water jet erosion platform.

The water jet erosion tests were carried out according to ASTM G73-10 (ASTM International, West Conshohocken, PA, USA) [21]. The experimental platform used is shown in Figure 4. The liquid is projected the surface of the flat sheets of composite materials through a nozzle at a pressure of 150 bar using a 25 hp industrial Hydro-pump. The nozzle has a tungsten carbide flat section exit tip with a 110-millimeter long flow stabilizer. The samples to be evaluated are located 65 mm from the end of the nozzle. To determine which of the composite materials has greater resistance to erosive wear, 3 tests were performed on each material at an angle of 75° , with an exposure time of 10, 20 and 30 min.

- The water jet erosion platform developed for this research work showed a very acceptable performance, applying a constant pressure throughout the tests and generating a uniform wear on the surface of the tested composite materials.

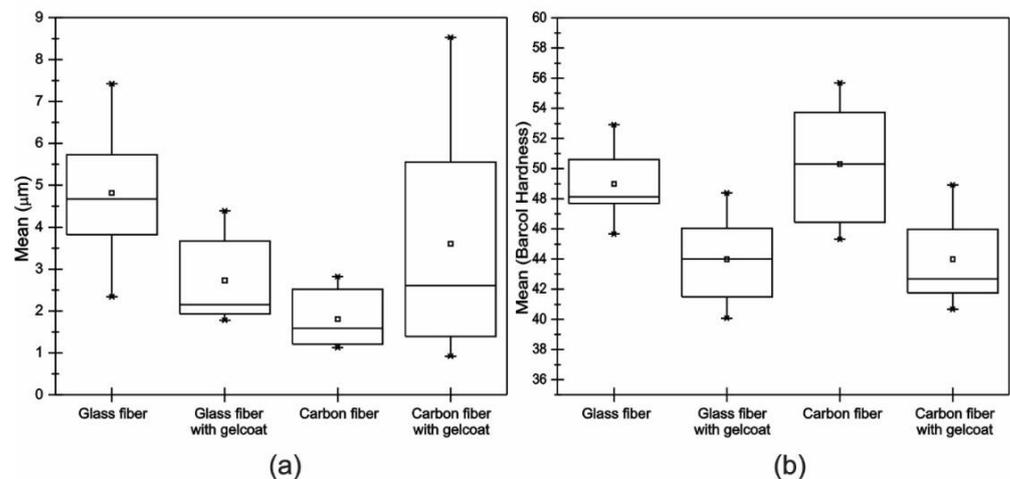
Figure 5. Box diagram of (a) roughness and (b) hardness.

Figure 5a shows the acquired values of roughness of all the samples. It can be seen that, due to the manufacturing of the VIP and the operating conditions applied, mean values of roughness, R_a , greater than $1 \mu\text{m}$, were obtained. This indicates that the surfaces of the samples have significant irregularities, which influences the wear during the water jet erosion tests [22–24]. In addition, it was observed that in the sample of carbon fiber with Gelcoat, there was a wide dispersion of the roughness results. This could be due to the method used to apply the Gelcoat, which, as explained before, was performed using a brush [25]. Figure 5b shows the values obtained for the Barcol hardness. The carbon fiber and glass fiber without Gelcoat show the highest values. This is due to the mechanical properties of the Gelcoat [26], which means that the hardness is lower for samples with Gelcoat [27]. Table 1 shows the average data of roughness and hardness for the materials before the water jet erosion tests.

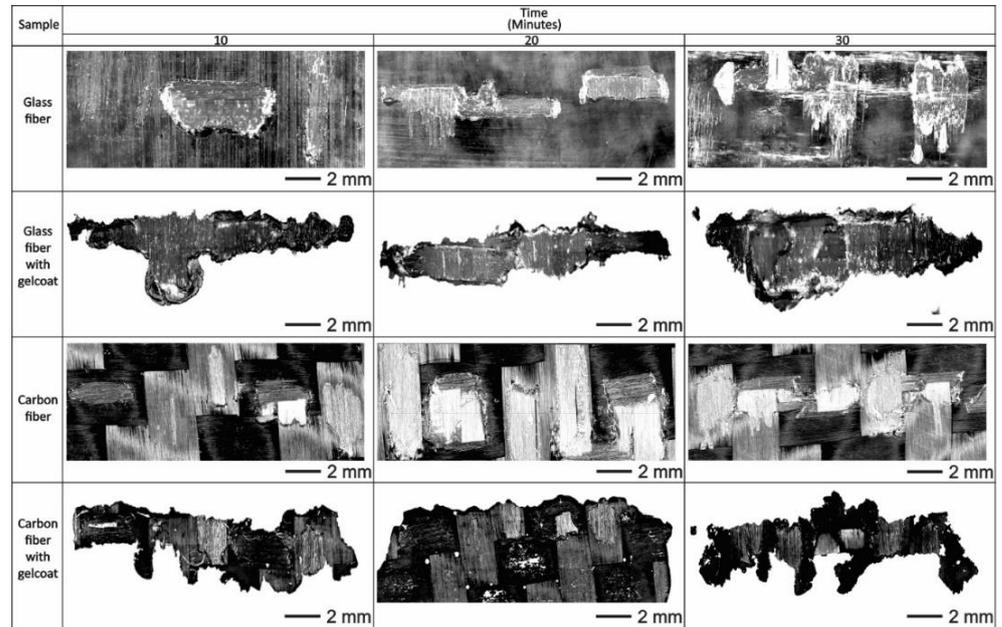
Figure 6. Damage of the surface of the samples using the test of liquid erosion at an impact angle of 75°.

Figure 6 shows the scars generated in the composite materials due to the water jet erosion tests, with and without Gelcoat, at an angle of 75° in periods of 10, 20 and 30 min. These test times were established to examine possible failures in the Gelcoat such as cracking, fractures, pitting and loss of adhesion. Once the test started, it was observed that the samples that showed the greatest damage due to the impact of the liquid, in the first instance, are those that contain Gelcoat on the surface, as a result of their low hardness and high roughness [28]. Despite this, Gelcoat can be considered as a coating against water jet erosion, even for a short period. The acquired shape of the scars in the evaluated materials is due to the fact that the nozzle has a tip with a rectangular geometry. At the same conditions, carbon fiber sheet is the material that presented the least damage. This confirms that its performance, in these tests, is due to the good properties of this composite material that were already reported in other studies [29,30]. The evaluated samples did not present damage in the whole area exposed to water jet erosion, only in certain regions and later spread to more vulnerable sections [31].

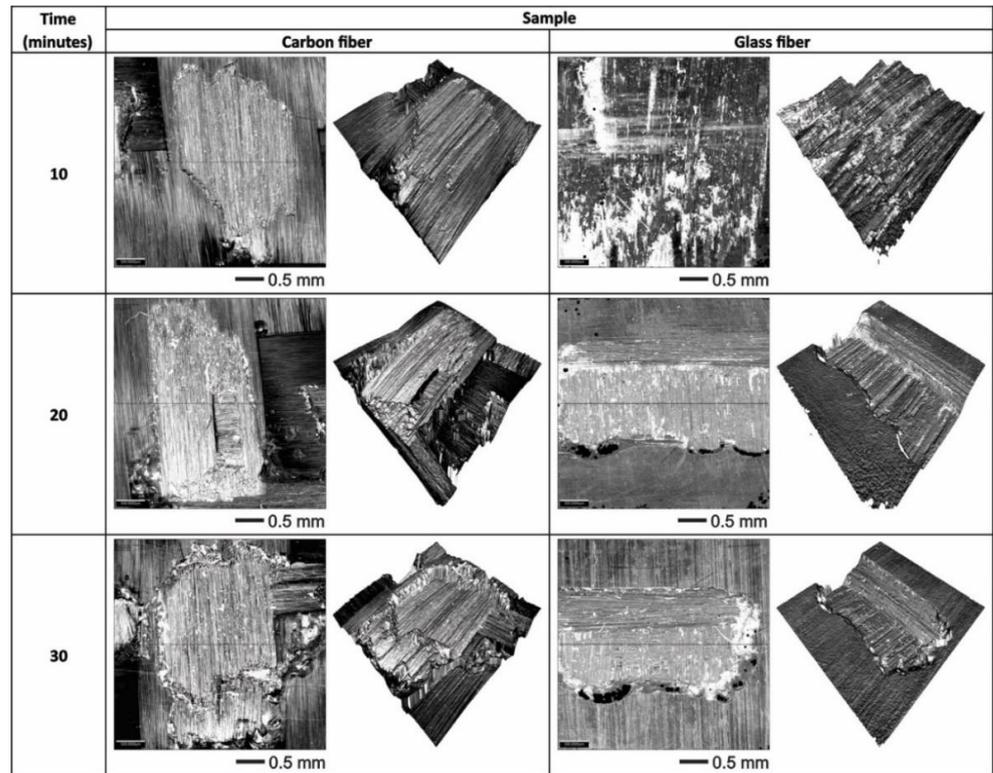
Figure 7. Optical microscopy and 3D view of the wear scars of the samples evaluated using water jet erosion.

Figure 7 shows the optical microscopy and the corresponding 3D view of the damaged regions in the evaluated samples of carbon fiber and glass fiber at different times of duration test. It was observed that, after 10 min, the fiberglass presented a deeper wear scar produced by the impact of liquid on the surface. At 20 and 30 min, it was seen that the damage on the surface gradually increased, generating a deeper scar. In comparison, after 10 min, the carbon fiber shows less damage, because the liquid particles only slightly erode the surface, which corresponds to the detachment of the polymer matrix leaving the fibers exposed. After a period of 20 min, small, eroded areas can be observed, and the surface roughness is modified. At 30 min, the repeated impacts of the liquid particles caused the presence of cuts in the upper carbon fibers and the accumulation of removed material around the wear trace. When making a comparison, it is very evident that carbon fiber presented less wear than glass fiber under the conditions in which the liquid erosion test was carried out, this is mainly due to the roughness, the hardness and the type of fabric of each sample [32,33]. The studies carried out have found results where glass fiber has the lowest resistance to wear [34]. Carbon fiber composites can be used in place of glass fiber

- From optical microscopy, it was observed that the fiberglass presented a deeper wear scar compared to the carbon fiber where less damage was observed, which corresponds to the detachment of the polymer matrix, leaving the fibers exposed. After 30 min of testing, the repeated impacts of the liquid particles caused the presence of cuts in the upper carbon fibers and the accumulation of removed material around the wear trace.

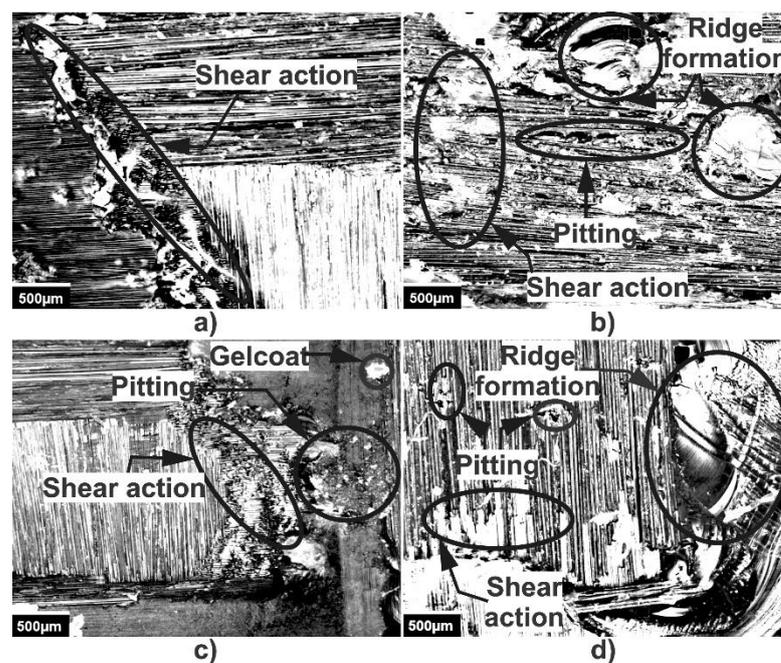
Figure 8. Wear mechanisms by water erosion in (a) carbon fiber, (b) glass fiber, (c) carbon fiber with Gelcoat and (d) glass fiber with Gelcoat.

Figure 8a shows the microscopy of the wear zone corresponding to carbon fiber, in which a slight depth was observed, caused by the number of broken fibers due to the

repeated impacts of the liquid on the surface during the test [36]. Figure 8b shows the wear zone of glass fiber where the removal of the polymer matrix and fibers cut randomly by the impact of the liquid on the surface can be seen; in addition, there was the formation of ridges in the direction of impact, which caused an increase in the surface roughness [37,38]. In the sample of carbon fiber with Gelcoat, shown in Figure 8c, the damaged region was observed, where there was the presence of a small remainder of Gelcoat applied on the surface; additionally, small pitting, formed by the continuous attack, was created, which subsequently caused cracks. This leads to the removal of the polymer matrix and the presence of cutting action on the fibers [39,40]. In the case of the glass fiber with Gelcoat, corresponding to Figure 8d, it was observed that the coating was removed quickly at the beginning of the test, leaving the exposed surface of the fiberglass, allowing the subsequent detachment of the polymer matrix and fibers, as well as the formation of ridges, cut fibers and pitting. Once surface damage begins, erosion accelerates due to the roughness changes over the test region of the sample [41–44]. The impact of the liquid particles on the surface produces gradual wear, modifying its roughness. As the test progresses, the roughness increases, creating valleys and ridges in the impact zone. When a liquid particle collides with this rough surface, the particle tends to lose speed while sliding on the surface, and at the same time, due to the impact of the liquid with a valley or a ridge, the detachment occurs, causing progressive erosive wear.

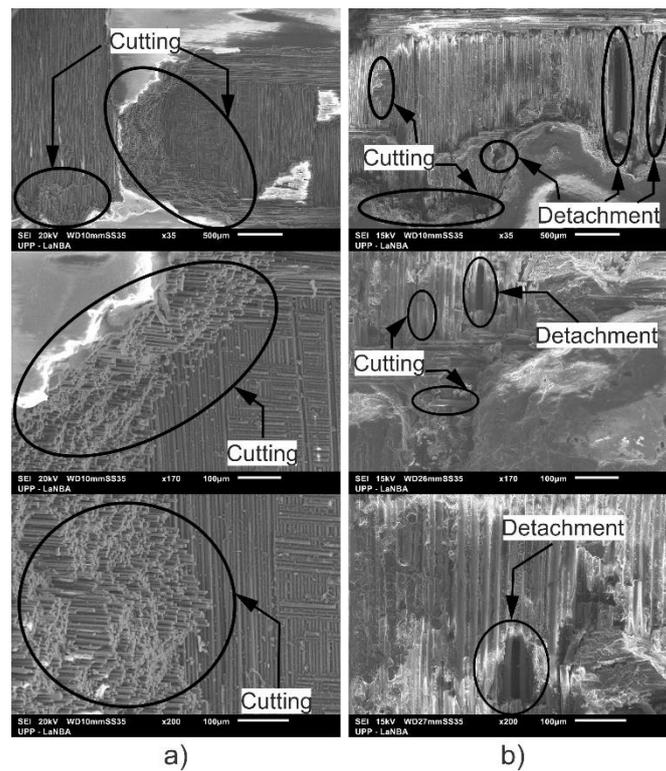
Figure 9. Cutting and detachment action: (a) carbon fiber and (b) glass fiber.

Figure 9a shows, in greater detail, the damage of the cutting action on the fibers and the removal of the epoxy resin due to the constant impact of the pressurized water on the surface of the carbon fiber sample. In Figure 9b, corresponding to the glass fiber sample, cuts in the fibers and the removal of the epoxy resin were also observed, but in this case, there are some regions that showed greater damage and depth due to the impact of water. This confirms that the resistance to water erosion in glass fiber is lower than in carbon fiber.

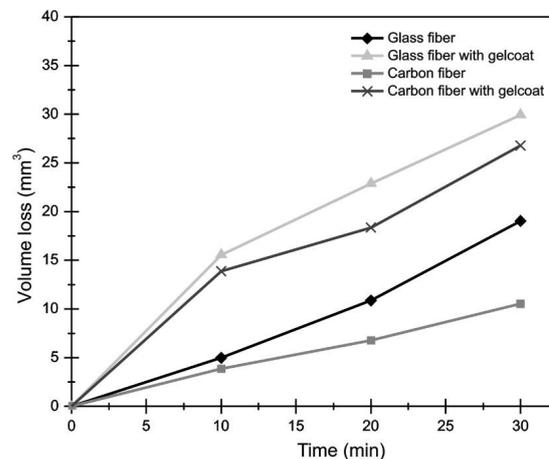
Figure 10. Volume loss during the liquid erosion test with 75° impact angle.

The ASTM G73-10 [21] standard for water jet erosion tests determines that erosion must be reported as volume or mass lost with respect to time. The lost volume was determined from the measurement of the wear scars of samples using a 3D optical microscope. Figure 10 shows the volume lost in the coated and uncoated composites materials. It is observed that the carbon fiber presented, at the end of the duration test, the smallest volume loss; this is due to its good mechanical properties [45,46]. On the other hand, the samples of carbon fiber and glass fiber with Gelcoat are the ones that lost more material during the test, confirming again its low resistance to water erosion [47,48]. It was observed that the behavior between the volume loss and time was linear (Figure 10), due to the progressive damage of the surface and that the increase in roughness is proportional to the increase in erosion wear.

- Based on the data obtained, in most of the tests carried out, a linear behavior was observed between the lost volume and the test time, confirming the existence of progressive damage on the surface and concluding that the increase in roughness is proportional to the increase in erosion wear.

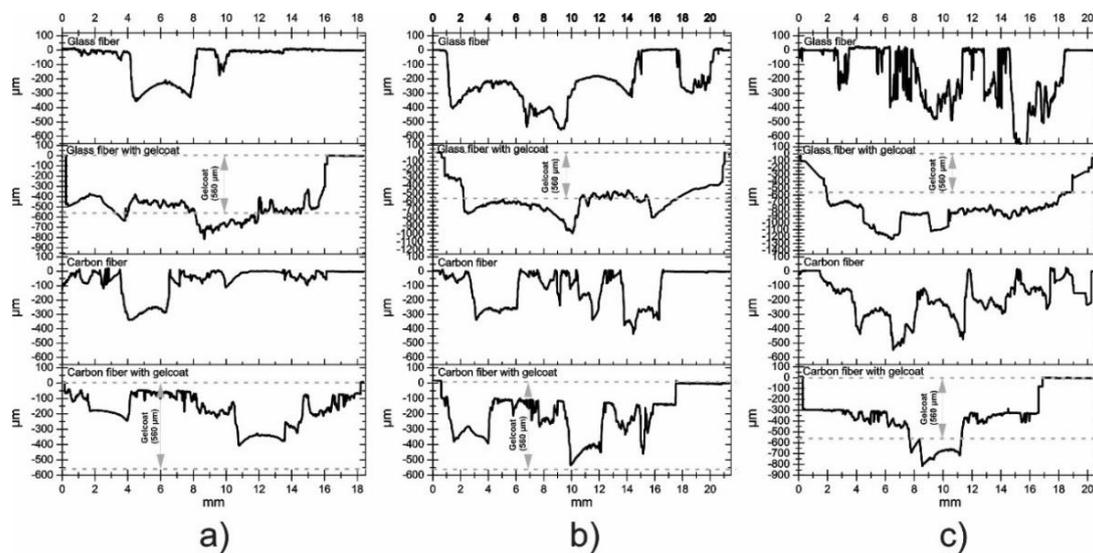
Figure 11. Profilometry of carbon fiber and glass fiber samples with and without Gelcoat with a duration test of (a) 10 min, (b) 20 min and (c) 30 min.

Wear profiles across the scars were obtained. Figure 11a,b show the profilometry of the samples at 10 and 20 min of duration test, respectively. In all cases, it can be observed that at 10 min, the impacts of the liquid particles modified the surface roughness of the materials. In both times, the sample of glass fiber with Gelcoat is the one that presented the scar with a greater depth, while the carbon fiber presented the lowest depth. Figure 11c, corresponding to the exposure time of 30 min, shows that the profiles with high magnitudes of depth were obtained in the samples with Gelcoat and again the sample of carbon fiber is the one that presented the lowest depth in the wear scar during the test, confirming its resistance to water erosion at the conditions tested in this experimental study. Additionally, in the case of coated samples, Figure 11 shows, with dotted lines, the thickness of the Gelcoat in order to observe the depth of wear produced both in the Gelcoat and in the composite material, depending on the test time.
