# Comparison of the damage and microstructure evolution of eutectoid and hypereutectoid rail steels under a rolling-sliding contact

**Abstract:** The wear and rolling contact fatigue (RCF) performance of eutectoid and hypereutectoid rail steels were studied. Subsequently, the microstructure evolutions of subsurface materials of these two rail steels after testing were comparatively investigated. The results indicated that, compared with the eutectoid rail, the hypereutectoid rail had lower wear loss, but longer RCF crack lengths. After the rolling-sliding testing, the original equiaxed and undeformed coarse grains of rails in the matrix were transformed into nano-grains rich in high angle grain boundaries (HAGBs). The microstructure evolution of rail steels under rolling-sliding contact could be result from two mechanisms. Firstly, the initial deformation and the breaking of the lamellar structure of pearlite grains occurs through the movement of dislocations. Secondly, the formation of the nanostructure grains happens through continuous dynamic recrystallization (cDRX). Compared with the eutectoid rail, the hypereutectoid rail had finer interlamellar spacing and higher contents o

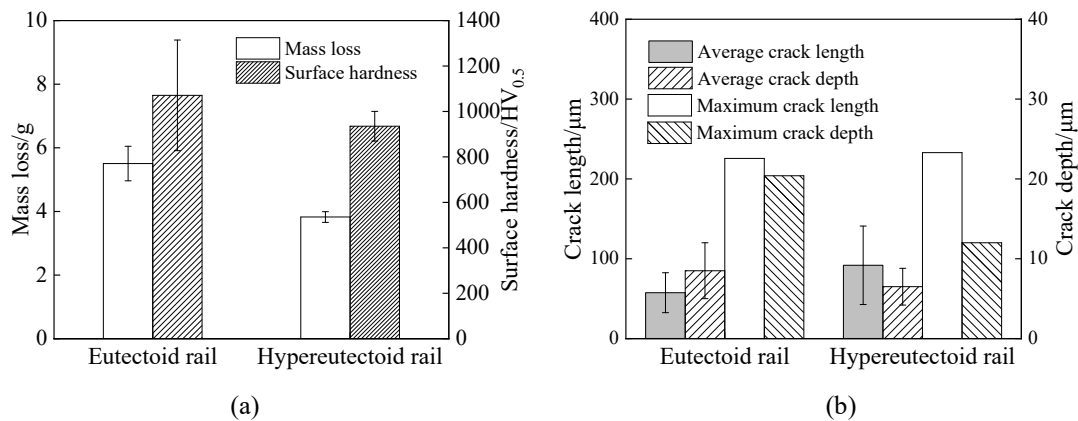
Fig. 3a shows the mass losses and surface hardness of eutectoid and hypereutectoid rail steels after testing. It could be observed that the hypereutectoid rail steel with higher hardness has lower mass loss and lower surface hardness after testing than eutectoid rail. Therefore, the hypereutectoid rail has better resistance to wear and work hardening than eutectoid rail. Fig. 3b shows the RCF crack data for eutectoid and hypereutectoid rail steels. It could be observed that the hypereutectoid rail has longer crack lengths, but a shallower crack depth than eutectoid rail.

**Fig. 3.** (a) Mass losses and surface hardness; (b) statistical RCF cracks of eutectoid and hypereutectoid steels after testing.

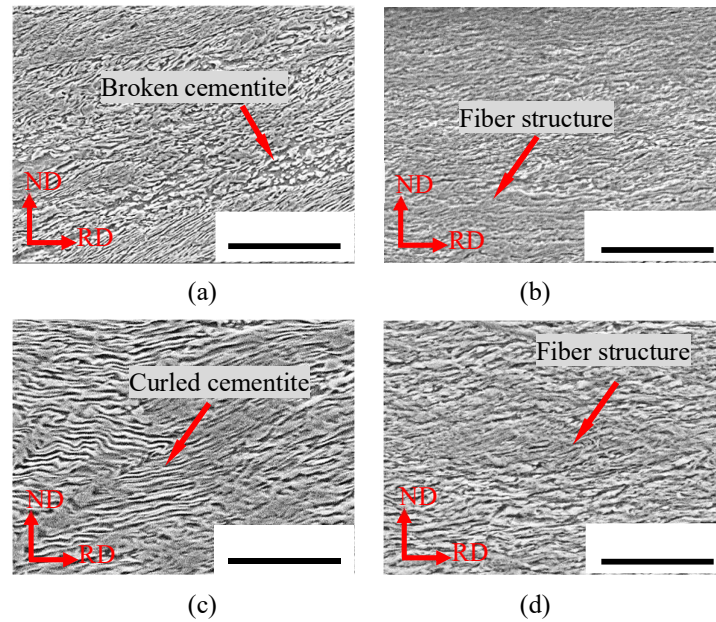
The microstructure of the subsurface materials of eutectoid and hypereutectoid rail steels after testing were observed via SEM, as shown in Fig. 5. With increasing distance from the worn surface, the plastic deformation and the material defects alleviate gradually until reaching the bulk matrix. According to the degree of plastic deformation, the subsurface material after testing could be divided into three zones: the severely deformed zone (within 30  $\mu\text{m}$  from the worn surface), the transition zone (within 30-70 $\mu\text{m}$  from the worn surface) and the matrix zone.

dominated by cementite twisting and breaking. In the severely deformed zone (Fig. 5b and d), the cementite plates are thinned and broken into granules. A fibrous structure that is nearly parallel to the RD could also be observed.

As for the eutectoid rail, both the curled and broken cementite could be observed in the transition zone (Fig. 5a). However, due to the smaller interlamellar spacing, the material defects are dominated by curled cementite in the hypereutectoid rail (Fig. 5c). In summary, the cementite plates in the hypereutectoid rail have better resistance to deformation and breakage than those in the eutectoid rail.

**Fig. 5.** SEM observation of microstructure deformation of rail, (a) eutectoid rail-transition zone; (b) eutectoid rail-severe deformed zone; (c) hypereutectoid rail-transition zone; (d) hypereutectoid rail-severe deformed zone.

During the initial deformation stage, the strain in the grains is relatively low and the initiation and movement of dislocations in ferrite plates dominated the microstructure evolution of the rail material. The ferrite had more slip systems and lower strength than cementite [23]. Therefore, the dislocations were preferentially initiated in ferrite plates. Furthermore, the pearlite grains orientated in anisotropy and the ferrite and cementite plates were aligned randomly to the shear stress. Where the lamellar direction was perpendicular to the shear stress, the dislocations slipped and piled-up at the interface between the ferrite and the cementite plates. The cementite would be curled and broken under a high density of dislocations (Fig. 10b and d). Where the lamellar direction was parallel to the shear stress, the dislocations slipped and piled-up at the grain boundaries. Two types of grain boundaries could be observed in rail materials: LAGBs and HAGBs. Basically, the LAGBs were considered as softer obstacles for dislocations, while HAGBs were harder obstacles [32]. With the elongation of durations, dislocations moved through the LAGBs while they piled-up at the HAGBs continually. The continuous accumulation of dislocations at the HAGBs adjusted the misorientation angles of adjacent grains and caused the transition from HAGBs to LAGBs (Fig. 6 and 9). Furthermore, pearlite grains rotated to the direction of shear stress gradually under the action of the high density of dislocations with shortened interlamellar spacing (Fig. 5a and c).

With the further accumulation of deformation, the strain in the grains is relatively large and the dynamic recrystallization would dominate the microstructure evolution process of rail materials due to the severe plastic deformation, known as the continuous dynamic recrystallization (cDRX) [33]. The shear strain on the top of rail materials would accumulate as high as 12 to 14 [18] [19], which would high enough to cause a cDRX (e.g.,  $\epsilon > 12$ ). The cDRX originated from the transition of dislocations sub-boundaries into nanocrystallized grains with HAGBs. During this transition process, the LAGBs were converted into HAGBs (Fig. 6) and the grains were significantly refined into equiaxed nanocrystalline grains with a diameter less than 1  $\mu\text{m}$  (Fig. 7b). Besides, a fibrous structure was formed (Fig. 5b and d).

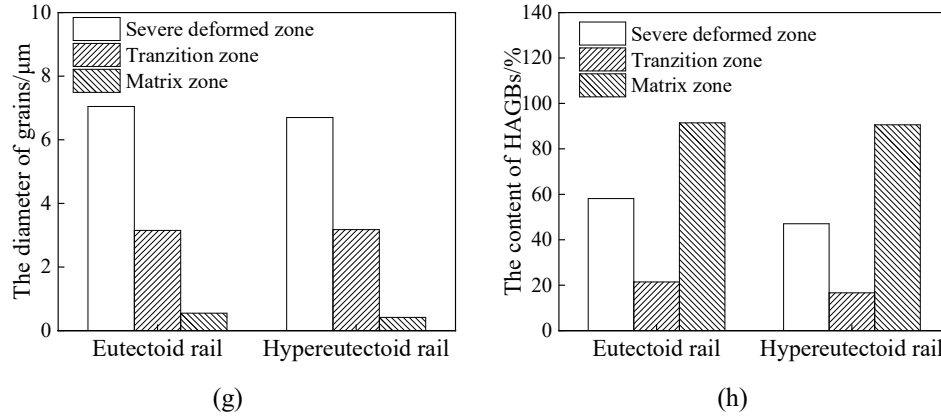
Fig. 7 presents the grain boundary (GB) maps of eutectoid and hypereutectoid rail steels in different zones after testing. The GB map can describe the grain boundary angle and the grain size. Two types of grain boundaries can be observed: low angle grain boundaries (LAGBs) from  $0^\circ$  to  $15^\circ$  (green curves), and high angle grain boundaries (HAGBs) from  $15^\circ$  to  $65^\circ$  (black curves). With the increase in deformation (from the matrix zone to the transition zone and to the severely deformed zone), the size of grains decreases gradually (Fig. 7g). In the severely deformed zone, nano-grains with average diameters of  $0.548$  and  $0.417 \mu\text{m}$  can be observed. Concerning the grain boundary angles, the content of HAGBs and LAGBs would experience two transitions (Fig. 7h). In the initial deformation stage (from the matrix zone to the transition zone) (Fig. 7a, b, d and e), the HAGBs would be transformed into LAGBs. Therefore, the

defects of rail materials are dominated by the low angle sub-grain structure at the initial stage of deformation, which implies an increase in the lattice defects and the dislocation density. In the severely deformed zone (Fig. 7c and f), the LAGBs would be transformed into HAGBs, which indicates that the surface material would have undergone a dynamic recrystallization under cyclic loading [18].

The hypereutectoid rail has a higher content of LAGBs (52.98%) than eutectoid rail (41.78%) in the matrix zone (Fig. 7a and d). The more LAGBs in the matrix zone, the higher the dislocation density is, which could enhance the dislocation strengthening and increase the strength and hardness of the rail material. In the transition zone (Fig. 7b and e), the content of LAGBs of hypereutectoid rail (83.4%) is slightly larger than eutectoid steel (78.57%). This might be related to the fact that the dislocation tangling in hypereutectoid rail steel is more serious in the transition zone. In the severely deformed zone, the content of HAGBs of eutectoid and hypereutectoid rail steels are nearly the same (i.e., 91.45% and 90.6%).

**Fig. 7.** IPF and grain boundary map of hypereutectoid rail, (a) eutectoid rail-matrix zone; (b) eutectoid rail-transition zone; (c) eutectoid-severely deformed zone; (d) hypereutectoid rail-matrix zone; (e) hypereutectoid rail-transition zone; (f) hypereutectoid rail-severely deformed zone; (g) the average grain diameter and (h) the content of HAGBs of eutectoid and hypereutectoid rail steels.

The hypereutectoid rail had finer interlamellar spacing and higher content of LAGBs (Fig. 7a) than eutectoid rail in the matrix zone. Therefore, the microstructure evolution of hypereutectoid was different from that of eutectoid rail after the rolling-sliding testing. In the initial deformation stage, the hypereutectoid rail would be deformed slightly and a texture could be observed. This is due to the higher content of LAGBs could coordinate the deformation of neighboring grains through rotating the pearlite orientation in the transition zone. In the severely deformed zone, the rail material would experience the cDRX process. As mentioned above, the cDRX was originated from the transition of dislocations sub-boundaries into nanocrystallized grains with HAGBs. In the present study, the hypereutectoid rail material had a higher content of LAGBs both in the transition zone and in the matrix zone. However, in the severely deformed

zone, the HAGBs of eutectoid and hypereutectoid rail were nearly the same (Fig. 7a). This phenomenon indicated that the hypereutectoid rail would experience more severe LAGBs-to-HAGBs transitions and more severe cDRX than eutectoid rail in the severe deformed zone. The dynamic recrystallized grains could be the weak part for crack initiation and propagation [34]. Therefore, the hypereutectoid had a longer RCF crack length in the surface material. In summary, at the topmost layer, the hypereutectoid rail would present a higher cDRX degree in the severely deformed zone than eutectoid rail, which might be the possible reason for the lower RCF resistance of hypereutectoid rail in the present study.

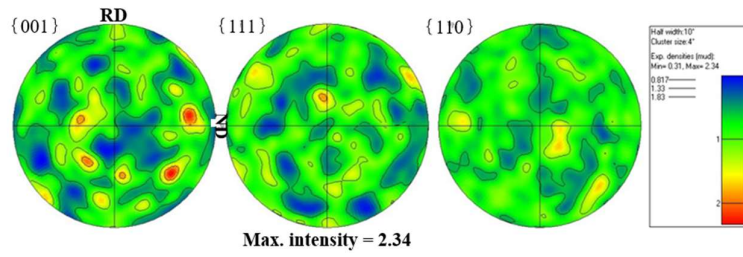
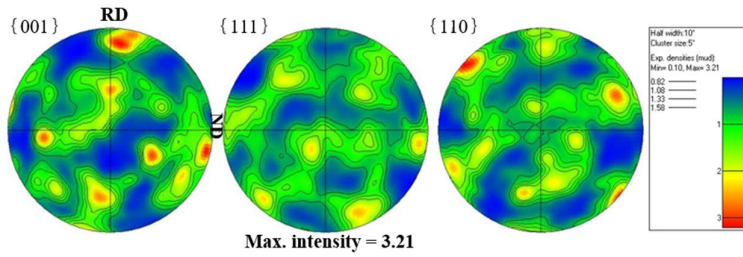
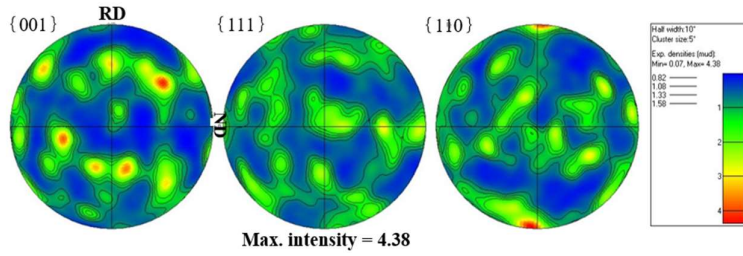
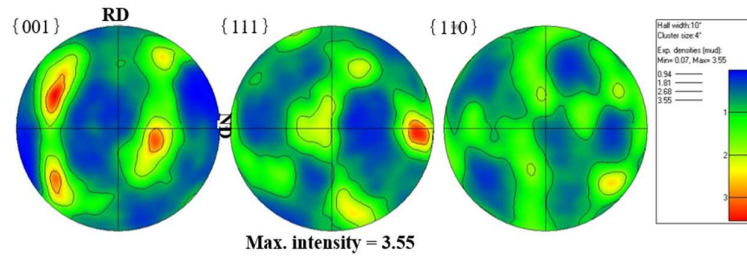
Fig. 8 shows the pole figure (PF) of eutectoid and hypereutectoid rail steels after testing. The PF is the method used to determine whether a preferred orientation (i.e., texture) is formed after plastic deformation. The PFs of the three crystal planes  $\{001\}$ ,  $\{111\}$  and  $\{110\}$  have been conducted in different zones. On the right is the scale of density intensity. The higher the density intensity, the more obvious the preferred orientation is in the deformed materials. It could be observed that for the eutectoid rail, with the increase in the deformation (from matrix zone to transition zone and to severely deformed zone), the maximum density intensity increases from 2.34 to 3.32 and to 3.82, respectively. In all three zones, the grains of eutectoid rail are distributed in a random orientation. Concerning the hypereutectoid rail, the maximum density intensities of the three different zones are 3.55, 4.38 and 3.54, respectively. Therefore, in the transition, the  $\{110\}$  plane along the RD direction of hypereutectoid rail has a more obvious preferred orientation than eutectoid rail.

**Fig. 8.** Pole Figures (PFs) in {001}, {111} and {110} crystal planes with an intensity legend, (a) eutectoid rail-matrix zone; (b) eutectoid rail-transition zone; (c) eutectoid-severely deformed zone; (d) hypereutectoid rail-matrix zone; (e) hypereutectoid rail-transition zone; (f) hypereutectoid rail-severely deformed zone.
