# A geometric assessment method for estimating dimensional change of retrieved dual mobility liners for total hip arthroplasty

Proc IMechE Part H:  
J Engineering in Medicine  
2023, Vol. 237(6) 782–787  
© IMechE 2023  
Article reuse guidelines:  
sagepub.com/journals-permissions  
DOI: 10.1177/09544119231176112  
journals.sagepub.com/home/pih

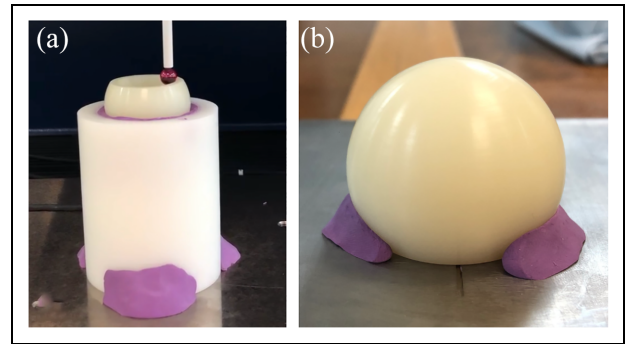
**Figure 1.** Liners were securely fixed to the measurement bed of the CMM using bespoke fixtures to facilitate measurements of the internal (a) and external (b) surfaces. Small amounts of plasticine were introduced at the outer edges of the components to prevent surface damage and component rotation.

Liners were securely fixed as shown in Figure 1 and measured through a series of 144 traces spaced in 2.5° intervals about the vertical axis. Each trace originated from the pole and terminated at either the retentive bore (for internal surface measurements) or 3-mm beyond the equator (for external surface measurements). The measurement time and number of acquired data points was dependent on the size of the sample. In the case of a BI-MENTUM™ liner (DePuy Synthes) with an inner diameter of 28-mm and outer diameter of 63-mm, which represents the largest available DM liner size available, the measurement time was 93 min which

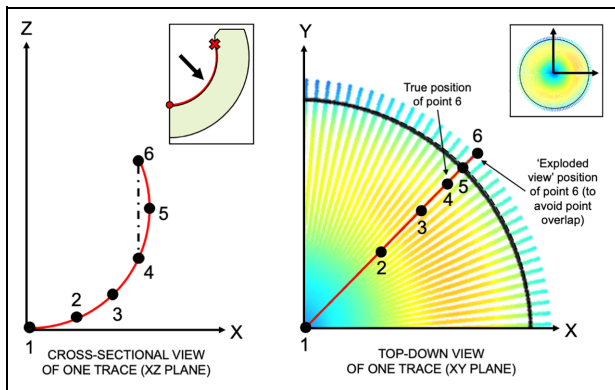
**Figure 2.** A cross-sectional view (XZ-plane) of one measurement trace is shown on the left, which features six example points. Due to the supra-hemispheric geometry of DM liners, Points 4 and 6 would overlap on a top-down (i.e. XY-plane) geometric variance heatmap of the surface. Therefore, points situated beyond the equator were represented in an 'exploded' form as shown by the image on the right to ensure the entire surface could be visualised. The location of the equator is marked by a black circle to make the distinction between the lower and upper hemispheres clear.

To visualise areas of surface damage, the coordinate data was plotted, and each point was assigned a colour based on its geometric variance. To ensure full surface visualisation, the spherical surface above the equator was displayed in an exploded view as described in Figure 2.

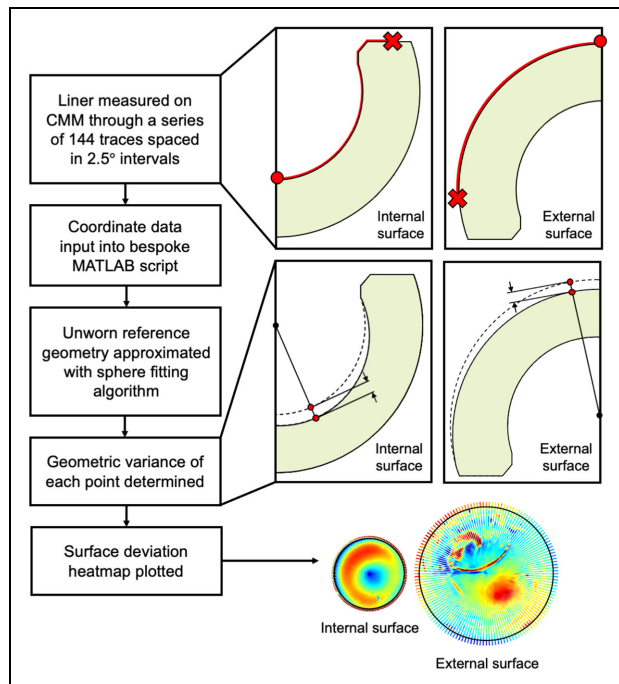
**Figure 3.** Flowchart describing the geometric assessment protocol.

A summary of the measurement methodology is depicted in Figure 3.

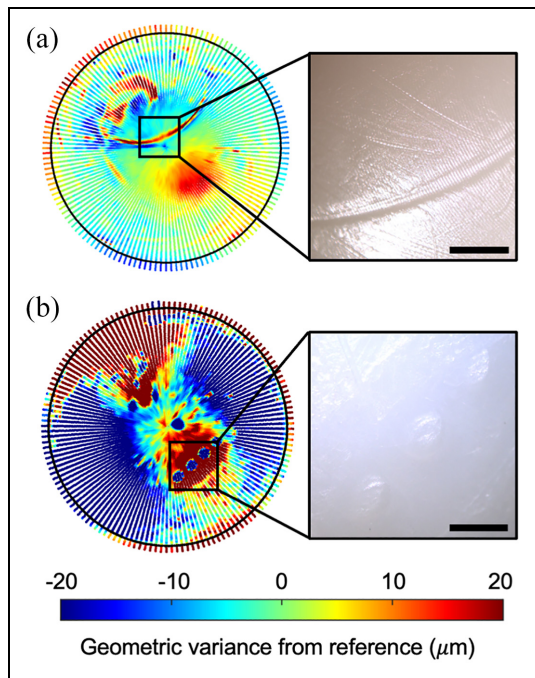
**Figure 4.** External surface deviation heatmaps of two retrieved DM liners, and corresponding microscope images (a) Sample 15; (b) Sample 19. Scalebars represent a unit of 2 mm.

Damaged features observed visually on the outer surfaces of retrieved DM liners were clearly identified on the surface deviation heatmaps as exemplified in Figure 4. The damaged features could be described as regions of deep penetrating gouges ( $n = 3$  liners), a cluster of four protruding circular marks ( $n = 1$  liner) and a C-shaped indentation ( $n = 1$  liner). As expected, the as-manufactured samples showed no visible signs of surface damage as demonstrated in Figure 5. Artefacts of the manufacturing process include circumferential machining marks and a small region of protruding material ( $< 20 \mu\text{m}$  in height) at the pole of each surface. Additionally, three penetrating regions were identified on the spherical surface above the equator of the external surfaces.

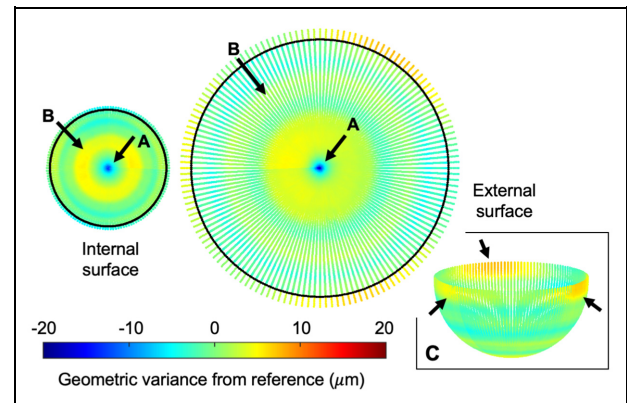
**Figure 5.** Surface deviation heatmap of an as-manufactured DM liner, depicting a small region of protruding material at the pole (A) and a circumferential stripe (B) on each of the surfaces. Three penetrating regions were also noted on the upper hemisphere of the external surface (C).

The sensitivity of the method was demonstrated through the analysis of an as-manufactured sample, whereby manufacturing artefacts with geometric variances below  $20\ \mu\text{m}$  were able to be detected. Additionally, the method was shown to be repeatable and robust against variations in component orientation.
