# Main Bearing Replacement and Damage – A Field Data Study on 15 Gigawatts of Wind Energy Capacity

**Technical Report**  
NREL/TP-5000-86228  
July 2023

The Advancing Main BEaRing Science for wind and tidal turbines (AMBERS) project seeks to improve the scientific understanding of main bearings in wind and tidal turbines through a program of research and innovation. One of the AMBERS work packages was initiated to establish a comprehensive baseline of knowledge for the replacement and damage of main bearings in wind turbines. Additionally, it has allowed for the implementation of established best-practice statistical methods for handling such data.

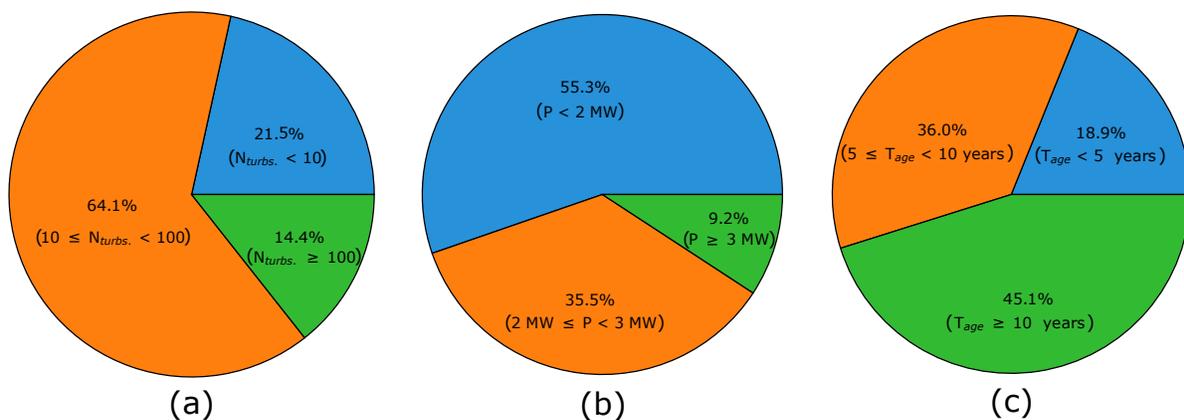
**Figure 1. Data set breakdown by a) wind plant size, b) wind turbine power rating, and c) turbine age**

We collected data on main bearing replacements and reported damage from a number of industrial partners based in Europe and the United States. These data included the dates of turbine/main bearing commissioning for all wind turbines, the date of replacement for each main bearing that was exchanged, turbine rated-power levels, and, where possible, the reported main bearing damage. In total, we obtained data for 167 wind power plants (7,707 wind turbines), with a combined capacity of 15.3 gigawatts (GW). Within this data set were 689 instances of main bearing replacement. Multiple main bearing replacements for the same wind turbine were found to be relatively uncommon in the data, with replacements occurring for different turbines in the vast majority of cases. Table 1 and Figure 1 provide breakdowns of the overall data set. Note, turbines of power rating less than 1 MW only comprise 1% of the overall data set. As shown in the table, complete information was not available regarding various characteristics of individual wind turbines and/or drivetrains. Therefore, we conducted the analysis without differentiating between land-based versus offshore, spherical roller bearings (SRBs) versus tapered roller bearings (TRBs), and three-point versus four-point mounts<sup>1</sup>. Most of the data set was comprised of land-based, three-point mount, SRB main bearings. The vast majority of main bearing failures in the data set occurred for the downwind row of the locating bearing. Additionally, the vast majority of turbines were geared, rather than direct-drive, machines.

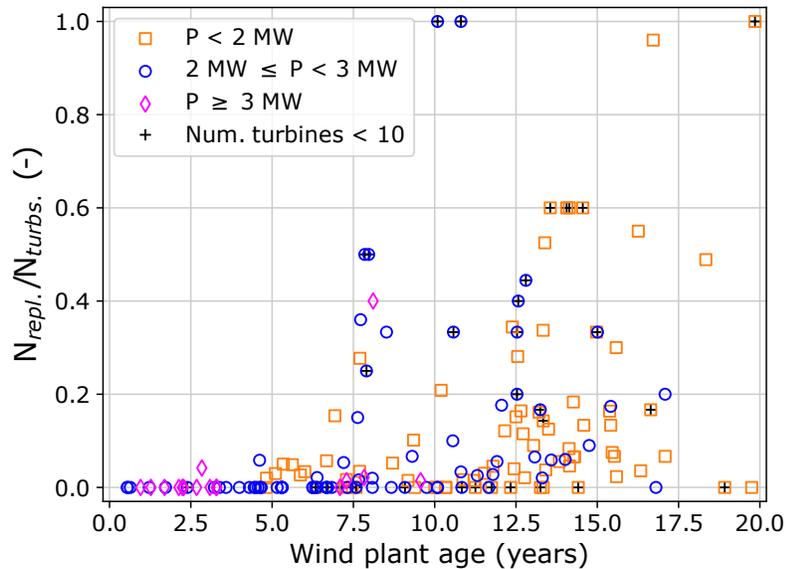
A power-plant-level summary of the collected data is provided in Figure 2. For each wind plant, age is plotted against the total number of main bearing replacements expressed as a proportion of the number of turbines. While this figure provides only a crude representation of the data, a number of pertinent observations can still be made. First, the proportional number of replacements appears only weakly correlated with wind plant age. There is also no

Figure 2. For each wind plant, age is plotted here against the total number of main bearing replacements,  $N_{repl.}$ , expressed as a proportion of the number of turbines at that plant,  $N_{turbs.}$ .

immediately obvious relationship with turbine rated power levels. Together, these results indicate that other factors (e.g., site conditions, maintenance practices, and technological changes) are driving variability in the number of replacements occurring for a given age of wind plant. Second, this figure indicates that main bearing replacement numbers appear not to be strongly driven by “infant mortality” effects. Third, the modified reference rating life of the main bearing is such that no more than 10% should need replacing, due to rolling contact fatigue, within the specified design life of the wind turbine—typically 20 years or more. From the figure, it is clear that this threshold is being passed before 20 years in many cases, and in some instances as early as 7–7.5 years. This result indicates that one of two scenarios must hold: either rolling contact fatigue is not a principal driver of premature main bearing replacements (meaning other damage mechanisms dominate); or rolling contact fatigue does contribute to observed replacements, but current rating life assessment methods do not capture it sufficiently; hence, they are unable to provide realistic rating life predictions. Finally, while some sites see high proportions of main bearing replacements, others have no or very low proportions replaced even after 12–20 years.

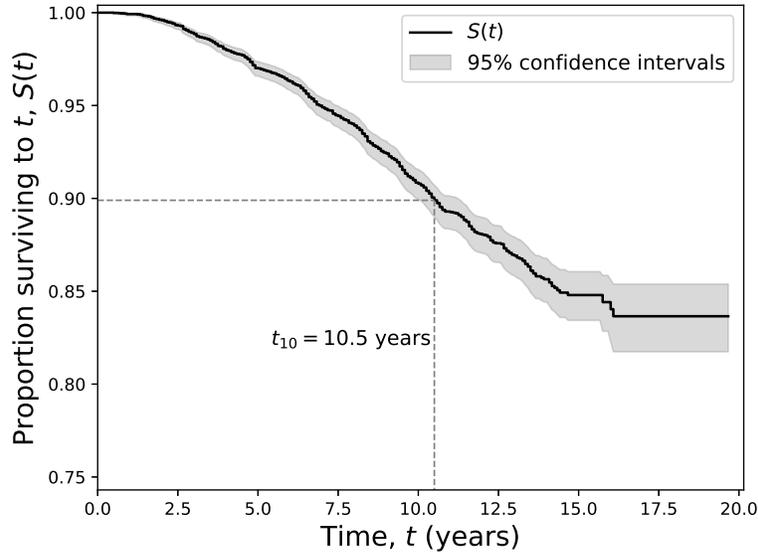
We then undertook a more formal statistical analysis by combining data from all sites into a single, large, time-to-replacement data set. From this data set the survival curve,  $S(t)$ , for main bearing replacements was obtained using the Kaplan-Meier estimator. In the current context,  $S(t)$  describes the proportion of main bearings “surviving” (*i.e.*, those that have not been replaced) until or beyond time  $t$  in a fixed population over time. At any time,  $t$ , the proportion that has been replaced is therefore  $U(t) = 1 - S(t)$ , which is sometimes referred to as the unreliability curve. Figure 3 shows the survival curve for the collected main bearing replacement data, including 95% confidence intervals<sup>2</sup>.

<sup>2</sup>Confidence intervals in this figure are based on data quantities alone. However, as described earlier, other uncertainties are present in the analysis that are not accounted for directly here. True confidence intervals are therefore wider than those shown here, although the additional uncertainty is understood to only be on the order of around  $\pm 1$  month.

Figure 3. Survival curve,  $S(t)$ , of main bearing replacement data, obtained using the Kaplan-Meier estimator.

Defining  $t_{10}$  to be the time at which 10% of main bearings in the population have been replaced (so  $S(t_{10}) = 0.9$ ), this value may be directly compared to the desired design value of 20 years. For this population of 7,707 wind turbines,  $t_{10} = 10.5$  years, which is close to half of the design value.

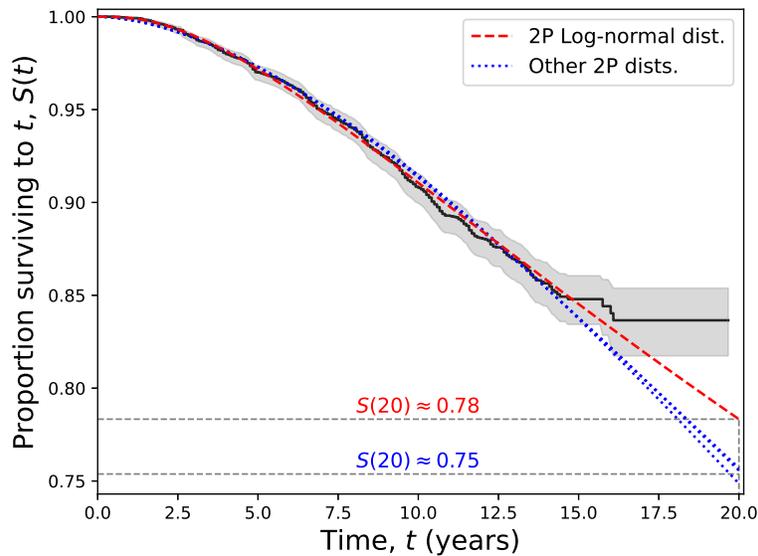
It is also of interest to consider the proportion of the main bearing population,  $S(20)$ , which would be expected to survive the 20-year design life. Since the data set itself does not reach 20 years, and only a small proportion of turbines are  $> 15$  years of age, parametric fitting is necessary to estimate  $S(20)$ . A number of common survival/reliability distributions were therefore fitted to the data, with goodness-of-fit determined via the Bayesian Information Criterion (BIC) score. The best-fitting distribution was the 2-parameter log-normal, followed by the gamma, log-logistic, and Weibull distributions (in that order). Fitted distributions are shown in Figure 4.

Figure 4. Survival curves obtained from the parametric distribution fitting

The log-normal distribution predicts  $S(20) = 0.78$ , equivalent to 22% of the main bearing population having been replaced by year 20. The other fitted distribution  $S(20)$  predictions are all lower than that of the log-normal distribution. The mean of these other predictions is  $S(20) = 0.75$ , equivalent to 25% having been replaced by year 20. This

In the current case, the Weibull fit results in the smallest  $S(20)$  value in Figure 4 and, correspondingly, the largest hazard rates in Figure 5. It is notable that the Weibull distribution, often the default distribution fitted during reliability analysis, provided the poorest fit (as determined by the Bayesian Information Criterion score) of the four distributions for which results have been shown. Other distributions may therefore provide a better characterization of reliability data in some instances. It is therefore recommended that, in general, a number of distributions are fitted and goodness-of-fit checks performed. Caution is advised when extrapolating beyond the data. This is due to a) possible later features of a parametric distribution that are not justified by the data, and b) the possibility of new mechanisms becoming important later in a component’s life.

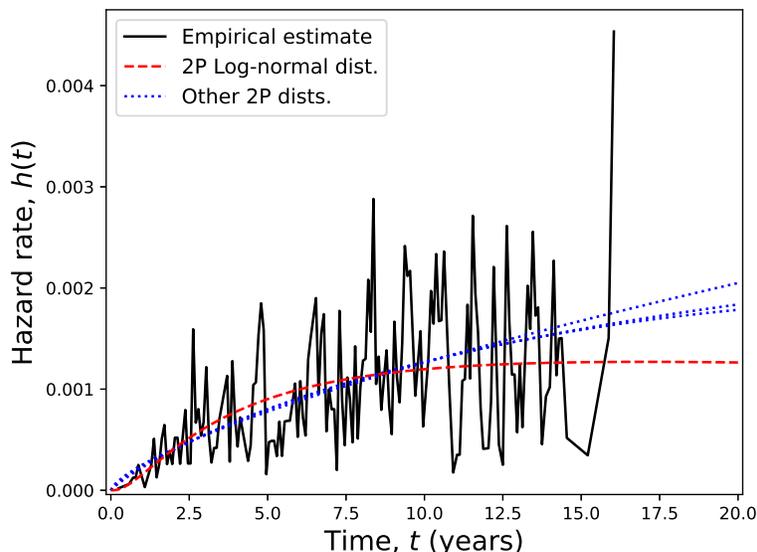
Related to the survival function is the hazard rate,  $h(t)$ , also referred to as the conditional failure rate. In the current context,  $h(t)$  estimates the probability of a main bearing being replaced in the next month, given that it has survived to time,  $t$  (for  $t$  in years). The hazard rate is generally considered to be more informative than the survival function when considering underlying mechanisms of failure.  $h(t)$  may be estimated<sup>3</sup> directly from  $S(t)$ , and a hazard rate curve can also be obtained for each fitted distribution. These various forms are shown in Figure 5 for the analyzed main bearing replacement data set. Both the empirical- and distribution-based hazard rate curves are shown to

**Figure 5. Monthly hazard rate,  $h(t)$ , for main bearing replacements obtained empirically and from fitted parametric distributions.**

increase from zero in the early years, with a roughly monotonic increase continuing until around  $t = 8.5$ . Thereafter, the trend is less certain, with the empirical estimate being very noisy<sup>4</sup>, the log-normal fitted distribution predicting a leveling of  $h(t)$  as  $t$  increases further, and the remaining fitted distributions predicting a continuing monotonic increase in  $h(t)$ .

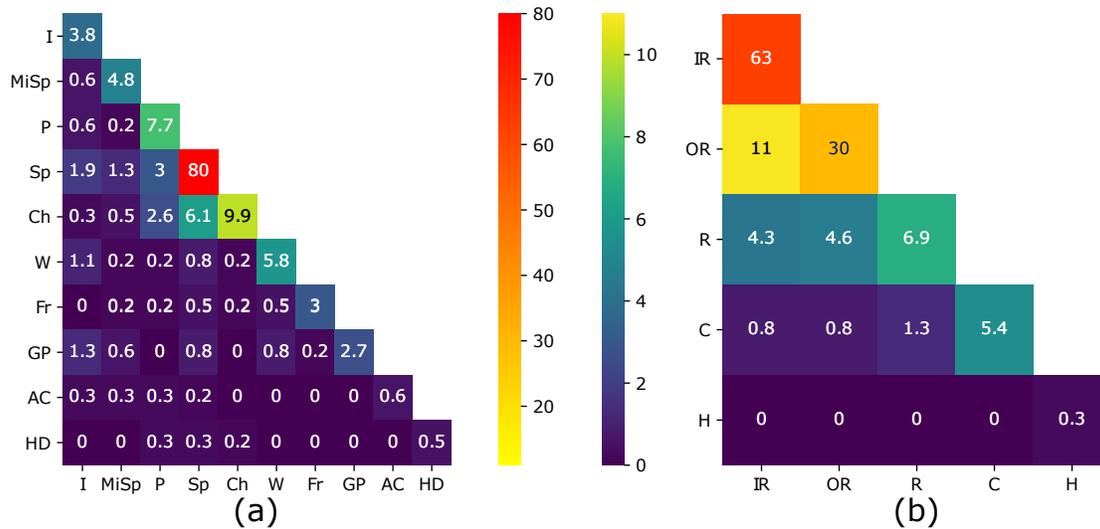
As outlined in Section 2, we processed damage reports into standard categories of listed damage types and damage locations. Damage types included: indents (I), microspalling (MiSp)<sup>5</sup>, pitting (P), spalling (Sp), chipping (Ch), wear (W), fracture (Fr), particles/debris in grease (GP), axial cracking (AC), and heat damage (HD). Damage locations included: inner raceway (IR), outer raceway (OR), roller (R), cage (C), and housing (H). Figure 6 shows occurrence distributions for damage and location (separately) from collected main bearing damage reports. In these figures, the diagonal elements indicate the proportion of damage reports listing that damage/location type. Off-diagonal elements indicate the proportion of damage reports listing both corresponding types of damage or location. A single damage report may include multiple damage types and/or locations.

**Figure 6. Occurrence distributions for a) damage type and b) damage location. Diagonal elements indicate the proportion of damage reports listing that type of damage or location. Off-diagonal elements indicate the proportion of damage reports listing both corresponding types of damage or location.**

Note, the different damage types and locations are not independent of one another. For example, indents can precipitate microspalling, which leads to spalling. Similarly, all observable damage is likely not listed in every damage report (for example, in cases of Sp there will always be GP, but GP tends to only be listed when it is the main type of damage observed). Spalling, which can result from both subsurface- and surface-initiated RCF, is mentioned in a significant proportion of damage reports. Subsurface-initiated RCF can therefore not be ruled out as possibly contributing to main bearing damage. The presence of surface damage (I, MiSp, P) in around 16% of cases indicates that some proportion of replacements are likely the result of surface-initiated RCF. This type of damage is typically caused by surface distress (due to deformation of asperities) and may be an indication of insufficient lubrication. The risk of surface-initiated RCF is significantly increased if slip is present in combination with abrasive particles or poor lubrication conditions. In such cases, there are non-trivial interactions occurring between wear and RCF mechanisms which can increase the likelihood of surface-fatigue damage initiation. For cases where fatigue has been precipitated by wear, RCF should be considered a secondary damage mode. Unfortunately, the information in the current dataset alone does not allow for easy differentiation between instances of “wear induced” surface-initiated RCF, surface-initiated RCF and subsurface-initiated RCF since widespread spalling is the eventual result in all cases. Wear, fracture, and heat damage are all indicative of non-RCF mechanisms, possibly associated with abrasion, smearing, or impact/excessive loads. Fracture of rings and cages can also result from classical fatigue (not RCF) initiated at a stress riser. With respect to damage locations, the inner raceway is most commonly listed in the collected data, followed by the outer raceway, rollers, the cage and, finally, the housing.

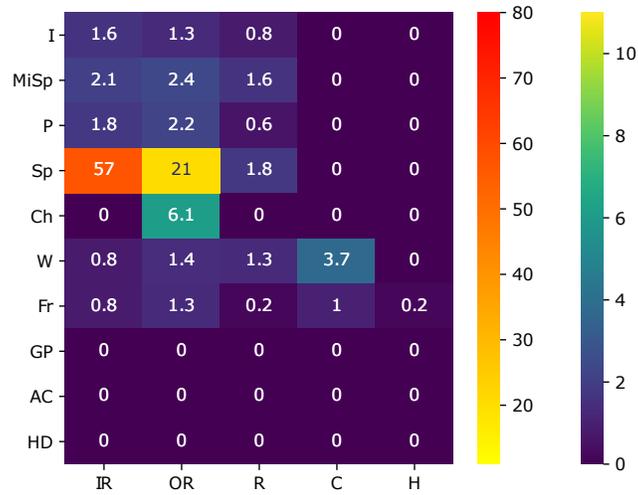
Figure 7 shows the occurrence distribution between damage type and location for the subset of data in which specific damage types are linked with specific locations in the main bearing. Note that chipping was only listed as occurring on the outer raceway, where spalling is the most common form of damage. These results may be linked, because

**Figure 7. Occurrence distribution between damage type and location. Each entry indicates the proportion of damage reports listing both the corresponding damage type and location.**

excessive spalling could lead to increased freedom of movement within the main bearing, allowing the load zone to shift toward the edge of the outer raceway. Under such circumstances edge stresses may occur that exceed the material strength, resulting in a local forced fracture (chip) on the edge of the outer raceway.
